CONCERNING THE PROPERTY AT **14877 Snowhill Drive, Frisco, Texas 75035**

TEXAS REAL ESTATE CONSUMER NOTICE CONCERNING HAZARDS OR DEFICIENCIES

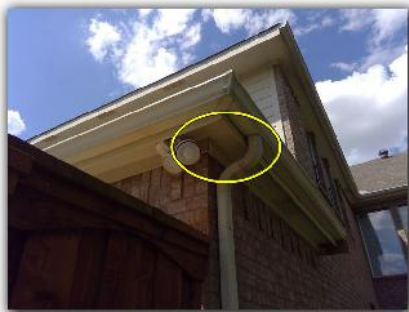
- Interior sheetrock cracks and/or stress indicators.
- Frieze board separations were observed.

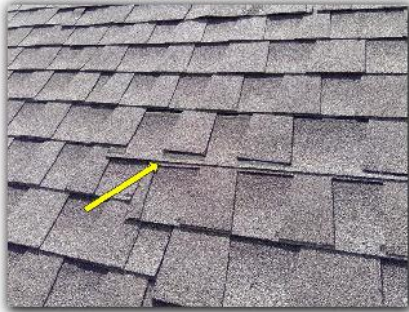
- One or more of the shingle panels were observed to be sliding out of place on the east side of the roof structure.

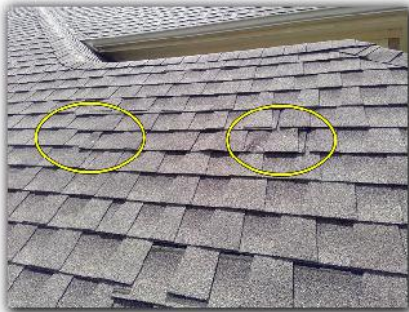
- Shingle fasteners (staples and/or nails) were observed to be pushing through the roofing material in various locations.

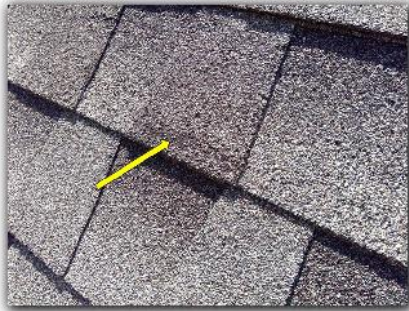
- The composition roofing material has experienced considerable granule loss in various locations throughout the roof.

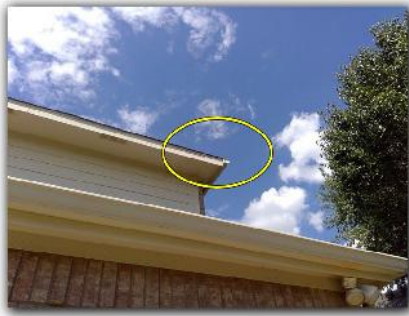
- Damaged shingles were observed on the south side of the roof structure.

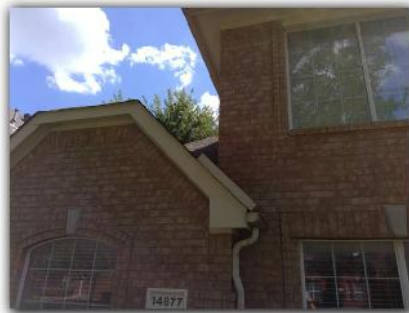
Note: The area pictured below is sometimes called a "dead valley" and can be a source of water intrusion if the flashing begins to fail. This area should be closely monitored and repaired as necessary.

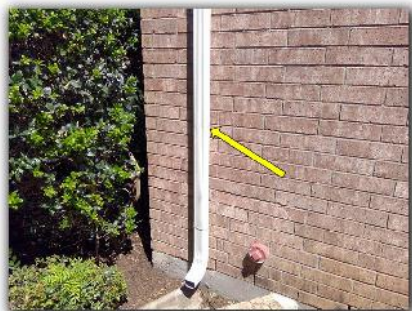
- The guttering system downspout is damaged on multiple sides of the structure.

Note: The gutter downspouts should discharge water at least sixty inches (60") away from the foundation perimeter beam. Storm water should be encouraged to flow away from the structure at the points of discharge.

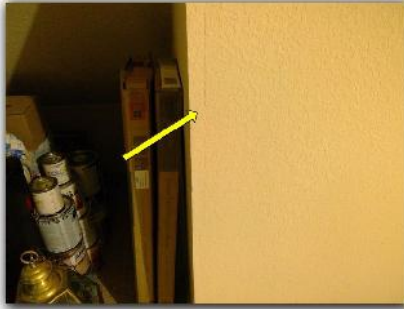
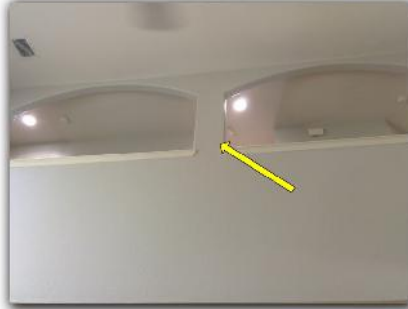
- Interior wall joint cracks were observed in various locations throughout the house.

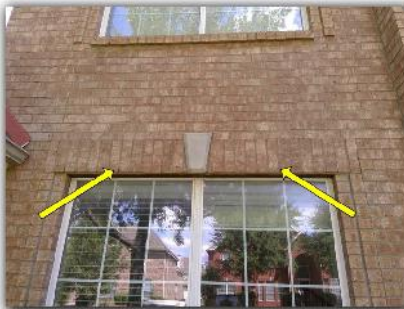
- There were no weepholes observed in the low course of the exterior masonry veneer over the window and door steel lintels. This condition does not meet current building standards and should be corrected as necessary.

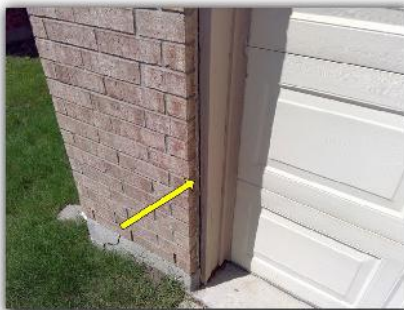
- Caulking improvements are recommended for the area between the exterior veneer and the garage door trim boards. It is recommended to use elastomeric caulking.

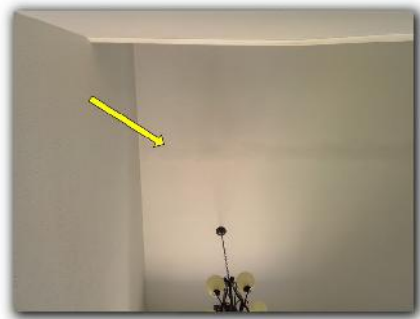
- Ceiling joint cracks were observed in various locations throughout the house.

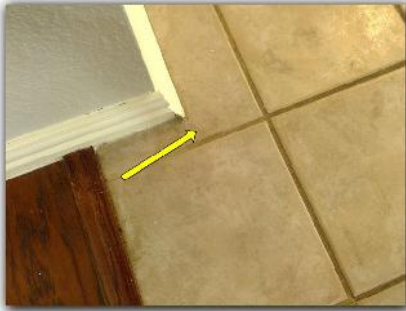
- The floor tile(s) were observed to be cracked and/or damaged in breakfast area.

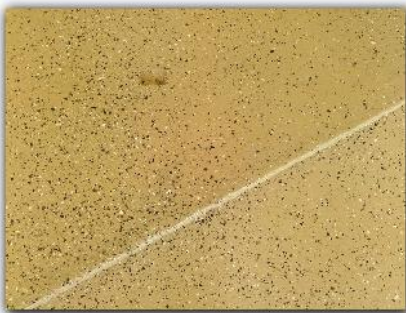
Note: Some cracking of the garage concrete floor finish was observed.

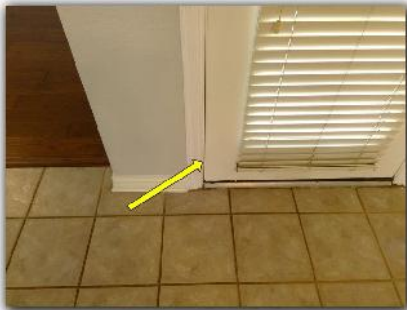
- Weather stripping improvements are recommended for exterior doors.

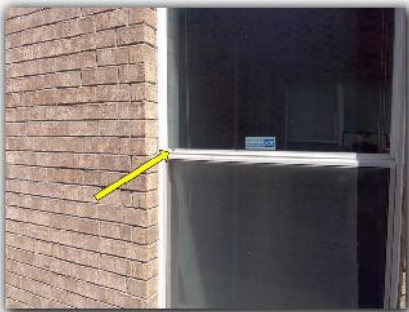
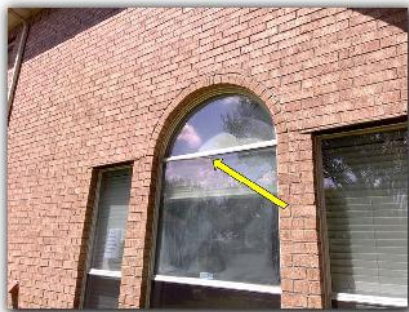
- The window weather-stripping is damaged and/or missing at one or more of the windows and improvements are recommended.

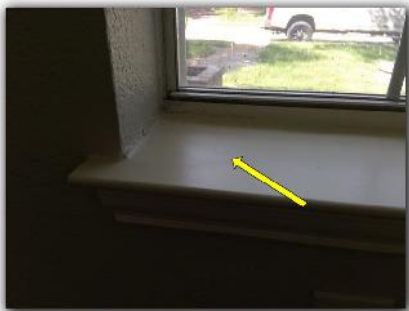
- The window sill(s) have some deteriorated and/or damaged to the living room.
- Visible evidence of water intrusion was observed at and/or around the window(s) in the living room. The cause and remedy should be investigated and corrected as necessary.

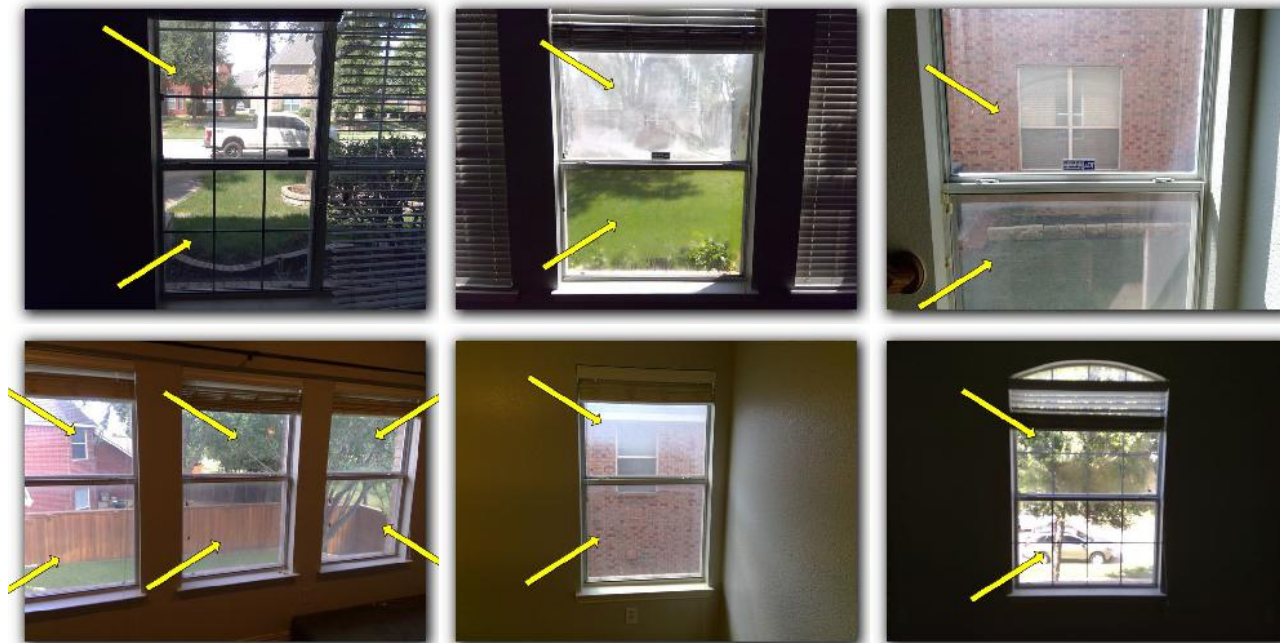
- One or more of the thermal pane windows were observed to have lost their seals. This has resulted in condensation or a fog like film to develop between the panes of glass. The thermal pane windows no longer function as designed when they loose their seal and replacement may be necessary. The windows that have noticeably lost their seals are listed but may not be limited to the following:
various locations throughout the house.

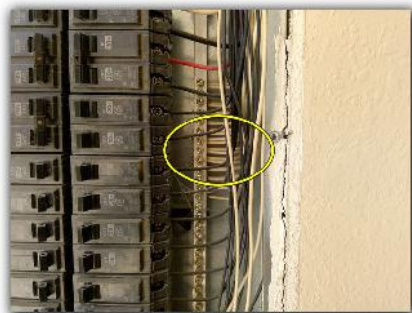
- The neutral bar was observed to be double lugged (two or more wires under one screw). Each neutral wire should have it's own

terminal on the neutral bar. *This is an a"as built" condition, but per the TREC standards , I am required to report this as a deficiency.*

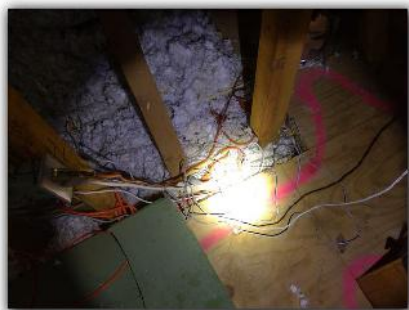
- Electrical flex extension cords should not be used for permanent wiring or pass through walls or ceilings. The improper use of extension cord was observed in or around the attic area.

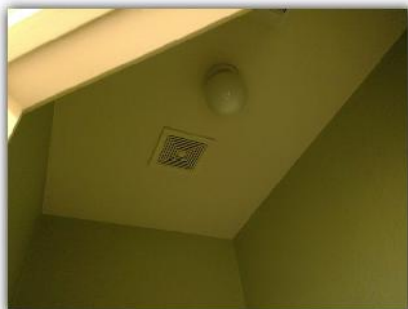
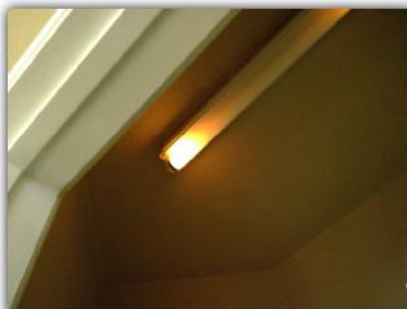
- One or more of the light fixtures appear to be inoperative in the master bathroom, pantry, guest bedroom closet, bedroom hallway. This may be due to a bad bulb or some other unknown condition. This condition should be further evaluated and corrected as necessary.

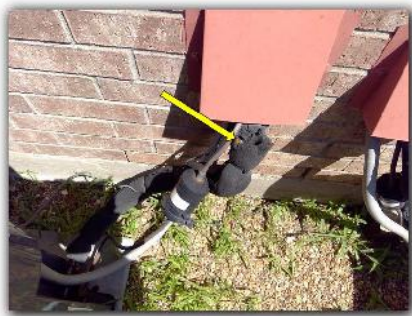
- Damaged, deteriorated and/or missing insulation on the refrigerant lines should be repaired or replaced at the outside condenser.

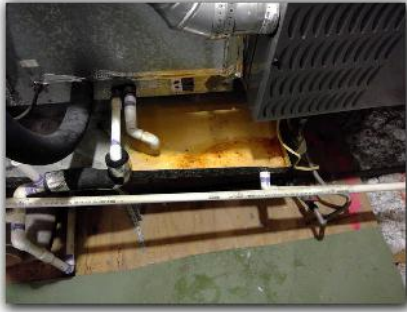
- The manufacturers listing plate on the outside condenser/coil list that the maximum over current device (breaker) to be used should not exceed 50-amp. There is a 60-amp breaker in place at this time. This breaker in place does not meet the manufacturers listing plate requirements.
- The auxiliary/secondary drain pan under the coil housing is holding water at the time of this inspection. The cause and remedy should be further evaluated and corrected as necessary.

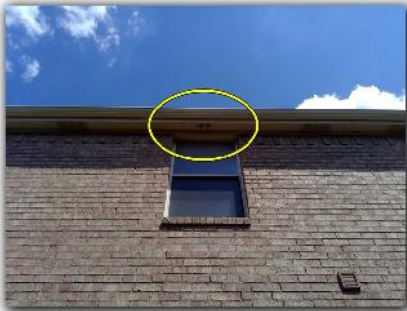
- The secondary condensate drain line is leaking water to the exterior of the house indicating the primary drain line is being bypassed. This usually indicates that servicing is needed.

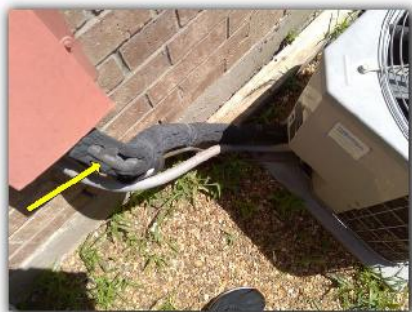
- Damaged, deteriorated and/or missing insulation on the refrigerant lines should be repaired or replaced at the outside condenser.

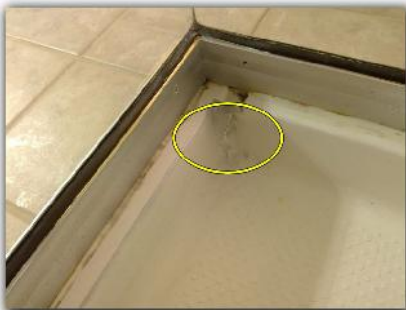
- The shower fiberglass enclosure glass is damaged.

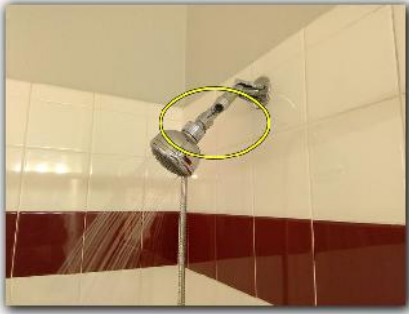
- Cracked, deteriorated and/or missing shower stall grout and/or caulking should be repaired or replaced as necessary.
- The shower spout is leaking at the neck connection.

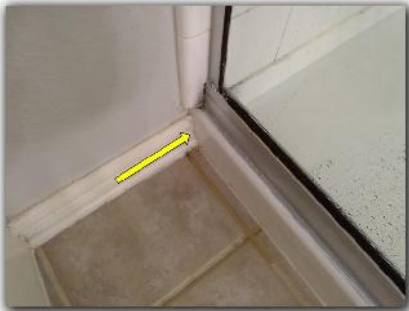
- The shower enclosure is not water tight and leaks to the area adjacent to the shower. This condition should be further evaluated and corrected as necessary.

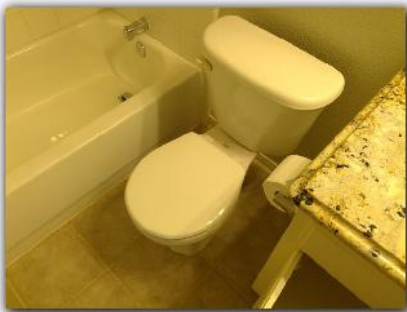
- The commode is inoperative. The cause and remedy should be further evaluated and corrected as necessary.

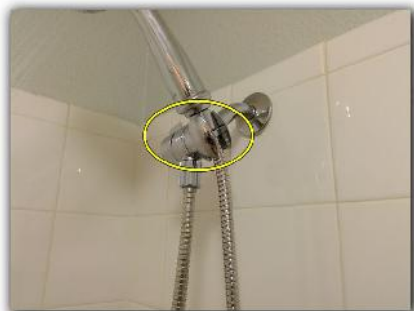
- The shower spout is leaking at the neck connection.

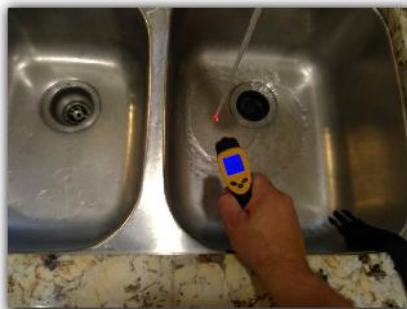
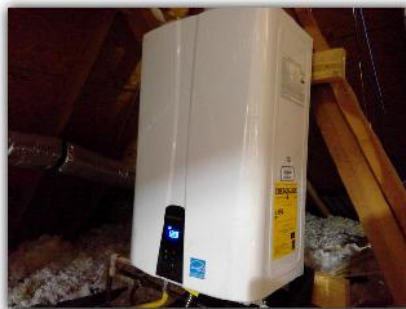
- The water heater gas supply line is not equipped with a sediment trap just before the gas appliance connector. This condition does not meet current installation requirements and should be corrected.

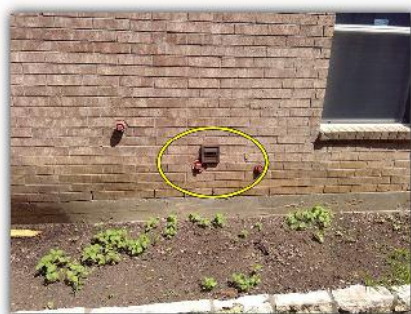
- The dryer exhaust duct (vent pipe) is dirty and needs to be cleaned.
- The exterior dryer duct termination cover is damaged.

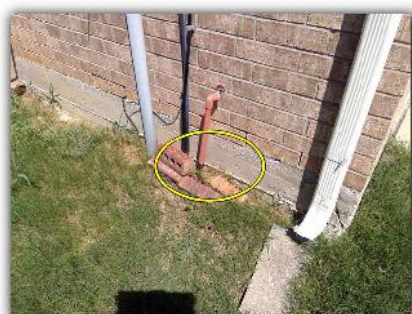
- The conduit that is protecting the sprinkler system wires is damaged.
