124 Norman Road
Aptos CA 95003

Country Home Inspection and Termite Inc.

Inspection Date: 4/12/2021
Report ID: 20210412-124-Norman-Rd

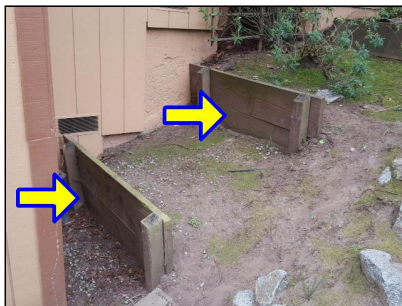
1.0 Item 1(Picture)

Retaining wall tilted at various areas of the yard. Recommend monitoring the retaining walls and have them further evaluated when needed by a Landscape Contractor.

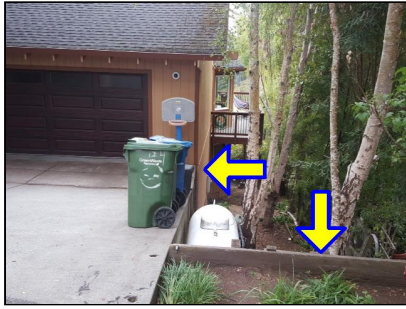
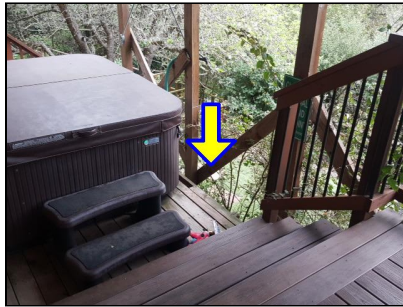
(1) The guard-rail(s) is missing on the right side of the driveway and around the hot tub. This is considered a safety hazard. Recommend installing a proper guardrail as needed by a qualified licensed contractor.

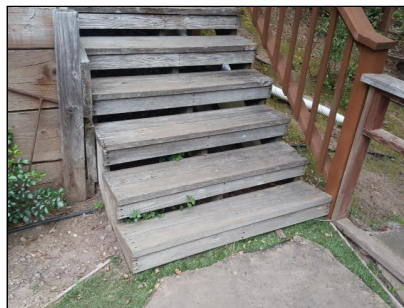
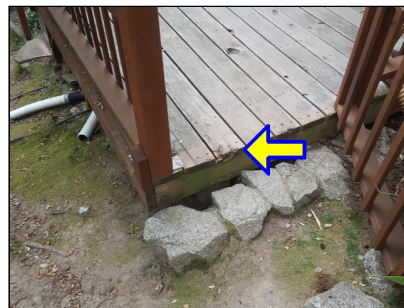
(2) Wood deck has signs of dry-rot and fungus damage on various areas of the decks, recommend refer to pest inspection or licensed Contractor for further information.

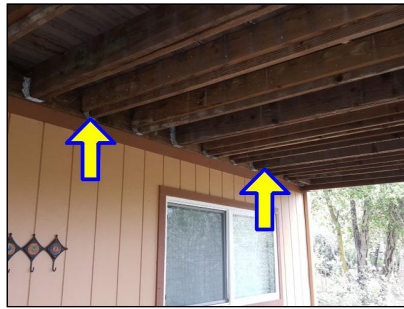
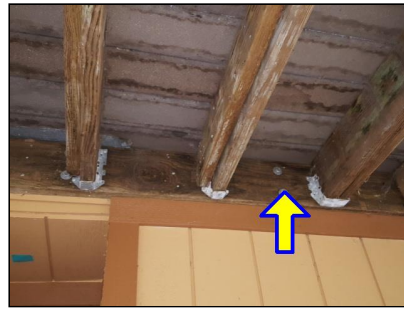
(3) The left side deck ledger board that is attached to the home has been installed without flashing, creating a condition conducive to deterioration. We recommend this board be flashed or properly sealed by a qualified licensed contractor to help prevent deterioration at this location.

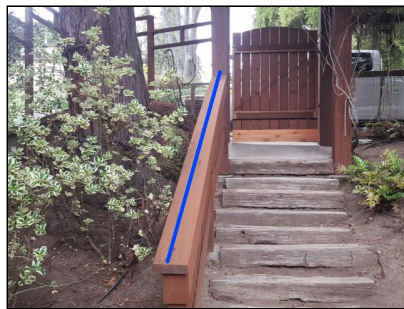
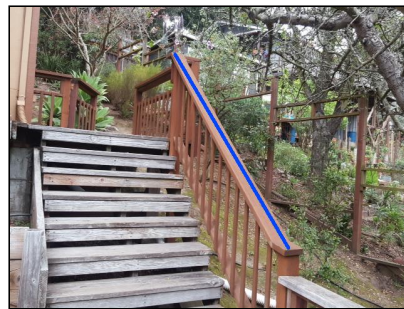
(1) Exterior steps handrail(s) improper. Noted on various stairs around the home. Although there is a handrail installed. Recommend installing a handrail that can be grasped with one hand. 1 1/2 width is recommended for the handrail(s).

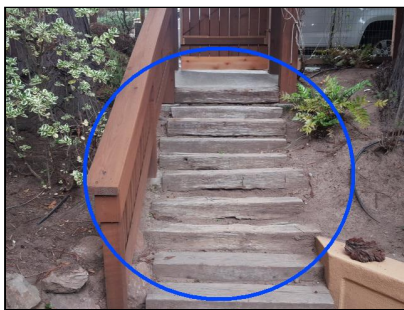
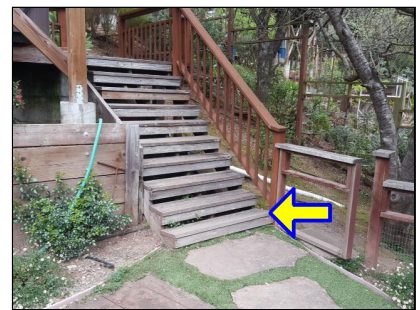
(2) Exterior stairway riser varies more than 3/8 of an inch and or over 8 inches in height. Noted on various stairs around the home. Improper rise or run was noted at the stairs. This means that one or more of the stairs was higher or longer than the others or that the length of the stairs does not meet current standards. This should be considered a tripping hazard and correction is recommended.

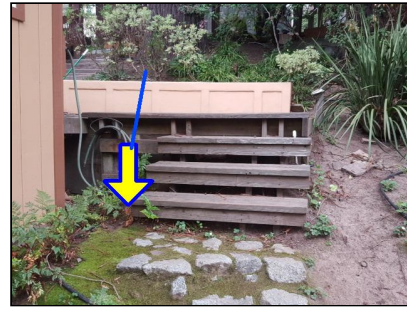
1.2 Item 6(Picture)

(3) The handrail on various stairs around the home is missing. Handrails are required on at least one side of stairs with 4 or more risers. The height of the handrail must at least 34 inches but cannot be more than 38 inches above nosing of the stair. The hand grip portion of handrail must be at least 1 1/4 inches but not more than 2 inches in circular cross section. A handrail should be installed for safety by a licensed qualified contractor.

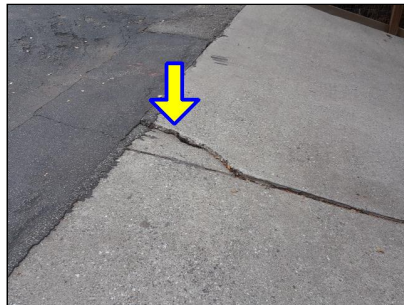
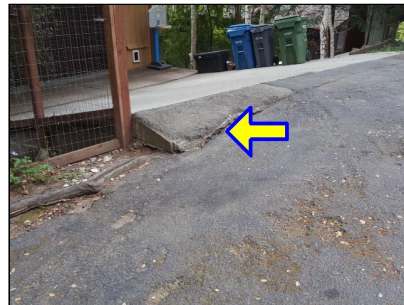
(1) Uneven walkways, possible trip hazard on the driveway. We recommend the trip hazards be corrected. Recommend further evaluation by a landscape contractor.

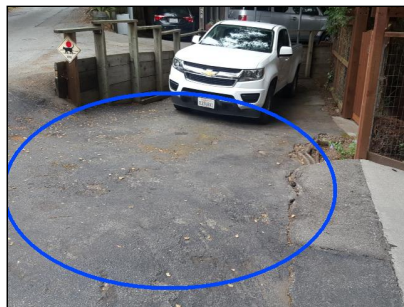
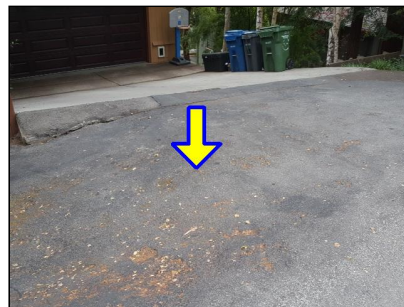
(2) Asphalt seal coat / general maintenance needed. The driveway is in serviceable condition. Proper maintenance will extend the life of the asphalt driveway. Recommend the driveway and all cracks be sealed.

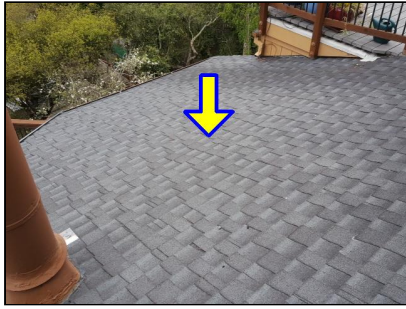
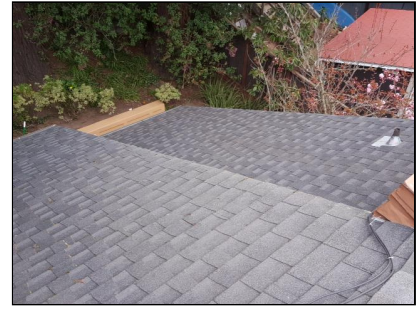
Roof weathering, showing signs of aging. Typical granule loss is noted on areas of the composition shingles. Appears to be normal wear. The exact age of the roof is uncertain. Recommend periodic inspections by a Qualified Roofing Contractor.

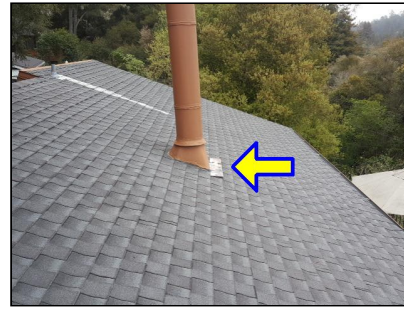
2.1 Item 1(Picture)

Metal flashing is lifting around the chimney. This can allow moisture to wick under the flashing. Recommend all flashing be secured / nailed as needed. Recommend further evaluation by a qualified roofing contractor.

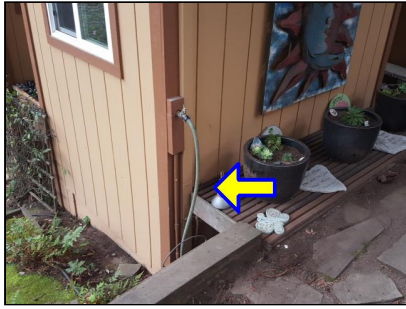
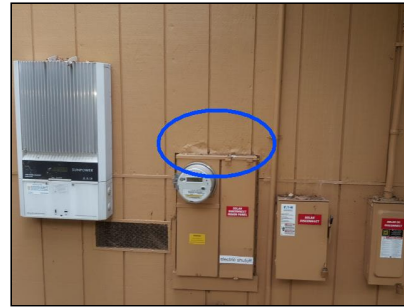
Exterior siding has signs of dry-rot or fungus damage. Noted on the home at various locations. Recommend refer to pest inspection for all locations of damaged siding.

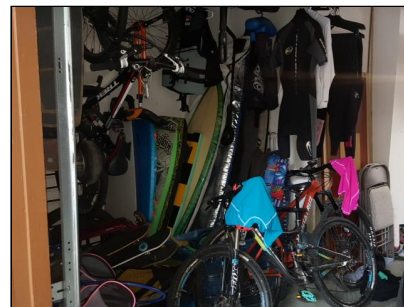
2.6 Item 2(Picture)

Access impaired. The garage was full of storage at the time of the inspection. The garage was not fully inspected. We recommend the storage be removed and the garage be fully inspected before the close of escrow.

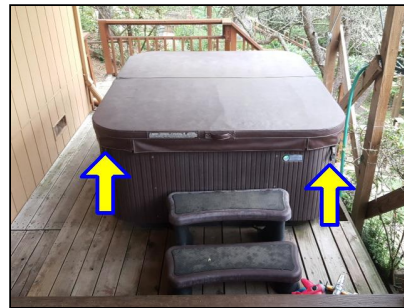
3.0 Item 1(Picture)

(1) The spa DOES have a locking cover. This DOES confirm to the Santa Cruz County Swimming Pool Ordinance.

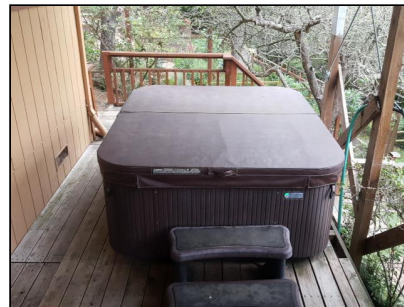
3.0 Item 2(Picture)

(2) The spa and its components were not inspected and is not part of the home inspection. Recommend the spa be inspected by a Qualified Pool Contractor prior to the release of the inspection contingency.

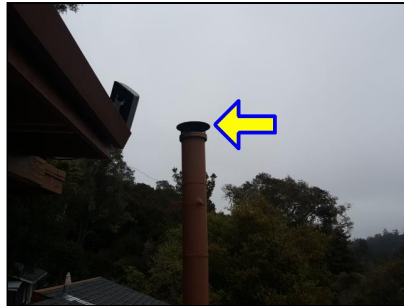
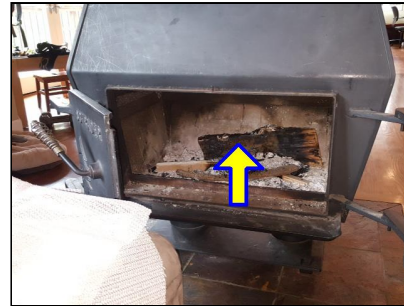
A limited fireplace inspection was performed. We recommend a clean and review of the chimney(s) and firebox(s). The inside of the chimney was not inspected. We were unable to determine the condition of the flue liner. It is recommended that the chimney(s) be cleaned to allow for further and complete inspection by a qualified chimney sweep.

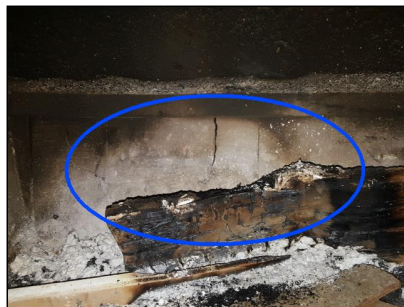
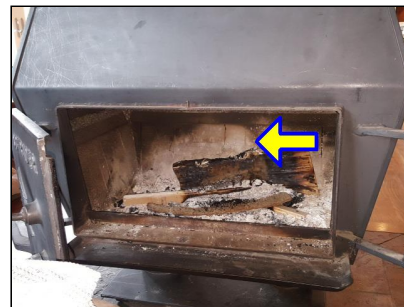
Fire-brick cracked. Recommend replacing fire-brick as needed. It is recommended that the finding be reviewed, and corrected as needed, by a qualified licensed contractor.

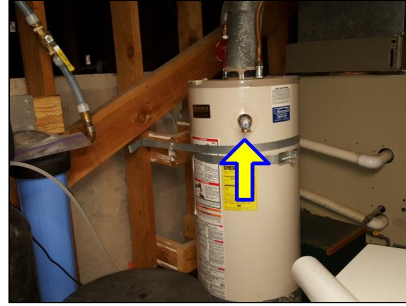
6.0 Item 2(Picture)

Water heater pressure / temperature relief valve discharge not terminated within 6" of the floor. Recommend installing a metal pipe on the water heater relief valve. Recommend the pipe extend to the floor or exterior of the home and within 6 inches of the ground. Recommend repairs by a qualified person.

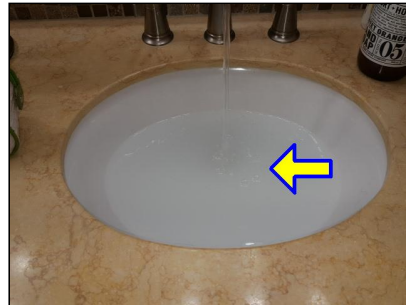
6.1 Item 2(Picture)

Fixture drain slow or possibly clogged in the downstairs bathroom on the sink drain. In most cases this is an indication that there is build up in the p-trap in the sink drain line. We recommend cleaning the p-trap. If there is no change in the drainage we recommend further evaluation and repair by a qualified licensed plumbing contractor.

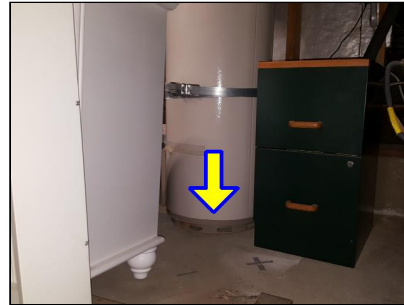
6.8 Item 1(Picture)

LPG drain pan not installed. This was noted at the water heater. Recommend installing a drain pan under the water heater with a drain line to the exterior. This is recommended in case of an accidental gas leak.

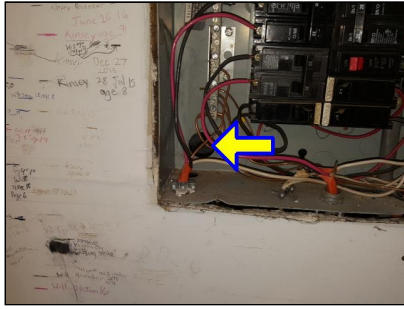
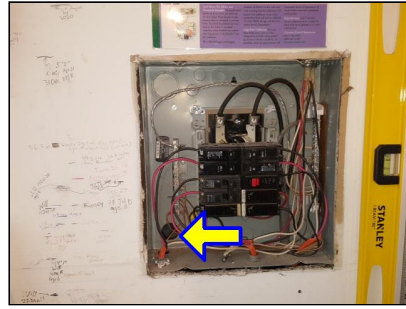
Recommend sealing all openings in the sub-panel. Recommend further evaluation and repair as necessary.

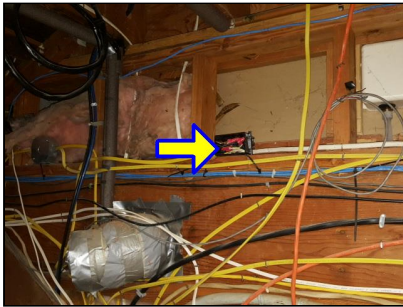
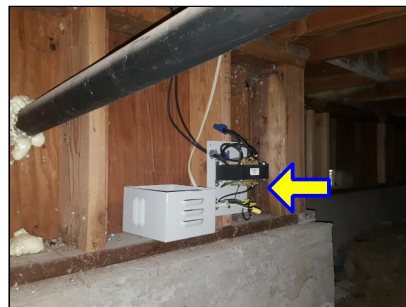
(1) Junction box cover plate missing. Noted in the sub-area. Junction box cover plates are required to prevent accidental contact with the splice and to confine heat in the event of an overheated splice. Recommend repair as soon as possible. There may be others missing junction box covers that were not located. It is recommended that the finding be reviewed, and corrected as needed, by a qualified licensed contractor before purchasing the property. A qualified licensed electrical contractor should correct as needed.

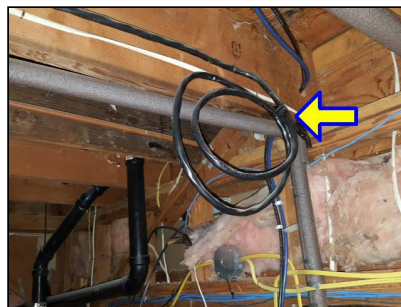
7.4 Item 6(Picture)

(2) Junction box not installed as required (exposed splice). Noted in the sub-area. Junction box's are required to prevent accidental contact with the splice and to confine heat in the event of an overheated splice. Recommend repair as soon as possible. There may be others missing junction boxes that were not located. It is recommended that the finding be reviewed, and corrected as needed, by a qualified licensed electrical contractor before purchasing the property.

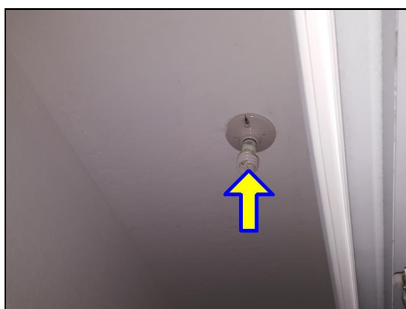
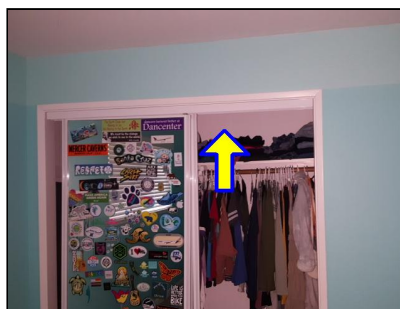
Incandescent bulb exposed in closet or type that could be damaged. The light bulb(s) in the closet(s) were not protected from coming into contact with combustible material. In some cases if stored items come in contact with the light bulbs this could be a fire hazard. We recommend upgrading the light fixtures to have safety covers. Modification or addition is generally considered an upgrade which should improve safety or efficiency. The opinion of a qualified repair person is recommended.

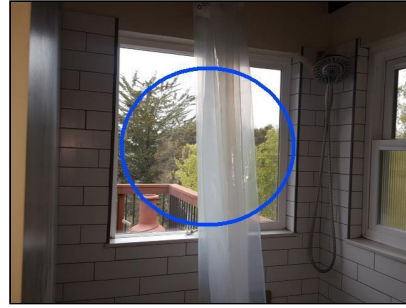
8.0.A Item 1(Picture)

Low window noted in bathroom shower area. Recommend installing a water proof curtain at the window. Correction or modification decreases the probability of continued and excessive deterioration.

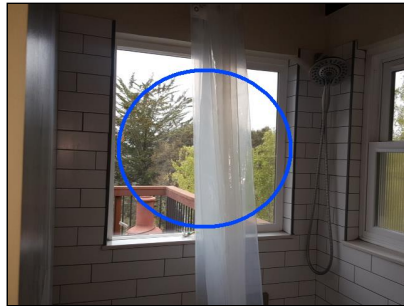
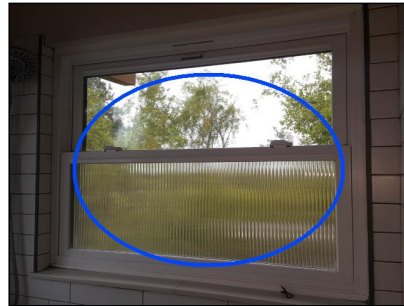
Window near tub or shower does not appear to be safety glaze / has no visible emblem to indicate safety glass. Noted in the master bathroom. Glazing in any portion of a building wall enclosing tub or shower compartments where the bottom exposed edging of the glazing is less than 5 feet above a standing surface and drain inlet should be tempered glass. Windows which are not tempered or shatterproof that are near tubs or showers can be dangerous. If the position of the window is such that someone could slip and fall against it, breaking the glass, the result could be severe personal injury. Older homes did not require this particular glazing. This item is often mentioned to bring to your attention a helpful safety reminder. Contact a Glass Company for an additional opinion and assistance if desired.

Window near tub or shower does not appear to be safety glaze / has no visible emblem to indicate safety glass. Noted in the master bathroom. Glazing in any portion of a building wall enclosing tub or shower compartments where the bottom exposed edging of the glazing is less than 5 feet above a standing surface and drain inlet should be tempered glass. Windows which are not tempered or shatterproof that are near tubs or showers can be dangerous. If the position of the window is such that someone could slip and fall against it, breaking the glass, the result could be severe personal injury.

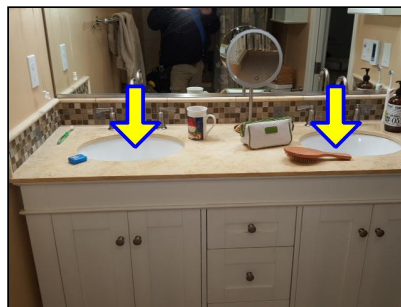
8.2.C Item 1(Picture)

Drain stopper needs adjusting on bathroom sink(s) in the downstairs bathroom. Recommend the drain stopper(s) be adjusted or replaced as needed.

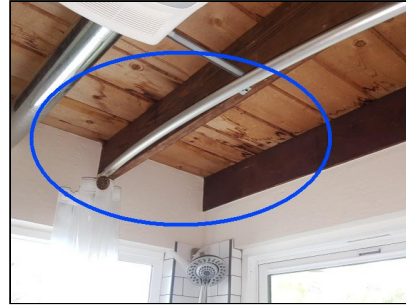
9.0 Item 1(Picture)

Stain noted on interior ceiling in the upstairs bathroom. It is recommended that the finding be reviewed, and corrected as needed, by a qualified licensed roofing contractor.

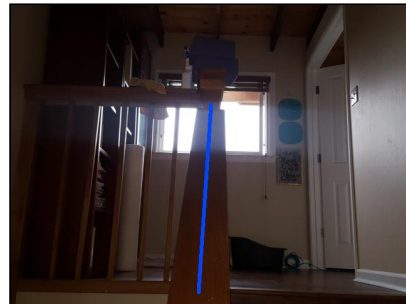
9.4 Item 1(Picture)

(1) Interior steps handrail(s) improper. Noted on the interior stairway. Although there is a handrail installed. Recommend installing a handrail that can be grasped with one hand. 1 1/2 width is recommended for the handrail(s). This can help prevent a fall or slip.

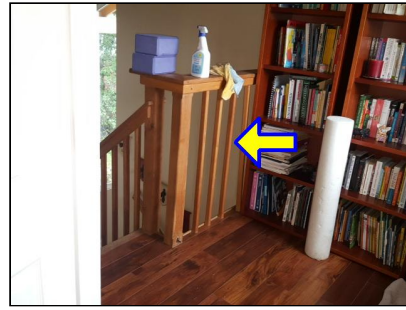
9.4 Item 2(Picture)

(2) Handrail / guardrail baluster spacing exceeds 4 inches at the stairway(s). Though the guardrail may have conformed to regulations at the time of construction, upgrading to current standards is strongly recommended. Recommend 4 inch spacing at all guardrails. Modification or addition is generally considered an upgrade which should improve safety or efficiency. The opinion of a qualified licensed contractor is recommended.

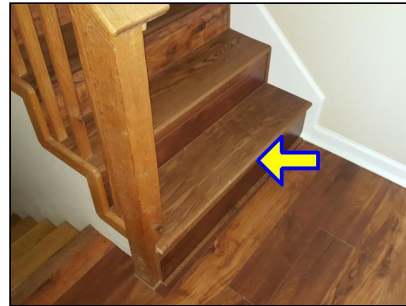
9.4 Item 3(Picture)

(3) The stairway riser varies more than 3/8 of an inch and or over 8 inches in height. Improper rise or run was noted at the stairs. This means that one or more of the stairs was higher or longer than the others or that the length of the stairs does not meet current standards. This should be considered a tripping hazard and correction is recommended. Correction is recommended.

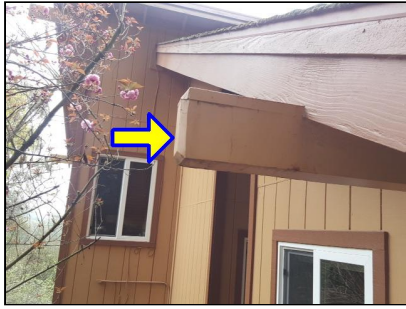
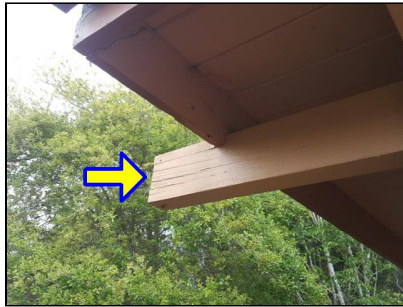
(1) Wood deterioration noted in roof beam ends at a number of locations. Recommend refer to pest inspection or a licensed Contractor for further information concerning all possible areas with dry rot, pest or fungus damage.

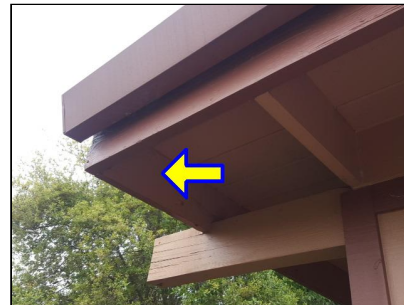
11.1 Item 5(Picture)

(2) Wood deterioration noted in barge rafter(s). Recommend further inspection and repair by a qualified licensed contractor.

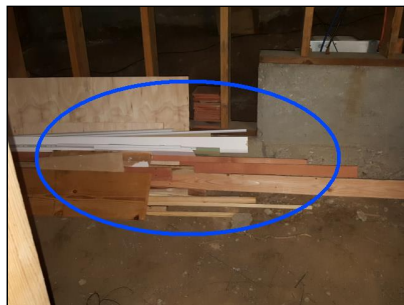
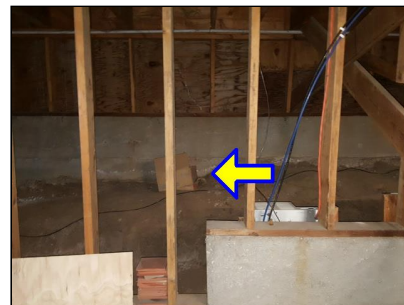
Cellulose debris (scrap wood ect.) present in sub-area. Recommend removing all scrap wood or cardboard from sub-area.
