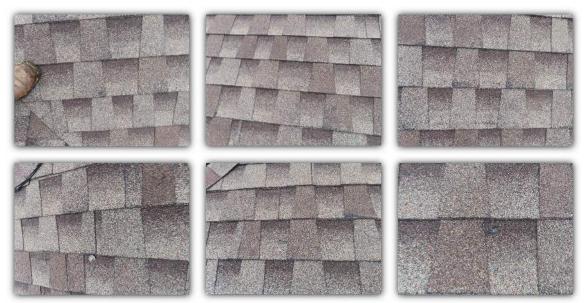
- There was no kickout flashing details observed at the lower bottom edge of the roof line interface and the sidewall that continues past the edge of the roof. The lack of this kickout flashing will allow water to penetrate at these points.

- Worn / scuffed covering noted. Refer to a roofing contractor for recommendation/ repairs/ replacement options.
- Notice: Refer to your seller for further information. Contact your insurance company & see if they will pull a CLUE report before closing to better inform concerning your future purchase. C.L.U.E. (Comprehensive Loss Underwriting Exchange) is a claims history database generated by LexisNexis® that enables insurance companies to access consumer claims information when they are underwriting or rating an insurance policy.

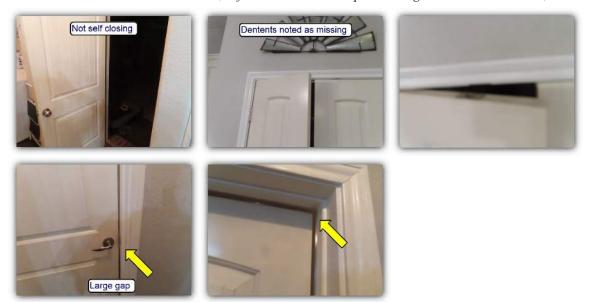
- The garage service door closer hinge spring was noted as not fully closing the door on a one foot swing.
- The door to the laundry room was noted to have a large gap along the striker plate side to the point it can pass the door stop as well as rubbing at the top corner.
- One or more of the doors for the structure interior were noted to be lacking detent ball and springs.

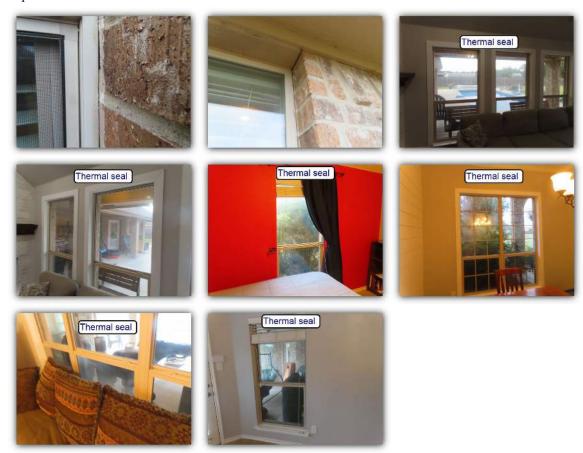
- The windows appeared to have loss of thermal seals, as noted at/ in multiple locations around the entire structure such as noted in the living areas, dining room and bedroom areas. See Pics above as examples.
- Exterior window(s sealant show separation/ age / in need of servicing/replacement/. Recommend all areas to be serviced at the purchaser's &/or repair professional's discretion.
