# WOOD DESTROYING PESTS AND ORGANISMS INSPECTION REPORT #: 20200533

BUILDING NO. 124	STREET NORMAN ROAD	CITY APTOS	ZIP 95003	Date of Inspection 11/04/2020	NUMBER OF PAGES 1 of 6
---------------------	-----------------------	---------------	--------------	----------------------------------	---------------------------

GENERAL DESCRIPTION:  
 This is a multi-story, single family residence on a raised foundation. It has an attached garage. It has a composition roof and was occupied and furnished at the time of inspection.

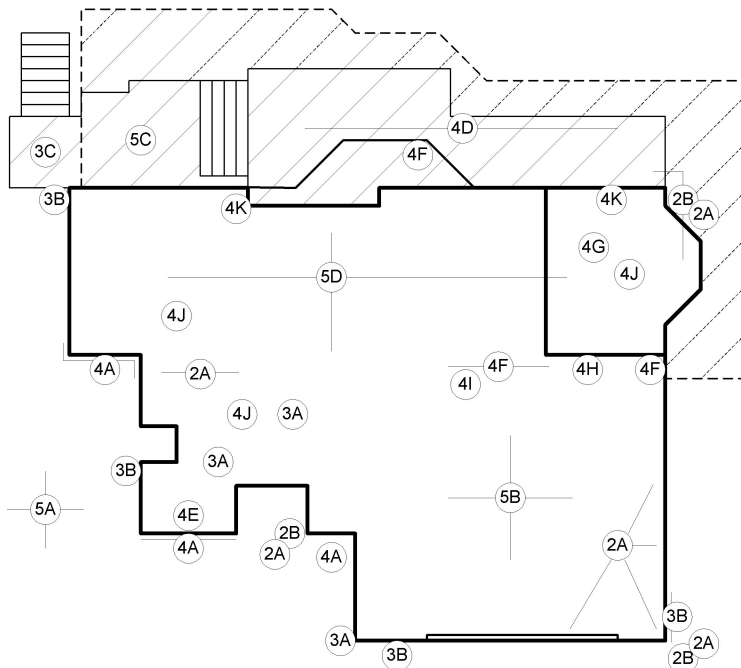
**FINDING:** EVIDENCE OF DRYWOOD TERMITES WAS FOUND IN THE ROOF EAVES AND THE SUBAREA UNDER THE GARAGE AS INDICATED BY 2A ON THE DIAGRAM.

**FINDING AND RECOMMENDATION: 2B** DRYWOOD TERMITE DAMAGE WAS FOUND IN THE ROOF SHEATHING, FASCIA AND EXPOSED BEAMS AT THE EAVES AS INDICATED ON THE DIAGRAM.

**FINDING AND RECOMMENDATION: 3A** FUNGUS/DRYROT DAMAGE WAS FOUND IN THE ENDS OF THE EXPOSED ROOF BEAMS AS INDICATED ON THE DIAGRAM.

**FINDING AND RECOMMENDATION: 3B** EARTH CONTACTS AND FUNGUS/DRYROT DAMAGE WAS FOUND IN THE BASE OF THE SIDING AS INDICATED ON THE DIAGRAM. THE DAMAGE EXTENDS INTO THE CRIPPLE FRAMING ADJACENT THE DRIVEWAY.

FINDING AND RECOMMENDATION: 3C FUNGUS/DRYROT DAMAGE WAS FOUND IN THE JOISTS AND FRAMING UNDER THE DECK AS INDICATED ON THE DIAGRAM.

FINDING: EARTH TO WOOD CONTACTS WERE NOTED AT THE SIDING AND RETAINER WALL PLATFORMS AS INDICATED ON THE DIAGRAM.

FINDING: EARTH TO WOOD CONTACTS WERE NOTED AT THE WALL FRAMING IN THE SUBAREA AS INDICATED ON THE DIAGRAM.

FINDING AND RECOMMENDATION: 4K EVIDENCE OF FALSE POWDER POST WOOD BORING BEETLES WAS NOTED IN THE SUBSTRUCTURE FRAMING AS INDICATED ON THE DIAGRAM. VARIOUS AREAS WERE PROBED AND THE EVIDENCE APPEARS TO BE INACTIVE.

**RECOMMENDATION: 2A** TARP AND FUMIGATE THE STRUCTURE WITH (SULFURYL FLUORIDE) A FUMIGANT LETHAL TO DRYWOOD TERMITES. SEE THE OCCUPANTS FUMIGATION NOTICE FOR FURTHER DETAILS. THIS COMPANY IS NOT RESPONSIBLE FOR DELAYS OR SCHEDULE CHANGES DUE TO INCLEMENT WEATHER OR OTHER AGENCIES, NOR IS IT RESPONSIBLE FOR DAMAGE TO ROOF OR PLANTS AS A RESULT OF THE FUMIGATION. REFER TO THE OCCUPANT'S FUMIGATION NOTICE/PREPARATION SHEET (SENT SEPARATELY) FOR ADDITIONAL INFORMATION.

CUT OUT DAMAGED WOOD AND REPAIR AS NECESSARY.

**RECOMMENDATION: 3A** CUT OUT THE DAMAGE AND REPAIR AS NECESSARY.

**FINDING:** CUT OUT THE DAMAGED WOOD AND REPLACE WITH NEW MATERIALS FREE OF GROUND CONTACTS. IF THE DAMAGE EXTENDS INTO INACCESSIBLE AREAS, ADDITIONAL COSTS WILL BE INCURRED.

FINDING: CUT OUT THE DAMAGED WOOD AND REPLACE WITH NEW PRESSURE TREATED MATERIALS. IF THE DAMAGE EXTENDS INTO INACCESSIBLE AREAS, ADDITIONAL COSTS WILL BE INCURRED.

FINDING: REVISE THE AREAS TO BE FREE OF EARTH TO WOOD CONTACTS.

FINDING: REVISE THE AREA TO BE FREE OF EARTH TO WOOD CONTACTS.
