# WOOD DESTROYING PESTS AND ORGANISMS INSPECTION REPORT

#: 20201274

BUILDING NO. 1365	STREET BROMMER STREET	CITY SANTA CRUZ	ZIP 95062	Date of Inspection 08/16/2021	NUMBER OF PAGES 1 of 6
----------------------	--------------------------	--------------------	--------------	----------------------------------	---------------------------

## WHEELER TERMITE CO.

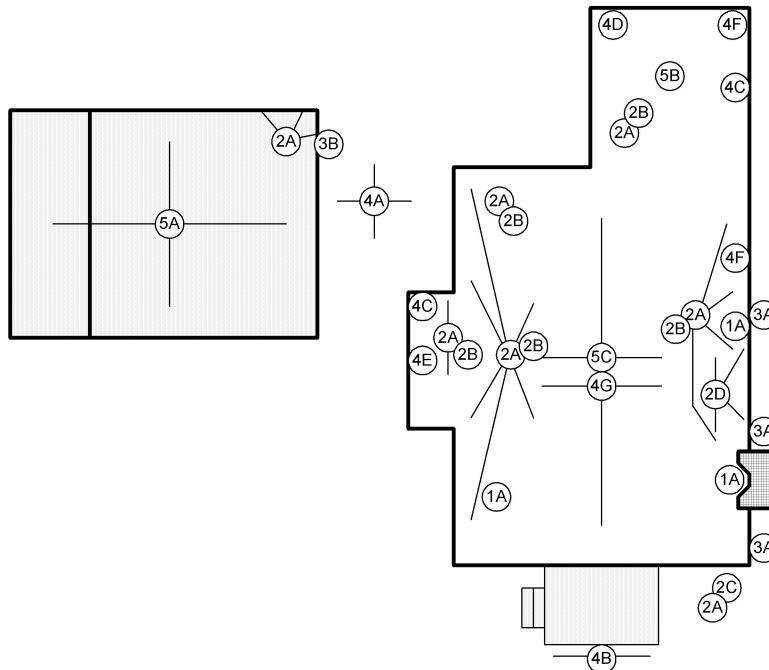
FINDING AND RECOMMENDATION: 1A EVIDENCE OF SUBTERRANEAN TERMITES WAS FOUND IN THE SUBAREA AS INDICATED ON THE DIAGRAM. VARIOUS AREAS WERE PROBED AND NO VISIBLE ACTIVITY WAS FOUND.  
 PERIODIC INSPECTION RECOMMENDED.

FINDING: EVIDENCE OF DRYWOOD TERMITES WAS FOUND IN THE ROOF EAVES, DETACHED GARAGE, ATTIC AND SUBAREA AS INDICATED BY 2A ON THE DIAGRAM.  
 RECOMMENDATION: 2A TARP AND FUMIGATE THE STRUCTURES WITH (SULFURYL FLUORIDE) A FUMIGANT LETHAL TO DRYWOOD TERMITES. SEE THE OCCUPANTS FUMIGATION NOTICE FOR FURTHER DETAILS. THIS COMPANY IS NOT RESPONSIBLE FOR DELAYS OR SCHEDULE CHANGES DUE TO INCLEMENT WEATHER OR OTHER AGENCIES, NOR IS IT RESPONSIBLE FOR DAMAGE TO ROOF OR PLANTS AS A RESULT OF THE FUMIGATION. REFER TO THE OCCUPANT'S FUMIGATION NOTICE/PREPARATION SHEET (SENT SEPARATELY) FOR ADDITIONAL INFORMATION.

FINDING AND RECOMMENDATION: 2B DRYWOOD TERMITE PELLETS WERE FOUND IN THE ATTIC AND SUBAREA AS INDICATED ON THE DIAGRAM.  
 REMOVE OR MASK THE PELLETS TO AID IN FUTURE INSPECTIONS.

FINDING AND RECOMMENDATION: 2C MINOR DRYWOOD TERMITE DAMAGE WAS NOTED IN THE RAFTER TAIL AT THE EAVES AS INDICATED ON THE DIAGRAM. THE DAMAGE APPEARS TO SUPERFICIAL AND AREA APPEARS TO BE STRUCTURALLY SOUND.  
 FILL AND PAINT AS NECESSARY.

FINDING AND RECOMMENDATION: 2D MINOR DRYWOOD TERMITE DAMAGE WAS NOTED THE RAFTERS AND ROOF SHEATHING IN THE ATTIC. THE MINOR DAMAGE DOES NOT APPEAR TO WARRANT REPLACEMENT AT THIS TIME.

FINDING AND RECOMMENDATION: 3A FUNGUS/DRYROT DAMAGE WAS FOUND IN THE WINDOW TRIMS AS INDICATED ON THE DIAGRAM.

FINDING AND RECOMMENDATION: 3B FUNGUS/DRYROT DAMAGE WAS FOUND IN THE GARAGE SERVICE DOOR AS INDICATED ON THE DIAGRAM.

FINDING AND RECOMMENDATION: 4A THE EXTERIOR WOOD MEMBERS WERE NOTED TO BE WEATHERED. SOME OF THE PLYWOOD ROOF EAVES ARE DELAMINATED.

REPAIR THE DAMAGED AREAS WHEN THE NEXT ROOF IS INSTALLED.

RECOMMENDATION: 3A CUT OUT THE DAMAGED TRIMS AND REPAIR AS NECESSARY.

RECOMMENDATION: 3B REPAIR OR REPLACE THE DOOR AS NECESSARY.

AS PART OF ROUTINE MAINTENANCE KEEP THE AREAS SEALED AND PAINTED. REPLACE WHEN NECESSARY.
