# espc::home report

3 Caiystane Gardens  
Edinburgh  
EH10 6TA  
29/01/2025

# SCOTTISH SINGLE SURVEY

**3 CAIYSTANE GARDENS  
EDINBURGH  
EH10 6TA**

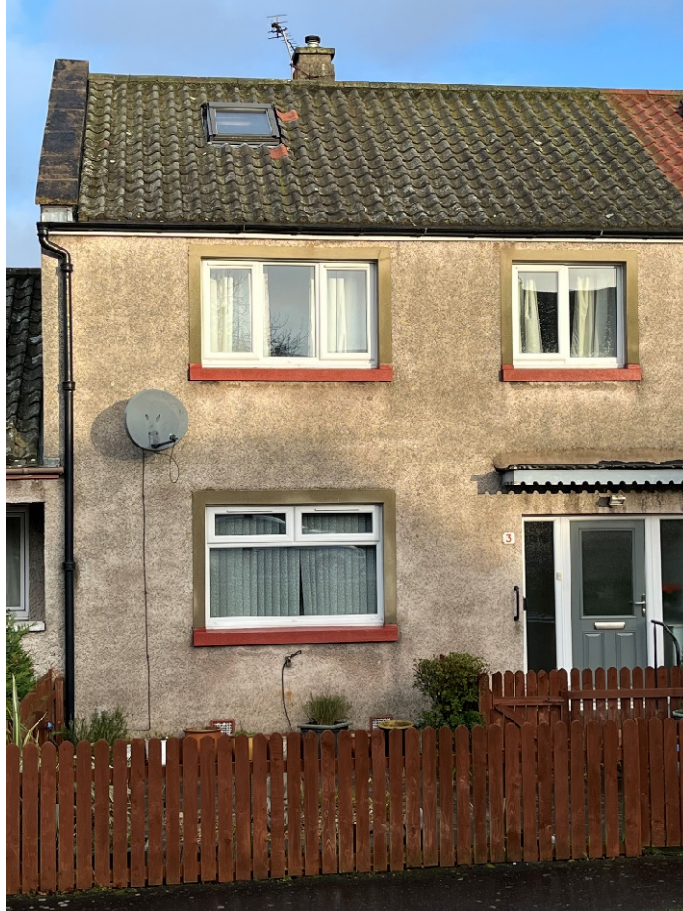
*Figure 1 – Front elevation of the Property showing level ridge line.*

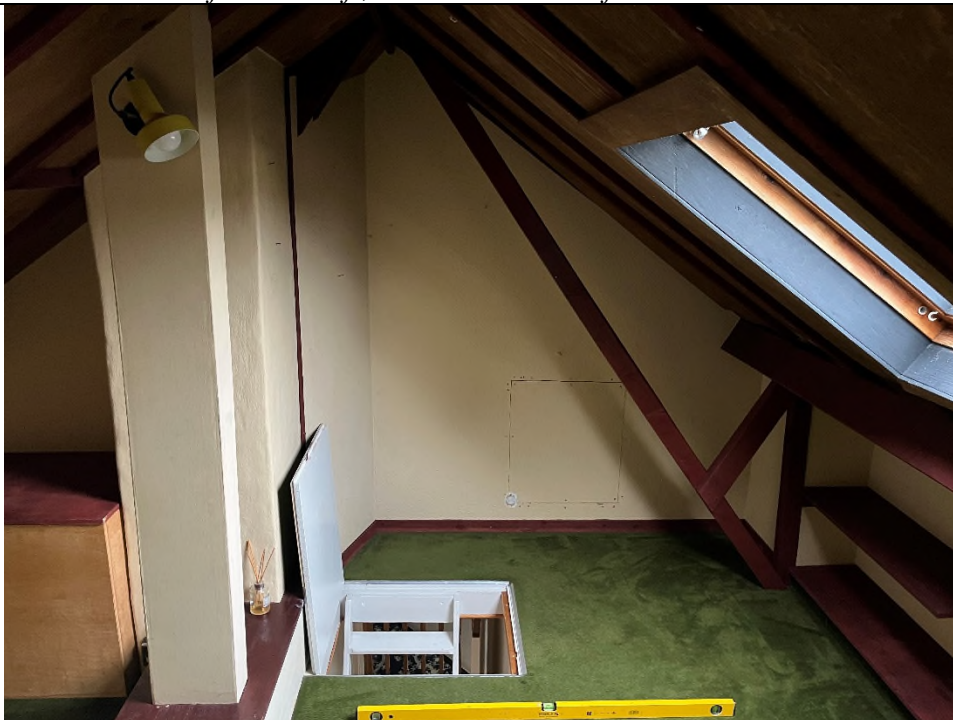
*Figure 2 – Floored semi-finished loft, access hatch and fixed ladder.*

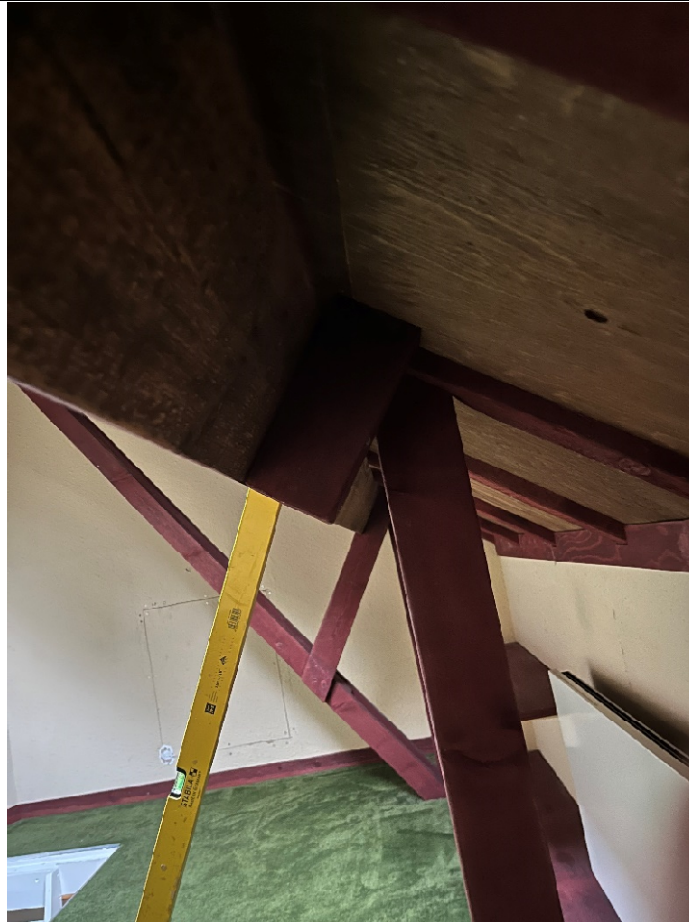
*Figure 3 – Evidence of removed internal roof members.*

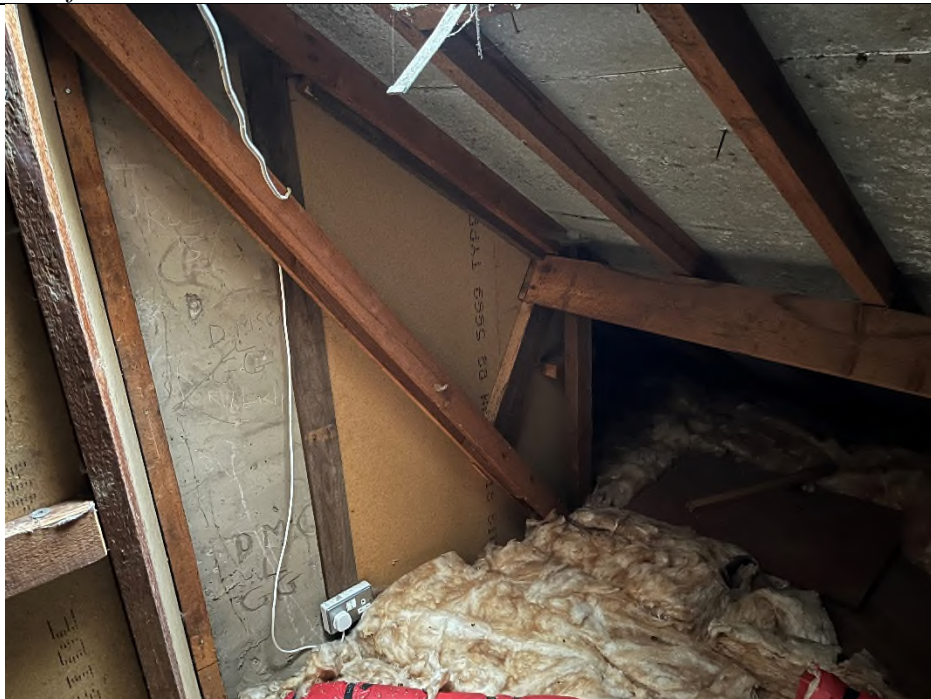
*Figure 4 – Roof structure within unaltered section.*
