April 12, 2021

RE: 4316 Valley View LR AR

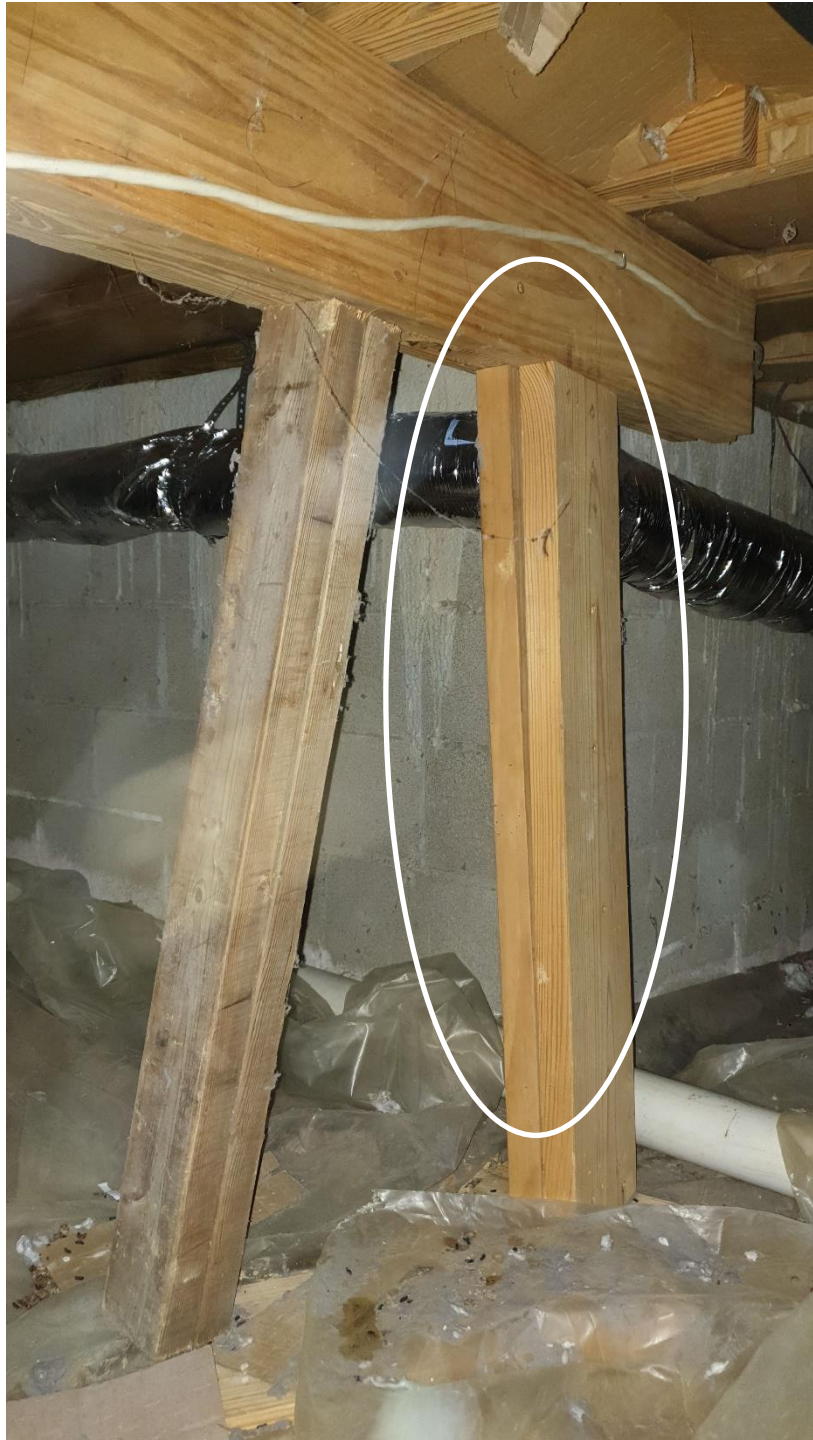
This item has been repaired.

See
Foundation Pro
Invoice
