Single Family Residence

INSPECTED FOR

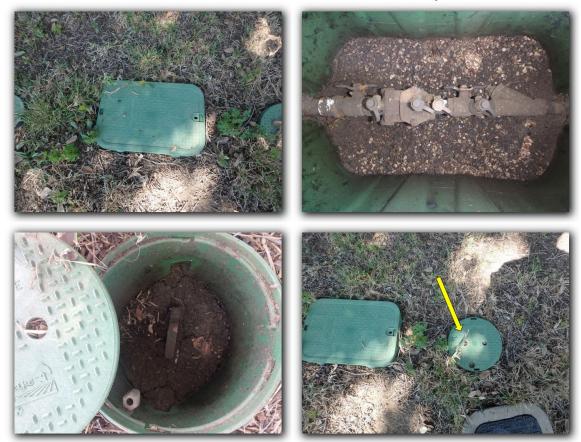
The main shut off valves and back flow valves were observed in the front yard.
