1365 Brommer St
Santa Cruz CA 95062

Country Home Inspection and Termite Inc.

Inspection Date: 8/16/2021
Report ID: 20210716-1365-Brommer-St

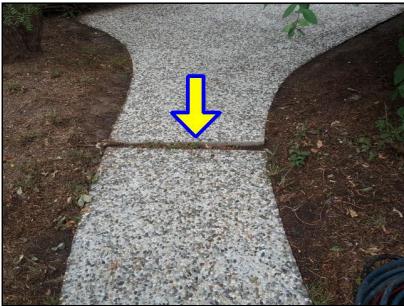
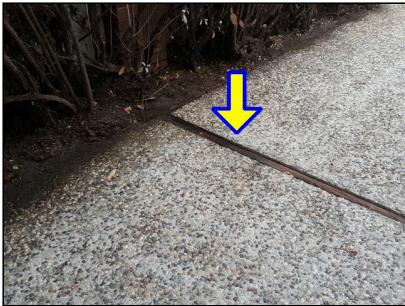
The wood between the sections of concrete on the walkways was missing / damaged. This is a potential trip / safety concern. We recommend repair or replacement.

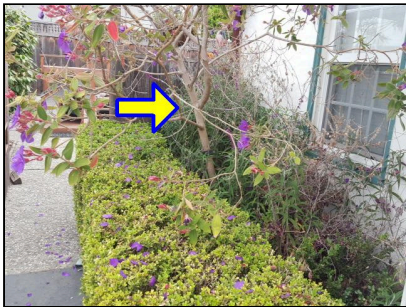
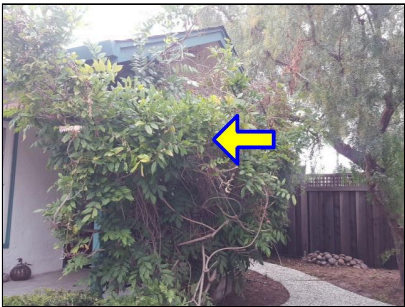
Shrubbery against home / siding. Noted at the exterior of the home at various locations. Recommend cutting back all shrubbery from the home to maintain 18 inches of clearance. Correction or modification decreases the probability of continued and excessive deterioration.

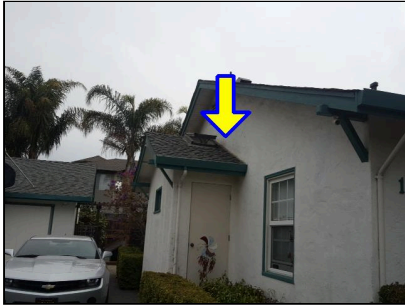
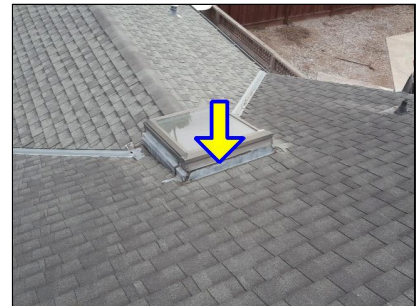
Application of "tar" as temporary roof repair noted. Noted on various locations of the roof. Recommend installing the proper flashing or keeping the areas sealed as needed. Correction or modification decreases the probability of continued and excessive deterioration.

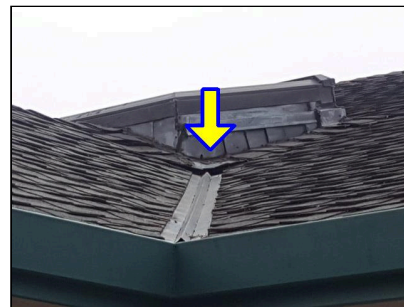
2.1 Item 1(Picture)

Metal flashing is lifting around the skylights. This can allow moisture to wick under the flashing. Recommend all flashing be secured / nailed as needed. Recommend further evaluation by a qualified roofing contractor.

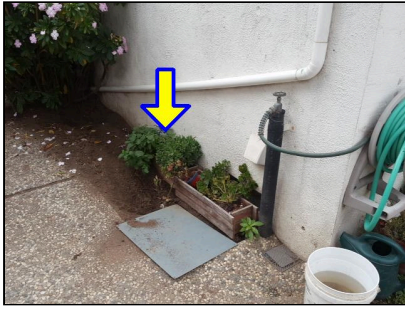
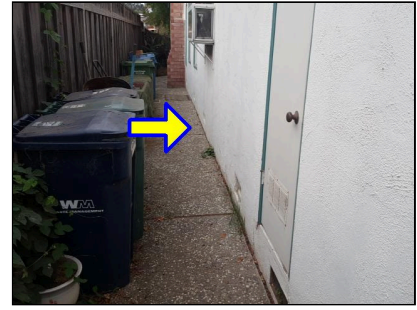
Stucco extends into the soil or walkways. This was typical for the era of construction. Current standards require weep screed to be installed above the soil or walkways. Recommend the stucco be cut or chipped away above the soil or walkways.

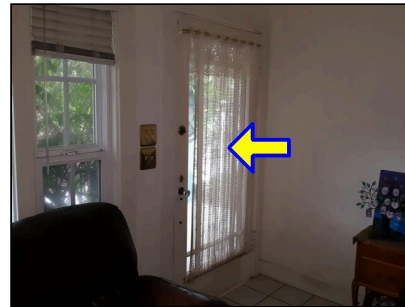
2.4 Item 1(Picture)

Safety glass not installed on various doors to the exterior. It is highly recommended the glass be replaced. Though the window may have conformed to regulations at the time of construction, recommend upgrading to current standards.

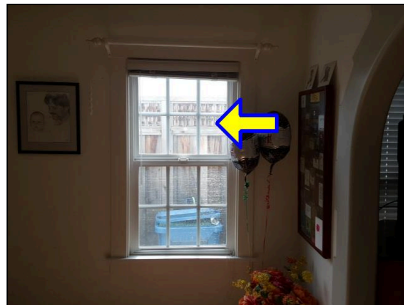
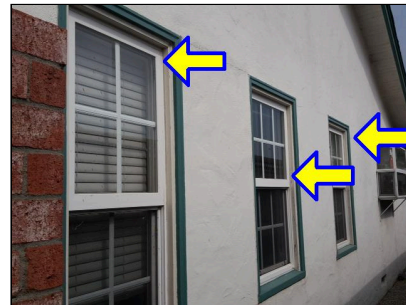
Insulated window (I.G.) appears to have lost seal on the right side of the home. When dual glaze windows lose the seal between the panes they will usually "fog up." Although this is mostly a cosmetic problem some insulating qualities will be lost and the window or windows should be considered a failure. Window panes which have lost their seal will ordinarily have to be removed and replaced. It is possible other windows have lost their seals. Recommend a glazing contractor further evaluate the windows.

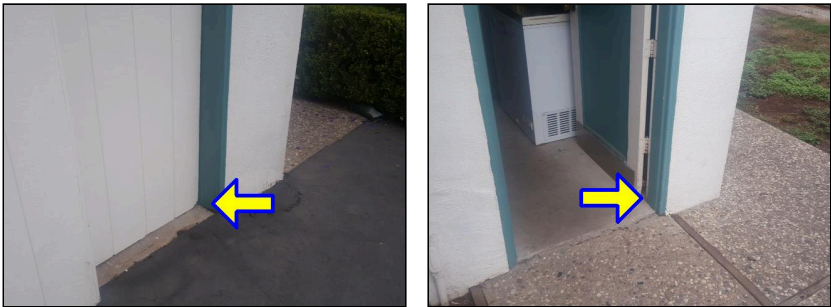
Garage door jamb(s) damaged. Recommend refer to pest inspection for further details concerning dry-rot or fungus damage.

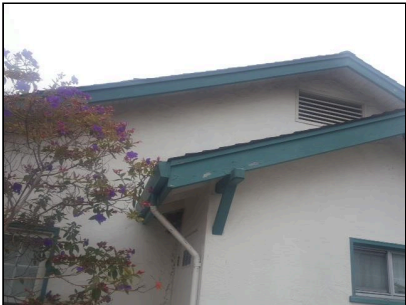
2.7 Item 1(Picture)

Paint maintenance recommended. Various areas of the paint is peeling and in need of maintenance. Repairing peeling paint will help protect your home. Recommend all peeling paint be scraped and properly painted.

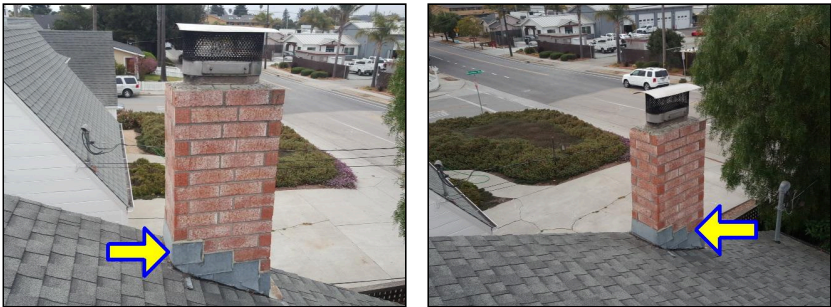
Chimney movement noted when pressure applied. It is recommended that the chimney be further inspected / repaired by a Qualified Chimney Contractor before the contingency release period.

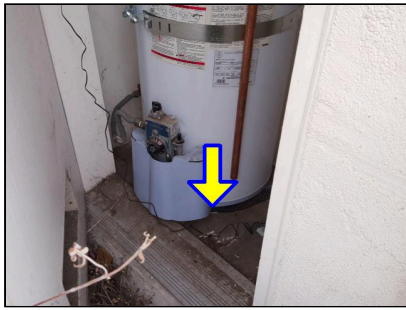
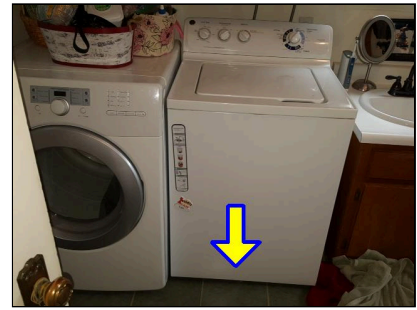
(1) Recommend installing a drain pan under the water heaters and washing machine with a drain to the exterior. This is recommended in case of a water leak at the water heaters or washing machine. The water will most likely drain to the exterior. Modification or addition is generally considered an upgrade which should improve safety or efficiency. The opinion of a qualified licensed contractor is recommended.

(2) Water heater seismic restraint system appears insufficient. Although the water heater is strapped with the correct straps, recommend adding bracing behind the water heater to help prevent any movement. Before purchasing the property, further study and corrections, as needed, by a qualified licensed contractor are advised.

straps, recommend adding bracing behind the water heater to help prevent any movement. Before purchasing the property, further study and corrections, as needed, by a qualified licensed contractor are advised.

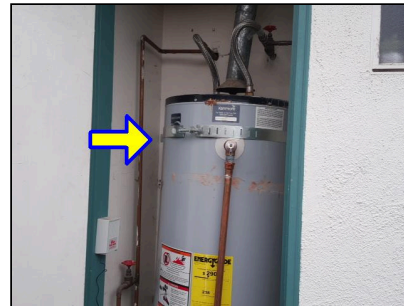
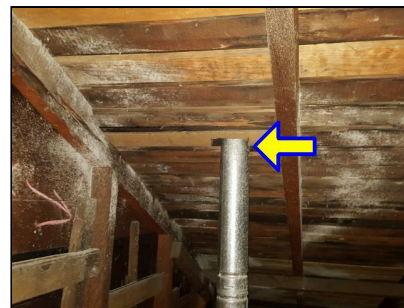
(3) Water heater vent is too close to combustible material. This was noted in the attic at the roof framing or sheathing. Manufacture recommends at least 1 inch of clearance. A qualified person should repair as necessary.

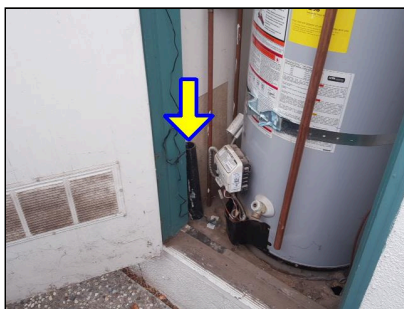
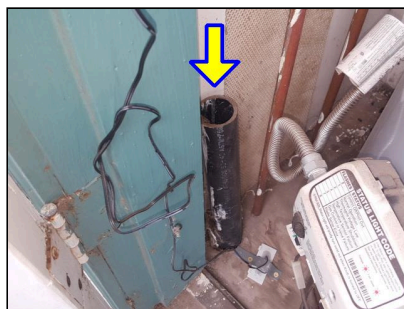
(1) Plumbing vent does not extend above the roof line in the right side water heater closet. Plumbing vents should extend above the roof line. Recommend repairing as soon as possible. The finding does not conform to building standards and practices in effect at the time of construction or installation. Before purchasing the property, further study and corrections, as needed, by a qualified licensed contractor are advised.

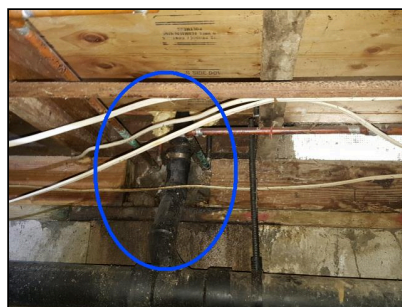
5.1 Item 3(Picture)

(2) The plumbing waste line leaks in the sub-area under the kitchen. Repairs are needed. I recommend a licensed plumber inspect further and repair as necessary.

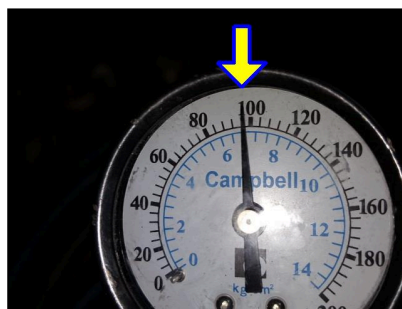
5.3 Item 1(Picture)

Water pressure high. Recommend 40 to 80 PSI. The water pressure was high at 100 PSI. Recommend a qualified licensed plumber install a pressure regulator at the main water line to lower the pressure.

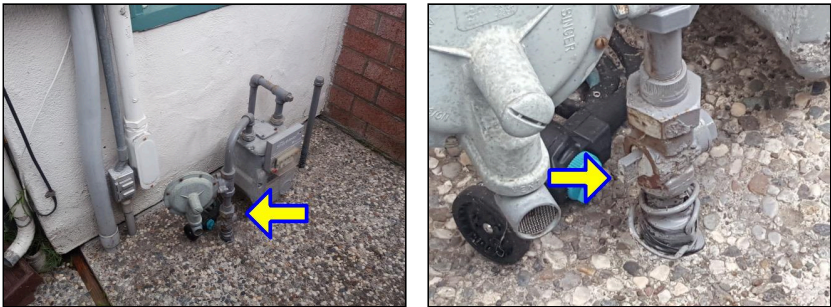
No wrench was located for the gas meter shut-off valve in the vicinity of the gas meter. Recommend installing a wrench for the gas meter to turn off in case of an emergency. The valve at the base of the meter pipe can be turned 90 degrees in either direction to shut the gas supply off. The wrench can be purchased at most hardware stores.

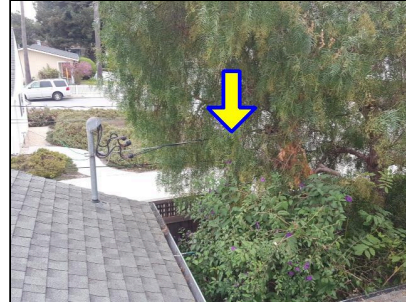
6.0 Item 1(Picture)

Service drop passes through tree. Recommend the trees limbs are trimmed back from the electrical service lines. Correction or modification decreases the probability of continued and excessive deterioration.

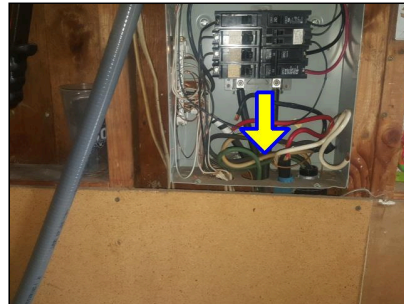
6.1 Item 2(Picture)

Box wire clamp not installed. Noted inside the sub-panel. Box clamps prevent the wires from possibly rubbing the metal edge. Recommend installing box clamps as needed. A qualified licensed electrical contractor should correct as needed.

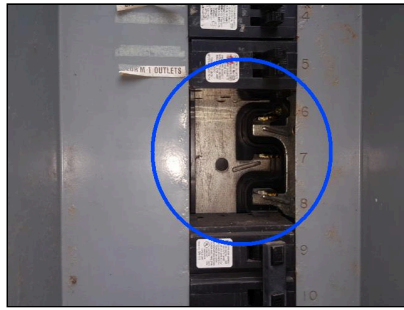
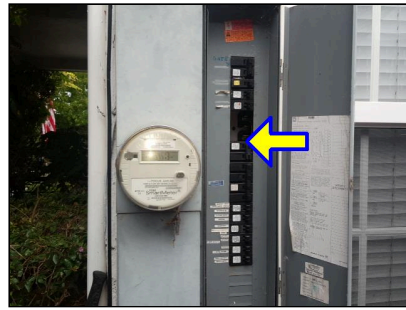
Breaker knockout missing from main-panel (exposes bus bar). Recommend installing knock-out covers at the panel. Knock-out covers are inexpensive plastic covers that cover exposed bus bars. Usually these are simply snapped into place. Knock-out covers prevent access to live power. Corrections are recommended by a qualified licensed electrical contractor as this is a safety or shock hazard.

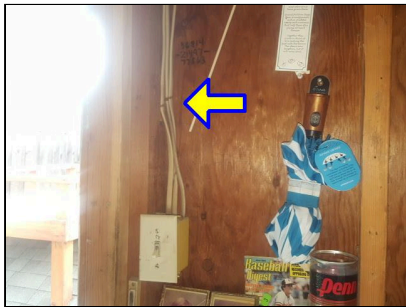
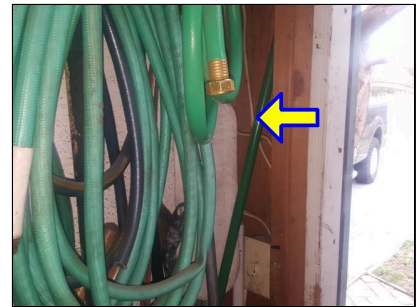
Romex sheathed cable exposed where could be damaged in the garage. Recommend the wiring be installed inside conduit or behind walls. A qualified licensed electrical contractor should correct as needed.

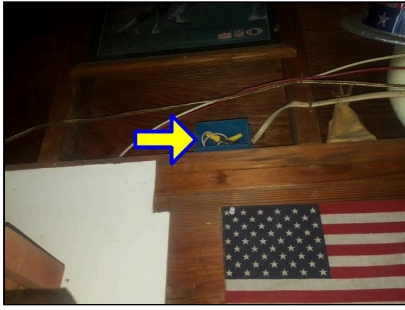
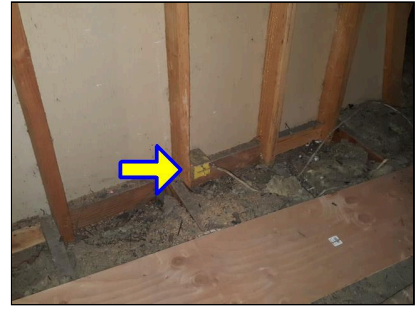
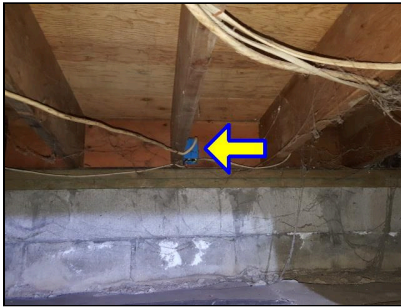
(1) Junction box cover plate missing. Noted in the garage, the sub-area and in the attic. Junction box cover plates are required to prevent accidental contact with the splice and to confine heat in the event of an overheated splice. Recommend repair as soon as possible. There may be others missing junction box covers that were not located. It is recommended that the finding be reviewed, and corrected as needed, by a qualified licensed contractor before purchasing the property. A qualified licensed electrical contractor should correct as needed.

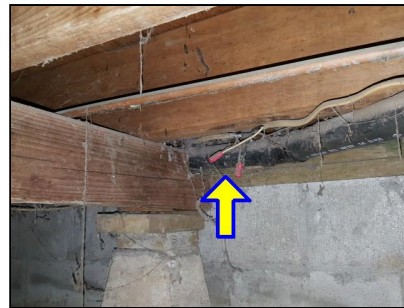
6.4 Item 5(Picture)

(2) Junction box not installed as required (exposed splice). Noted in the sub-area under the rear bathroom. Junction box's are required to prevent accidental contact with the splice and to confine heat in the event of an overheated splice. Recommend repair as soon as possible. There may be others missing junction boxes that were not located. It is recommended that the finding be reviewed, and corrected as needed, by a qualified licensed electrical contractor before purchasing the property.

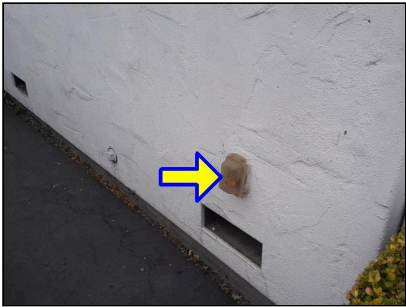
6.6 Item 1(Picture)

Circuit failure noted on the left exterior side of the home on a receptacle. A qualified licensed electrical contractor should correct as needed.

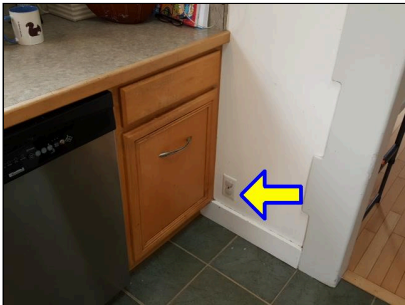
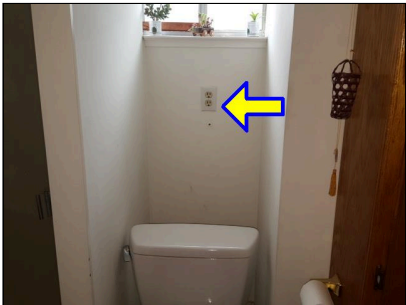
GFCI protection not provided at kitchen receptacle on the right side wall and rear bathroom behind the toilet. As an extra precaution and for safety it is a recommended upgrade that this component be installed when possible. Recommend GFCI type outlets that are within 72 inches of the sinks / damp areas be installed. Modification or addition is generally considered an upgrade which should improve safety or efficiency. The opinion of a qualified licensed contractor is recommended.

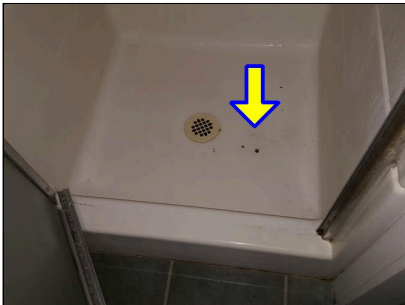
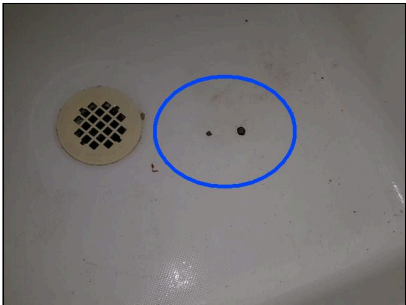
(1) Fiberglass shower has chips in the gel coat. Small chips were noted on the shower. These chips are typically in the gel coat but could possible leak over time. No leaks were noted from the sub-area at the time of the inspection. Monitor the situation on a regular basis. Corrections by a qualified licensed contractor, if and when necessary, are recommended.

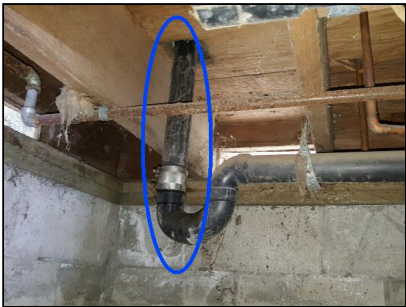
7.0.A Item 3(Picture)

(2) Fiberglass shower drain leaks in the bathroom. Noted from the sub-area. The leak is noted where the drain meets the fiberglass pan. A new rubber ring may need to be installed. It is recommended that the finding be reviewed, and corrected as needed, by a qualified licensed plumbing contractor before purchasing the property.

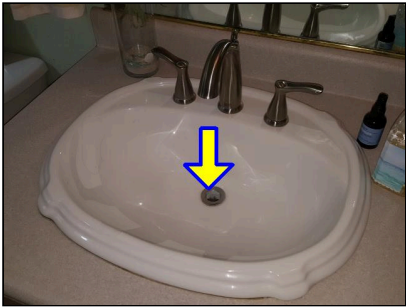
7.2.B Item 1(Picture)

Drain stopper missing on bathroom sink(s) in the hall bathroom. Recommend all damaged or missing stopper(s) be replaced as needed.

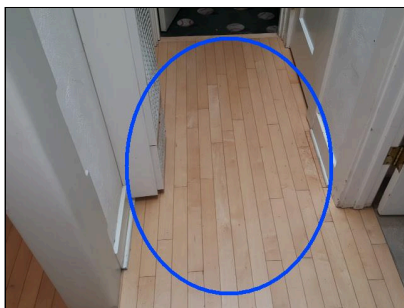
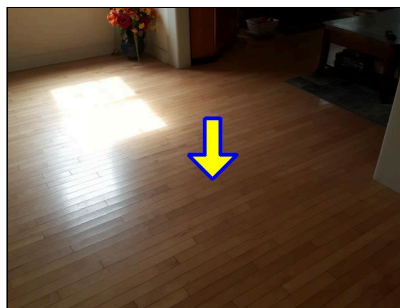
Wood flooring is nicked. Noted in the home at various locations. Recommend a flooring contractor further evaluate the floors.

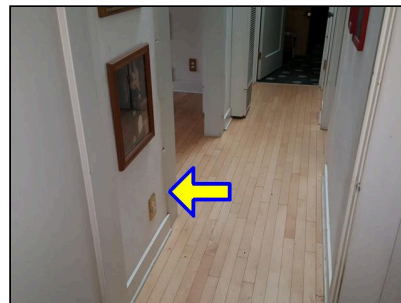
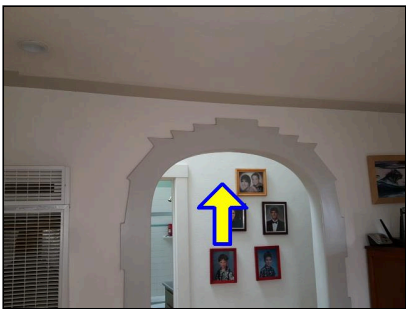
(1) There is no carbon monoxide (CO) detector(s) found in the home outside the bedrooms. Current code requires one per floor and within 10 feet of bedrooms. Recommend installing carbon monoxide detectors where required.

(2) Smoke alarm inoperative and or missing outside the bedrooms. Recommend replacing all non working smoke alarms and installing (PHOTOELECTRIC type smoke alarms) the smoke alarms outside the bedrooms and as a safety enhancement install smoke alarms in the bedrooms. We recommend installing 10 year battery smoke detectors.

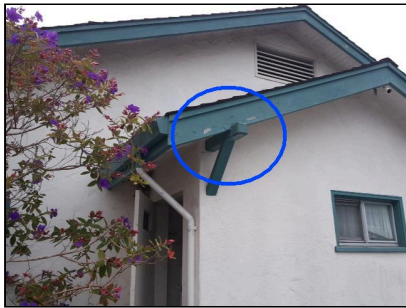
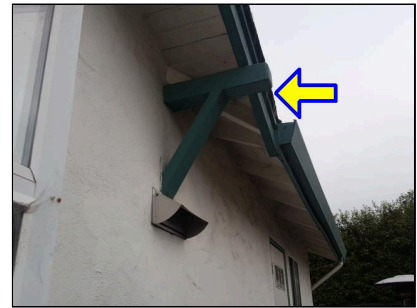
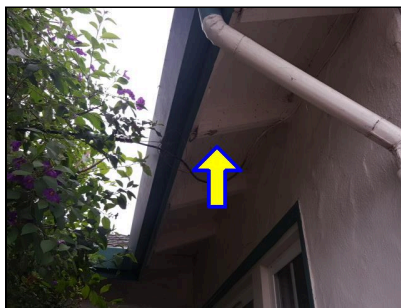
Wood deterioration noted in barge rafter(s) and in rafter tails. Recommend refer to pest inspection or a licensed Contractor for further information concerning all possible areas with dry rot, pest or fungus damage.

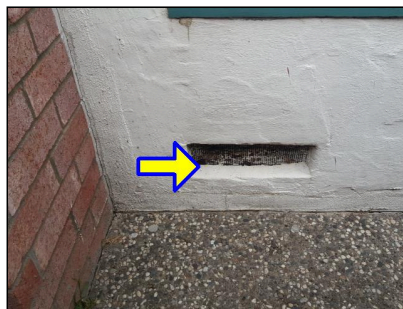
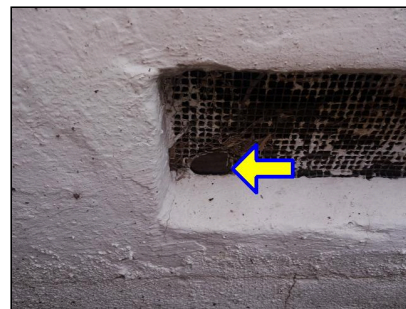
Sub-area ventilation screen(s) damaged. A few screens are damaged at various areas of the home. Recommend all screens be repaired or replaced with 1/4 inch galvanized screens.

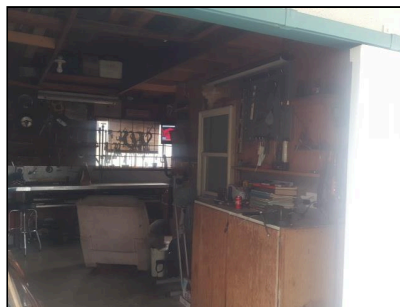
10.5 Item 2(Picture)

(1) Remodel, alterations, or additions noted. Areas of the home have been added on. Be sure to check for permits. The inspector cannot ascertain whether or not permits were used.

(2) Review pest inspection report for wood rot and wood boring insect information as home inspection reports do not specify dry-rot, fungus or pest damage. Only licensed Pest Companies can specify dry-rot, fungus and pest evidence. A current pest inspection has been done to the property. Be aware that a Home Inspection and a Pest Inspection are two different Inspections. It is always recommended that a current qualified Pest Inspection be performed for pest damage and possibly dry-rot or fungus damage. Be sure to carefully read the entire Pest Inspection report.
