SELLER'S DISCLOSURE NOTICE

CONCERNING THE PROPERTY AT 130 Laverna Lane, Hickory Creek, Texas 75065

Introduction	3
I. STRUCTURAL SYSTEMS	5
A. Foundations	5
B. Grading and Drainage	8
C. Roof Covering Materials	12
D. Roof Structure and Attics	18
E. Walls (Interior and Exterior)	19

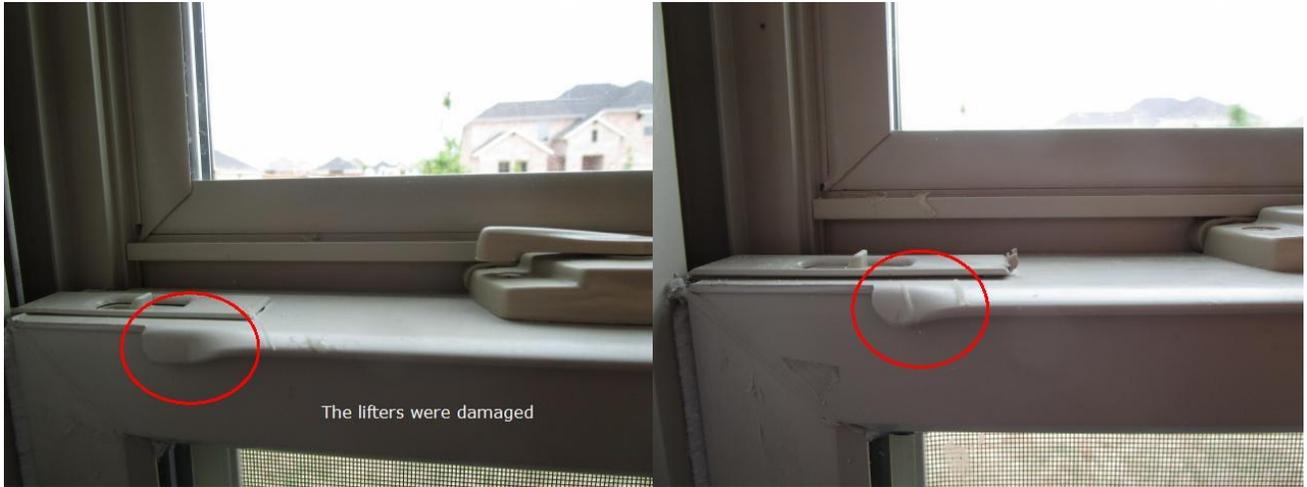
The lifters were damaged at some windows, including in the front bedroom.

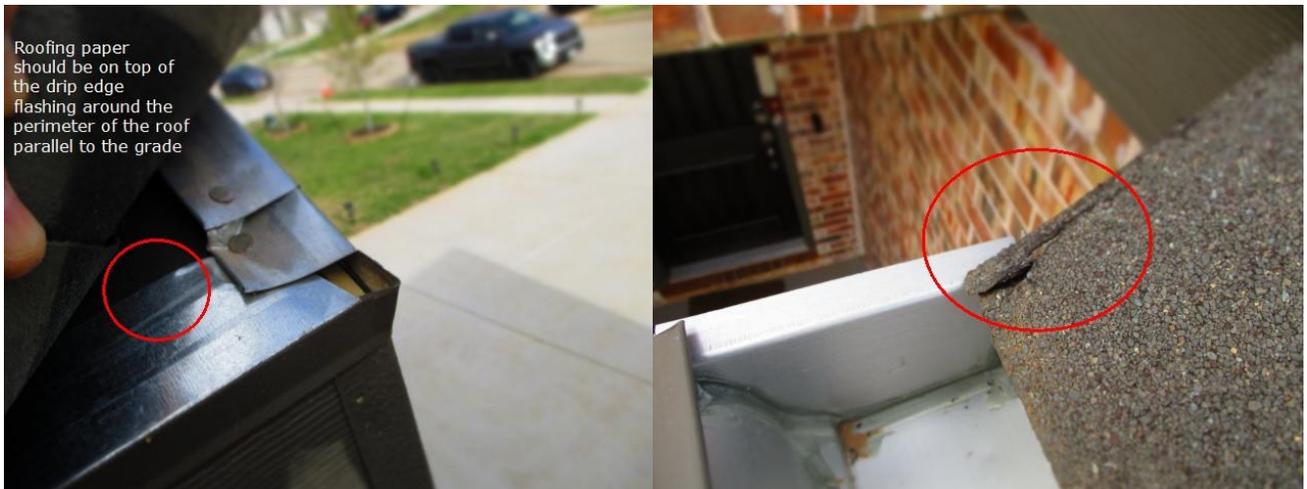
A few shingles were damaged/ cracked at the edge of the roof, including on the front side.

The shingles were stained with building material at places, including at the long and narrow roofed area on the front side.
