## SELLER'S DISCLOSURE NOTICE

CONCERNING THE PROPERTY AT 500 Oakhill Drive, Denton, Texas 76201

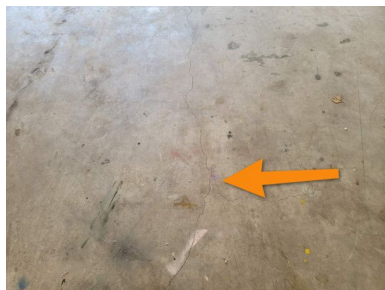
Fractures were observed in the exposed concrete areas of the foundation. This appears to be the result of movement. Further evaluation is recommended to determine if repairs are required.

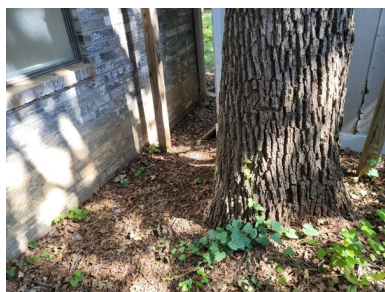
There are one or more trees near the foundation of the house. Tree roots may extract water from the soil causing a drying or shrinking affect. You may wish to consult with a qualified service company about installation of root barriers which may prevent feeder roots from nearby trees from migrating below the structure and extracting moisture from under the slab foundation. A root barrier typically consists of placing a barrier material in a 4' trench extending along the foundation. Root barriers are usually placed as far from the tree and as near to the foundation as possible in order to decrease damage to the tree roots. Typically, the barriers are 4' deep since the majority of the volume change occurs in the upper 4' of the soil.

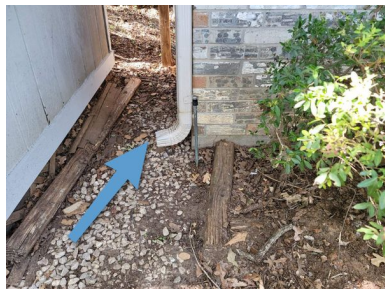
There are one or more gutter down spouts draining near the foundation. The down spouts should be extended to help divert drainage 3 to 5 feet away from the house.

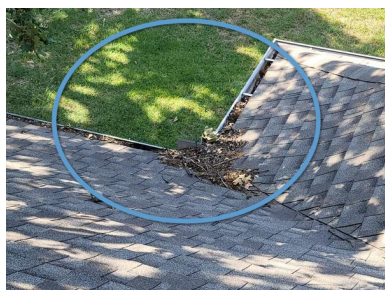
### 2: Tree litter in the gutters

There is tree litter in the gutters. It is recommended that the gutters be cleaned and evaluated for proper drainage.

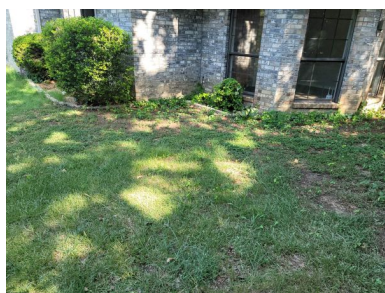
### 3: Improper grade slope

The grading near the foundation appears to be inadequately sloped. Proper grading should drop at least 6 inches per 10 feet away from the foundation, according to current standards. This area should be monitored for ponding water and the grading improved if necessary.

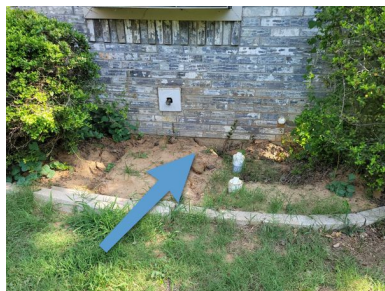
### 5: Areas of pooling or possible pooling water

There are areas of pooling or possible pooling water near the foundation at one or more locations. The grading may need to be improved to ensure proper moisture runoff in those areas.

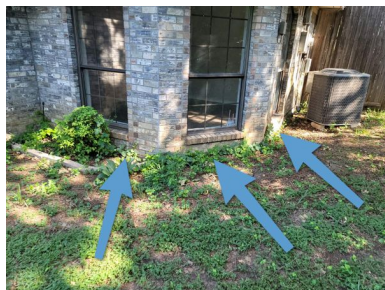
#### 6: High soil line

The soil line is at or above the top of the foundation at one or more locations. This may allow moisture to wick into the walls in these areas. The soil line should be lowered to expose 4 to 6 inches of the foundation and sloped away from the foundation for proper moisture runoff.

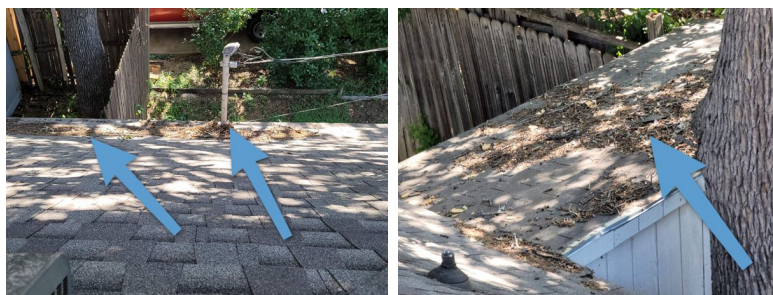
There is tree litter on the roof at one or more locations. The roof should be maintained free of tree litter to ensure the roof sheds water as intended.

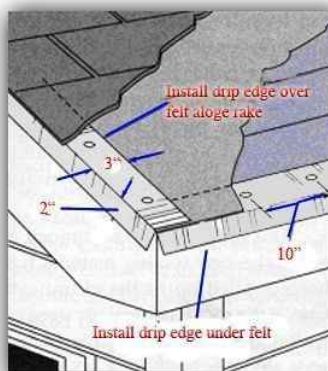
#### 4: Drip edge improperly installed

A drip edge shall be provided at eaves and gables of shingle roofs. Adjacent pieces of drip edge shall be overlapped a minimum of 2 inches (51 mm). Drip edges shall extend a minimum of 0.25 inch (6.4 mm) below the roof sheathing and extend up the roof deck a minimum of 2 inches (51 mm). Drip edges shall be mechanically fastened to the roof deck at a maximum of 12 inches (305 mm) o.c. with fasteners as specified in Section R905.2.5. Underlayment shall be installed over the drip edge along eaves and under the underlayment on gables. Unless specified differently by the shingle manufacturer, shingles are permitted to be flush with the drip edge.

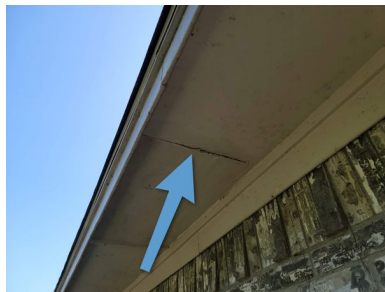
There are separated joints in the soffit and fascia board at one or more locations. The joints should be sealed to prevent moisture penetration and/or pest intrusion in those areas.

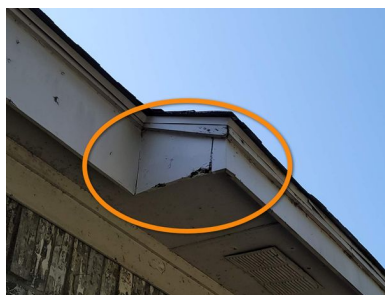
**4: Moisture damage on the soffit and fascia Boards**

Moisture damage was observed on the soffit boards and/or fascia boards at one or more locations. The soffit boards and fascia boards should be inspected and repaired as necessary

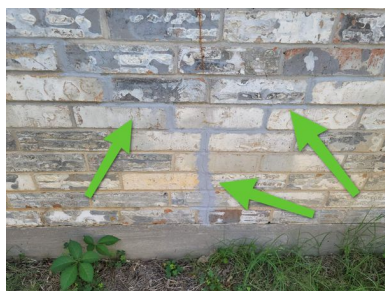
Previous repairs were observed on the walls. The cause or reason for repairs are unknown and the workmanship of the repairs is beyond the scope of this inspection. Contact sellers for more information.

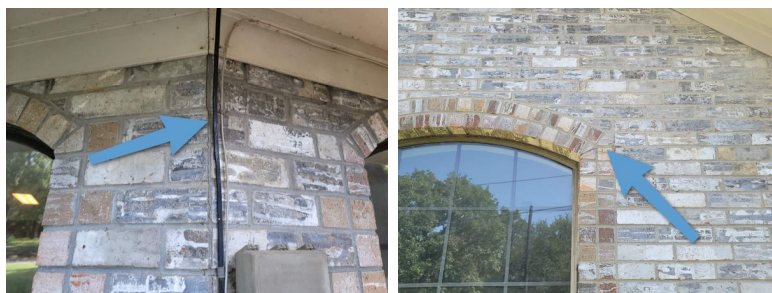
One or more common cracks were observed on the brick/stone veneer. This may be due to normal settling and/or thermal movement of the building materials. These areas should be sealed to prevent moisture penetration and monitored for further signs of movement.

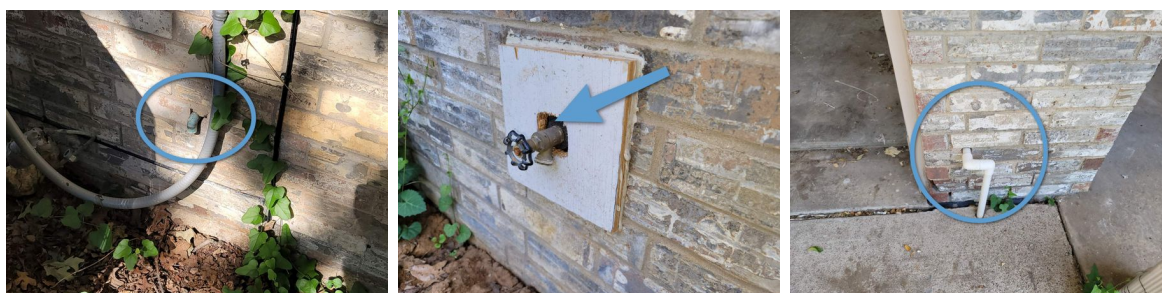
## 2: Wall penetrations not sealed

There are one or more exterior wall penetrations that are not sealed. The penetrations should be sealed to help prevent moisture and/or pest intrusion in those areas.

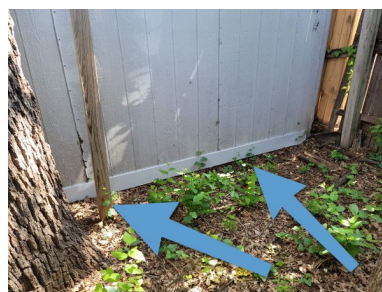
## 3: Siding clearance from ground

The cement board and/or composition wood siding does not have adequate ground clearance. This may allow moisture to wick into the siding causing it to delaminate. There should be 4 to 6 inches ground clearance to help prevent moisture from wicking into the siding.

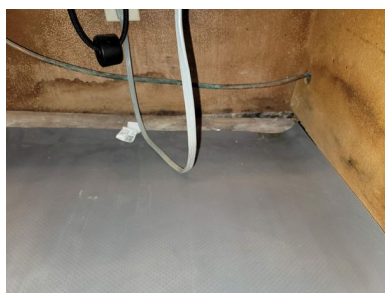
There is moisture damage under one or more sinks. This could be due to spills and/or may indicate a previous leak in that area. The cabinetry can be repaired or replaced as desired.

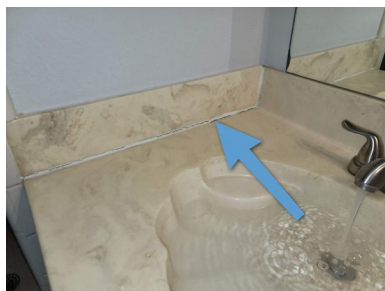
The counter top is not sealed to the backsplash. Sealant should be applied to prevent moisture penetration in this area.

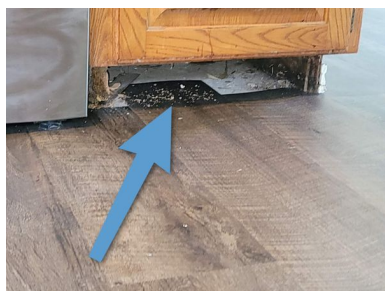
There is damage to the cabinets in various places. This could be from poor installation, heavy use, or a one time damage event. Repair as necessary.

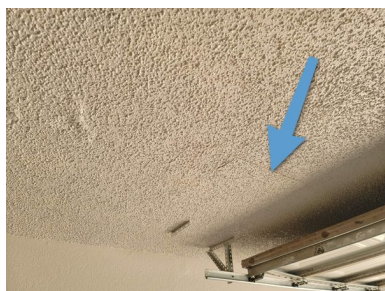
Cracked tape joints were observed on the garage ceiling. Cracked tape joints commonly occur on garage ceilings as a result of attic activity.

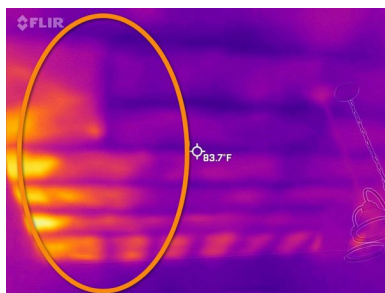
### 2: Ceiling - Temperature differential observed with thermal camera

Temperature differential was observed on the ceiling using a thermal camera. This may indicate a leak of some sort in this area or missing/compressed insulation. The cause of the leak if any and extent of damage is unknown. Further evaluation by a professional contractor is advised.

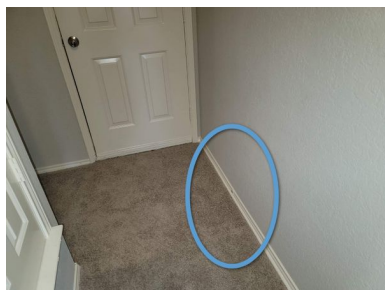
There are one or more doors without door stoppers or with non functioning door stoppers. The door stoppers should be repaired or replaced to protect walls adjacent to doors.

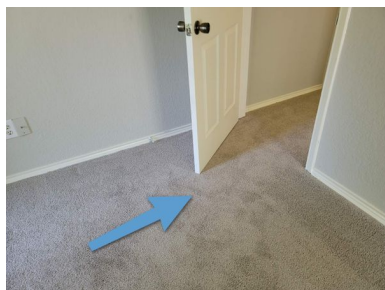
## 3: Door drags flooring

One or more doors drag the flooring. Over a long term, this condition will damage the flooring. In addition, this condition may not allow for proper HVAC airflow to the room when the door is closed. Trim bottom of door to clear.

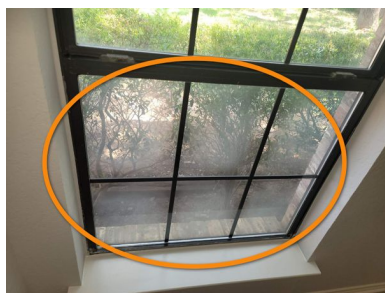
There are one or more window(s) with visible evidence of a broken thermal window seal. This causes condensation to form between the window panes leaving water deposits that cause discoloration between the panes over time. This does not materially affect the performance of the windows. Most of the identified windows were marked with a black X if easily accessible at the time of the inspection. All of the windows should be checked by a window specialist to determine if there are any more broken seals to properly estimate repair costs.

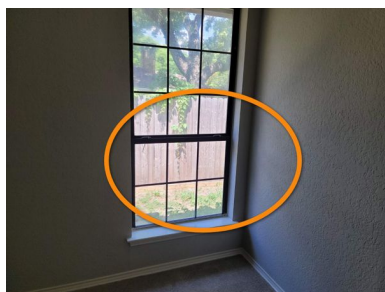
One or more windows in the house would not hold in the up position when tested. Further evaluation and/or repair by a window specialist is recommended.

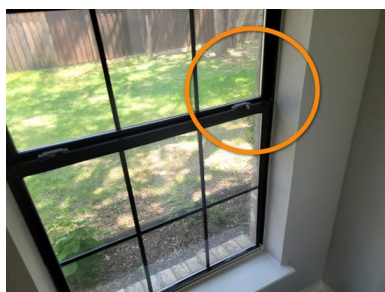
One or more windows would not lock or shut completely at the time of the inspection. This could be due to the window being out of square and/or a damaged or obstructed track. The window should be evaluated and repaired as needed to close and lock properly.

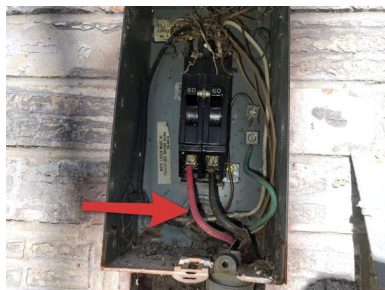
There are one or more conductors that are not properly protected at the panel entrance. Conductors should be protected with grommets or approved devices at the panel entrance to ensure conductor casings are not pierced or cut. This is reflected in the 2012 International Residential Building Code as follows: E3802.1 Installation and support requirements: Bushings shall be provided where entering a box, fitting or enclosure unless the box or fitting is designed to afford equivalent protection.

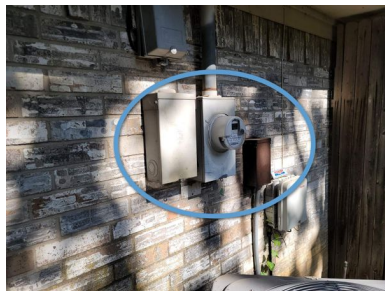
One or more exterior electrical panels are not sealed to the wall. The panels should be sealed to prevent moisture intrusion in the opening behind the panel.

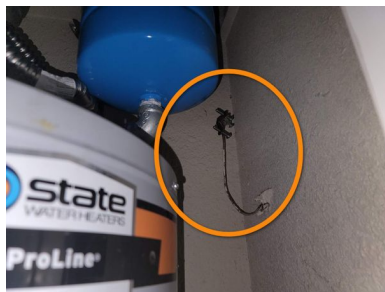
### 6: Ground is loose or disconnected

The grounding conductor is loose or disconnected from the ground rod. This leaves the house inadequately grounded. Further evaluation by qualified electrician is recommended.

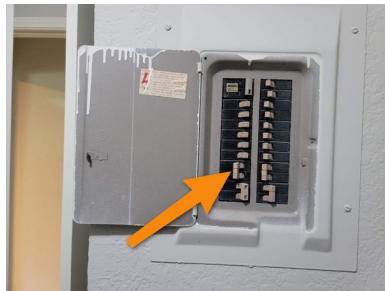
One or more breakers tripped during the inspection. This can indicate a fault in the wiring, fixture, or breaker. Further evaluation and repair by a licensed electrician is advised.

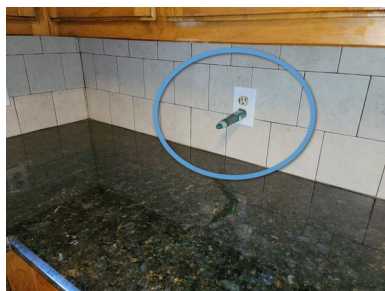
There are one or more electrical outlets that are loose to the junction box. The outlets should be properly secured to the junction box to ensure safe operation.

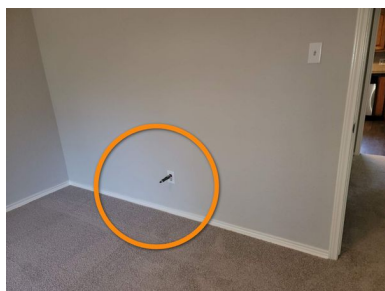
One or more outlets in the house tested as Open Ground. This may indicate the ground conductor is loose, disconnected, or not present. Further evaluation and/or repair by a licensed electrician is advised.

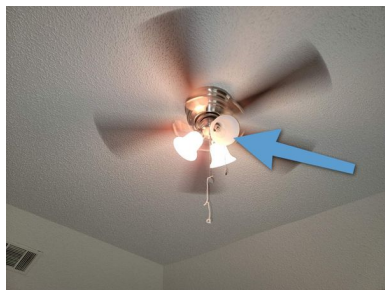
#### 4: Lights did not activate

One or more lights did not activate when tested. This is usually due to a burnt-out bulb in need of replacement but may indicate a faulty ballast. Further evaluation and/or repair by a licensed electrician is recommended.

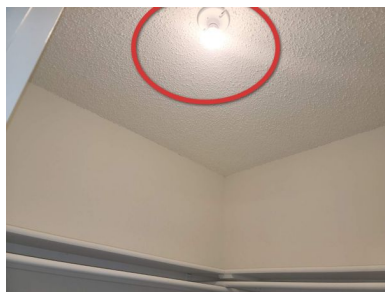
There are exposed incandescent light bulb fixtures in the closets. These should be replaced with covered fixtures for safety.

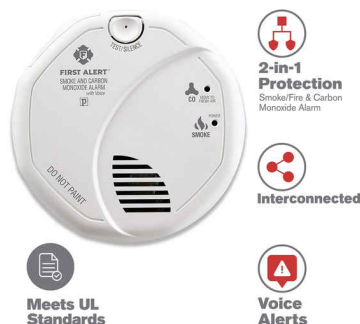
There are missing carbon monoxide alarms in the home. Carbon monoxide alarms should be installed in accordance with current standards, as follows: 2009 International Residential Code R315.2.1 New construction. Carbon monoxide alarms shall be provided in dwelling units when either or both of the following conditions exist. 1. The dwelling unit contains a fuel- fired appliance. 2. The dwelling unit has an **attached garage with an opening that communicates with the dwelling unit**. R315.3 Location. Carbon monoxide alarms in dwelling units shall be **installed outside of each separate sleeping area in the immediate vicinity of the bedrooms**. When a fuel-burning appliance is located within a bedroom or its attached bathroom, a carbon monoxide alarm shall be installed within the bedroom. Carbon monoxide is an odorless, colorless, and tasteless gas that is near impossible to identify without a proper detector. It is caused by fuels not burning completely, including wood, gasoline, coal, propane, natural gas, gasoline, and heating oil. This unburned fuel can come from anything from clothes dryers, water heaters, and ovens to ranges, a fire-burning fireplace, or a car left running in a closed garage.

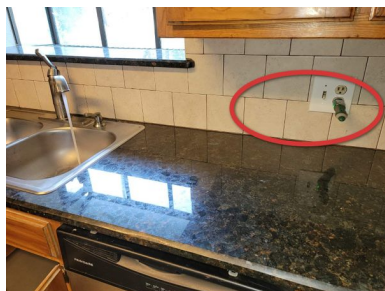
### 8: No GFCI installed within 6 feet of a source of water

According to current standards, any receptacle located within 6 ft of a water source should be protected by a ground fault circuit interrupter (GFCI). One or more receptacles in the home are within 6 ft of a water source, but are not GFCI protected. It is recommended that GFCI protected receptacles are installed at these locations, to protect the occupants from any potential shock hazards.

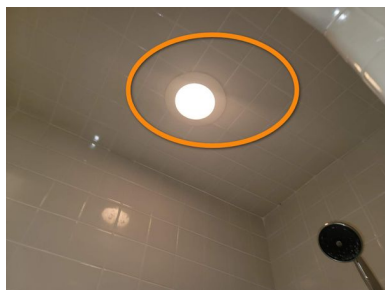
The light above the shower is not secured and sealed to the ceiling. This may allow moist humid air to enter the unit. Repair is recommended.

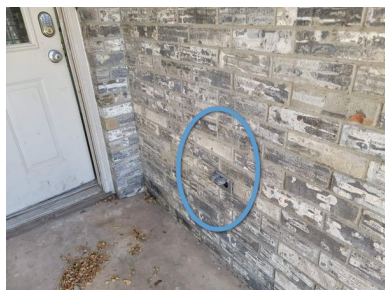
#### 11: Exterior outlet not sealed

The exterior outlet should be sealed to the wall to prevent moisture from causing damage. Seal and/or replace as necessary

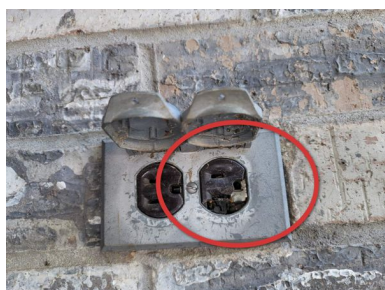
#### 12: Damaged receptacles

One or more receptacles are damaged. Replacement of the outlet by a licensed electrician is advised.

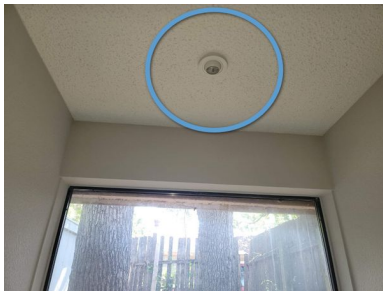
One or more fixtures are missing the bulbs. Repair as required.

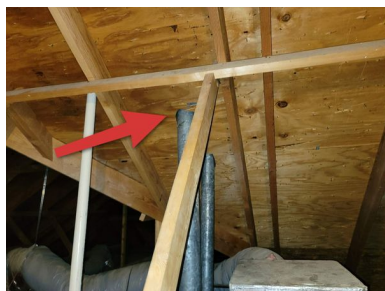
The furnace flue vent does not have adequate clearance from combustible material at the ceiling. One inch of clearance from combustible materials is recommended.

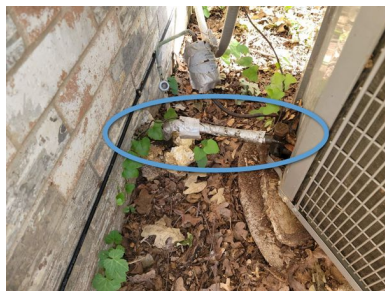
The suction line insulation is deteriorated and/or missing near the outside condensing unit. The insulation should be replaced to ensure proper operation.

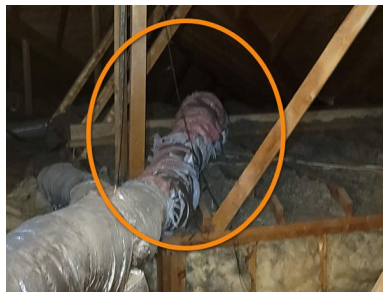
One or more Air ducts appear to have been damaged . Recommend a qualified HVAC contractor repair.

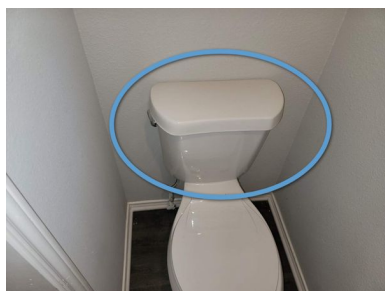
One or more toilet tanks were loose at the toilet. The tank should be tightened to prevent leaks.

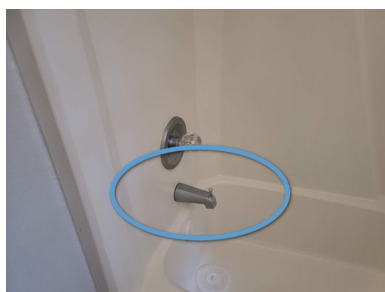
The bathtub and/or shower faucet are not properly sealed to the wall at one or more locations. The escutcheons and faucet should be sealed to the wall to prevent moisture penetration in those areas.

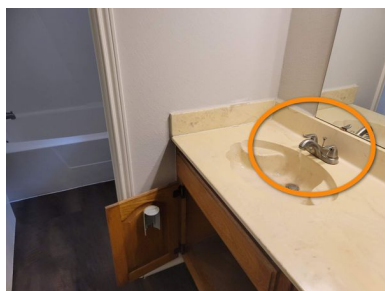
Water flow to one or more faucets appears to be restricted. This often occurs as sediment builds up at valves or inside the faucet, but may also indicate a blockage, or low water pressure. Further evaluation and/or repair by a licensed plumber is advised.
