INSPECTION REPORT

**21746-9794
Dustin & Sarah Reed
422 Village Commons Blvd
Georgetown, TX 78633**

PROPERTY INSPECTION REPORT FORM

422 Village Commons Blvd, Georgetown, TX 78633

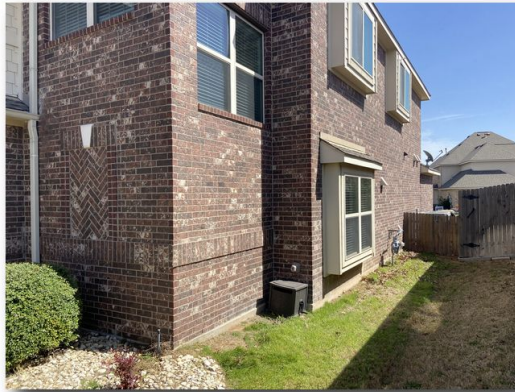
We recommend sealing the openings where the a/c lines, plumbing drains, conduits, etc. enter the sides of the house.

Seal penetration

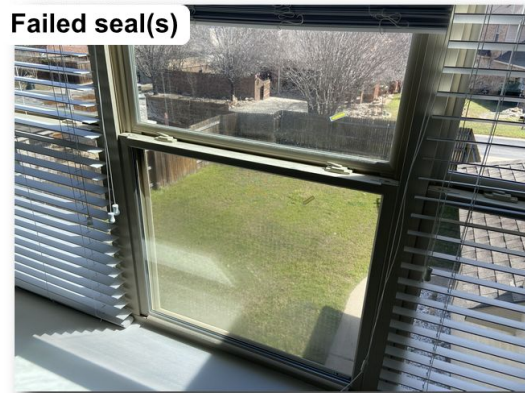
Condensation stains (failed seals) were noted in the thermal pane windows located in the following areas: master 2. Repair or replacement will be required if the visibility of the windows is to be restored. Recommend further evaluation by licensed contractor to estimate costs and repair as necessary.

Missing fall protection was noted at some of the windows; when a window is higher than 24" from the floor or 72" from the exterior grade (second story for example) child fall protection devices are recommended. We recommend repair to help ensure safety.

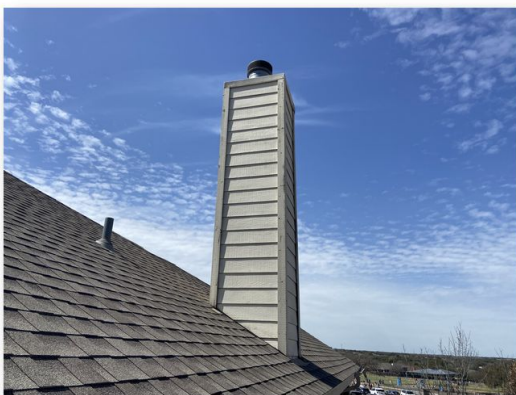
Peeling paint observed at the chimney, suggest scraping and painting as necessary as part of normal maintenance.

Wood deterioration damage noted at the chimney siding and trim. We recommend repairs to help prevent additional damage.

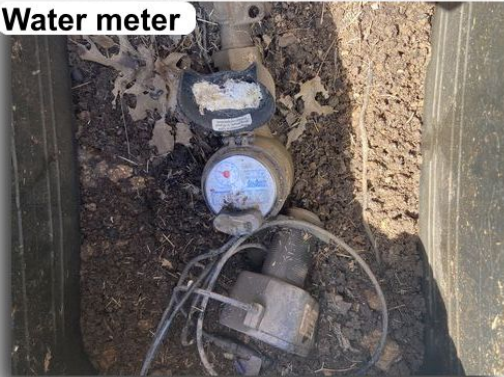
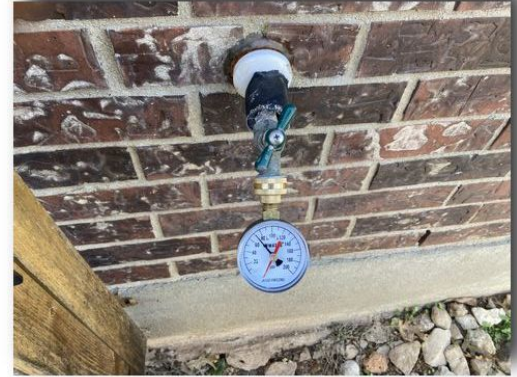
Water meter

The proper water pressure regulation equipment (expansion tank, reducing valve) has not been installed; recommend repair.

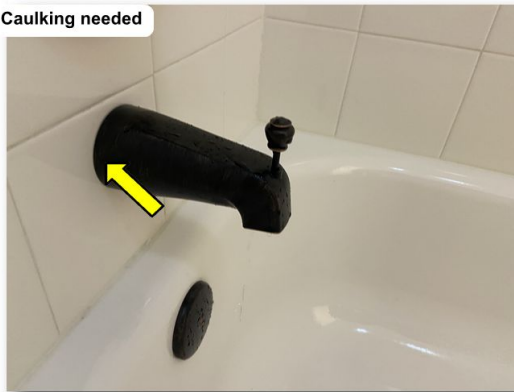
Caulking and/or grout in the tub/shower surrounds is cracking or loose. The grout/caulking needs to be repaired to help prevent possible water penetration behind tile and damage to interior walls. Such damage may not be apparent from a visual inspection of the outer surface.

Caulking needed

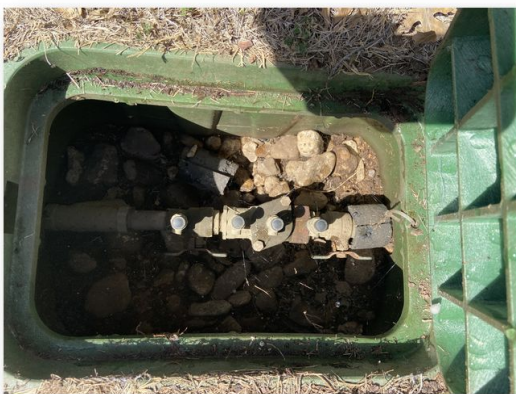
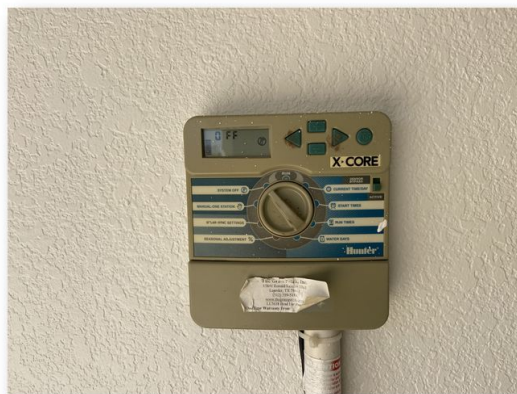
Many overgrown heads were noted.

Damaged heads and nozzles were noted; Repairs are necessary to ensure proper operation of the system.
