TREC REI 7-6 ASR

1176 Horizon Trace Dr  
Azle, TX 76020

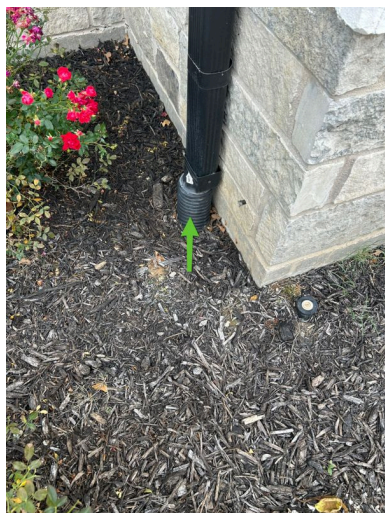
Observed one or more splash blocks installed backwards. Recommend turning the splash block around.

Recommendation: Contact a qualified professional.

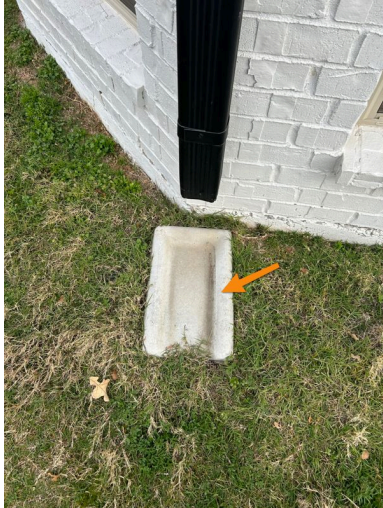
Exterior

**2: Downspout Terminates Near Foundation**

Downspout terminates near foundation. Recommend adding extension to divert water away from foundation.

Recommendation: Contact a qualified professional.

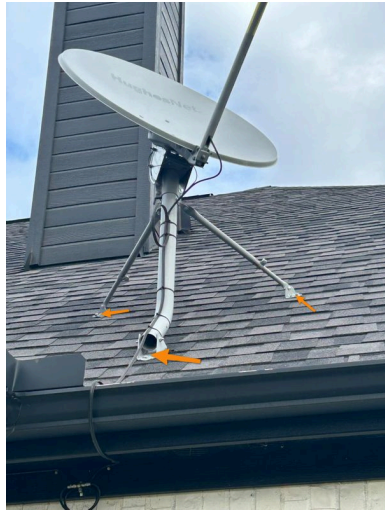
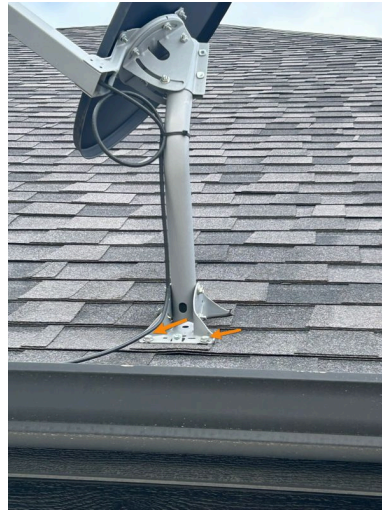
Satellite dish mounted directly to roof covering. The securing screws penetrate the roof covering, underlayment and sheathing. Potential for water to leak at screws. Recommend sealing.

Recommendation: Contact a qualified professional.

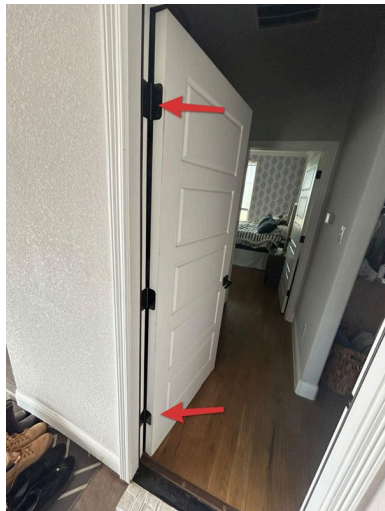
**1: Garage Door - Self Closing Hinges (Missing)**

Self- closing hinges are missing and should be added for safety. The hinge is placed on doors from the garage to the house to prevent the door from being left open. This is considered to be a safety issue to help prevent carbon monoxide and fire from entering the interior of the house. Recommend adding self closing hinges prior to settlement.

Recommendation: Contact a qualified professional.

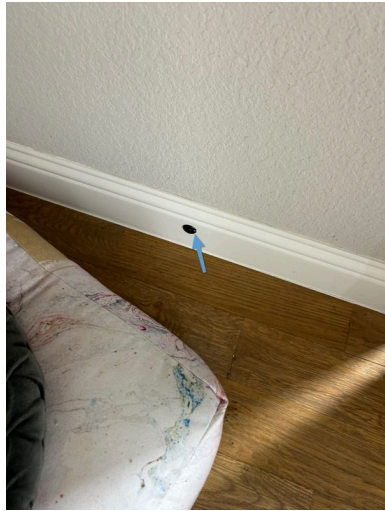
Master Bedroom

**2: Interior Door Stops**

One or more door stops are damaged or missing. Recommend install or repair as needed.

Recommendation: Contact a qualified professional.

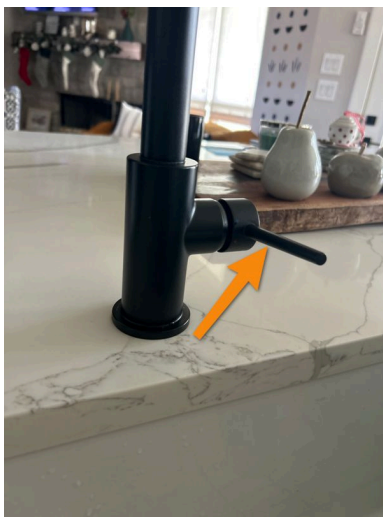
Kitchen

The hot and cold water is reversed. Recommend repair.

Recommendation: Contact a qualified professional.

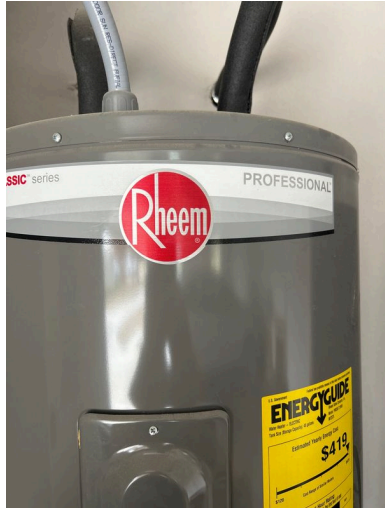
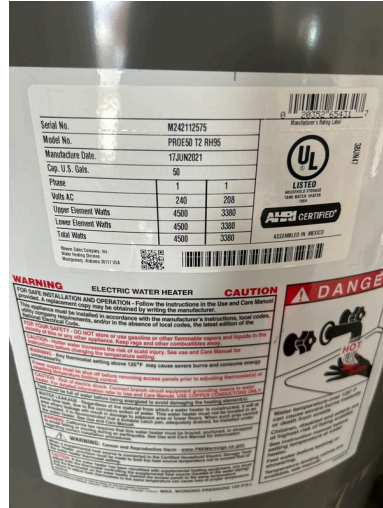
*Energy Sources: Electric*  
*Capacity: 50 Gallons*  
*TPRV Tested:*  
 TPRV tested good at time of inspection.

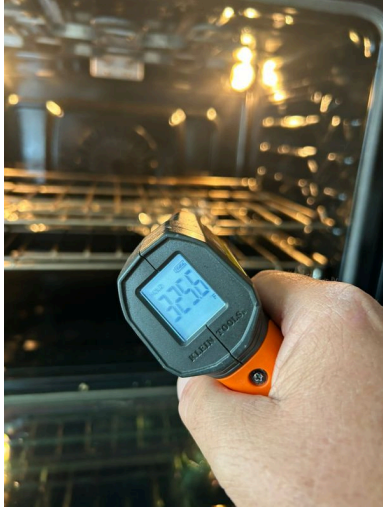
Kitchen

Lower oven tested at 350 degrees bake set point, 327 degrees was the actual reading (maximum 25 degrees variance).

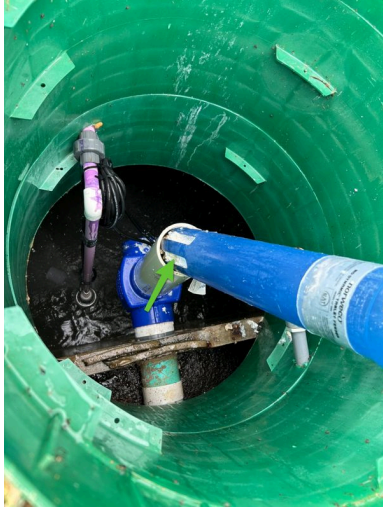
Exterior

The chlorine dispenser had chlorine tablets present at the time of the inspection.

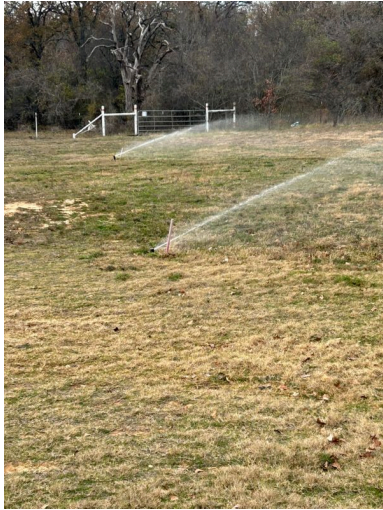
Exterior

Observed the 2 sprinkler heads operate and there was no odor from the spray.
