## SELLER'S DISCLOSURE NOTICE

CONCERNING THE PROPERTY AT 10809 Deer Trail, Fort Worth, Texas 76140

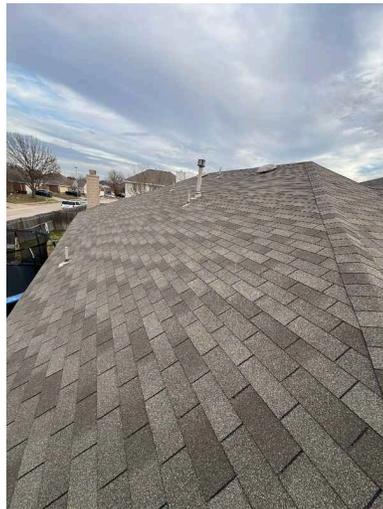
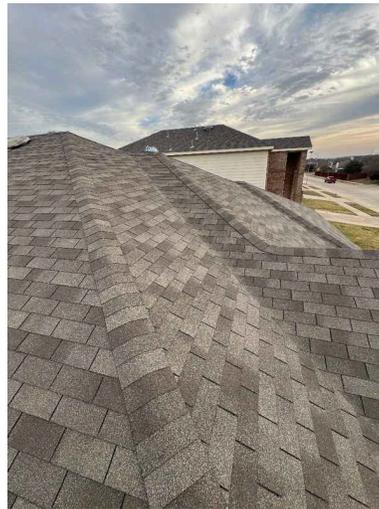
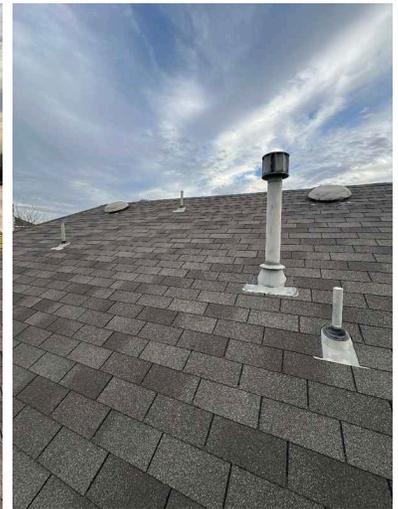
*Roof Photos :*

Here are some general photos for your information and records.

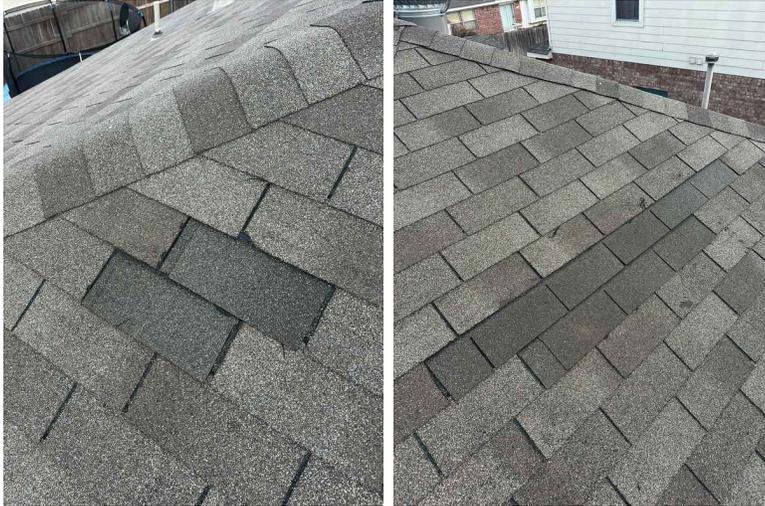
**1: Exposed Nails**

Under-driven or exposed nails were found in one or more areas of the roof coverings. Recommend sealing nail heads periodically to prevent potential leaks in the future.

Recommendation: Contact a qualified roofing professional.

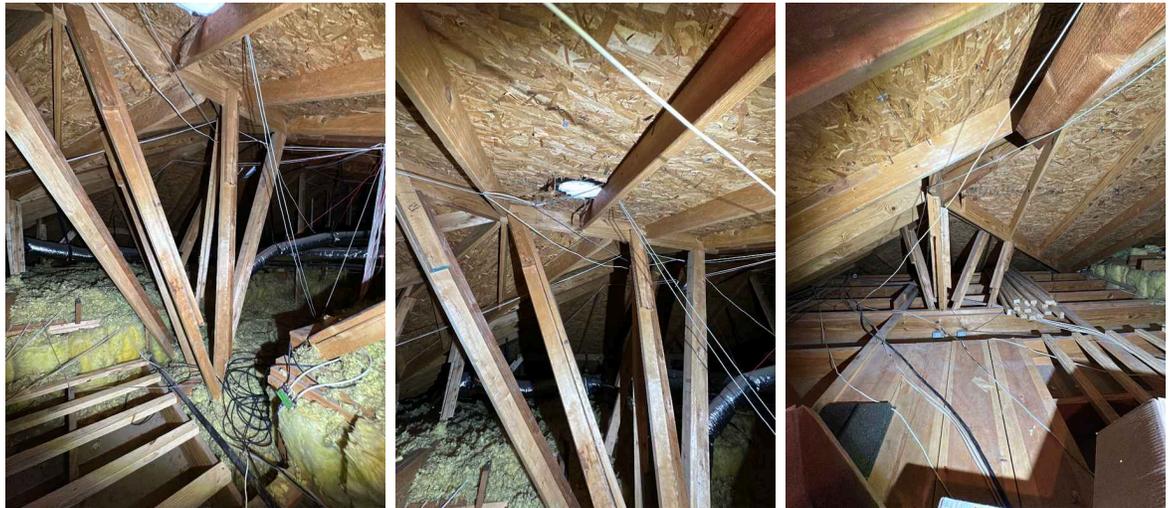
*Attic Photos :*

These are general attic photos for information purposes.

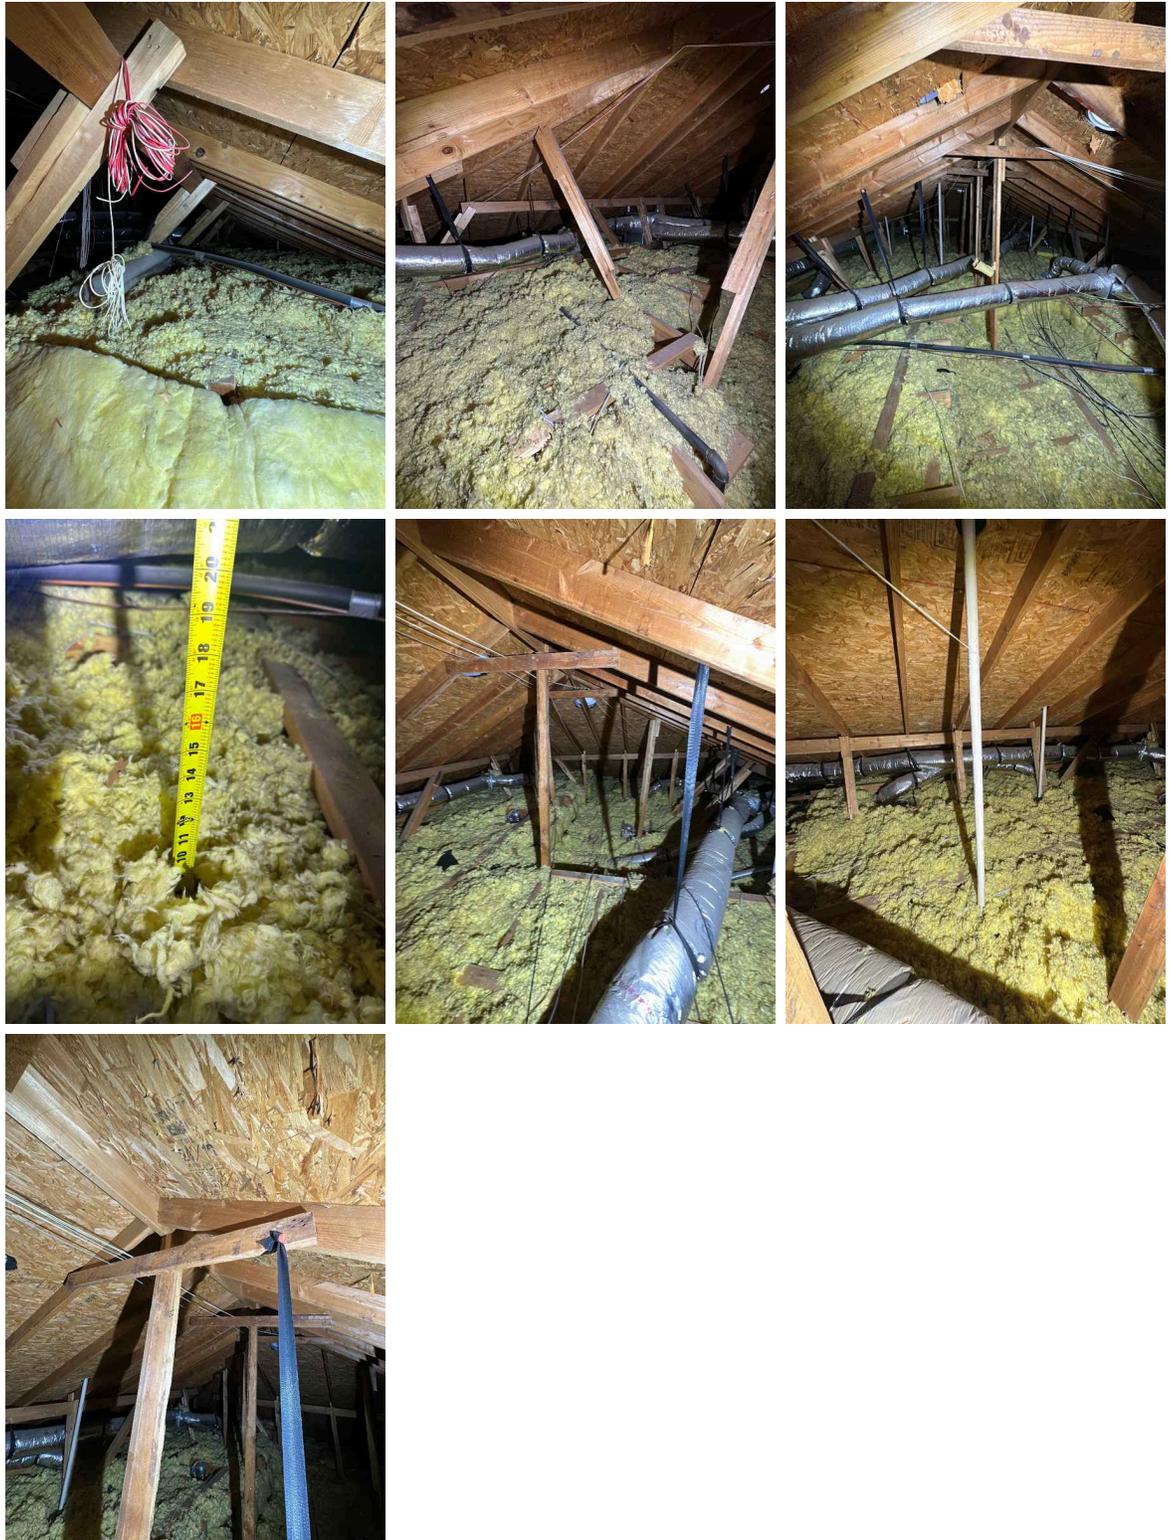
**1: Cracked Roof Framing**

🔴 Items To Monitor, Further Evaluation Recommended

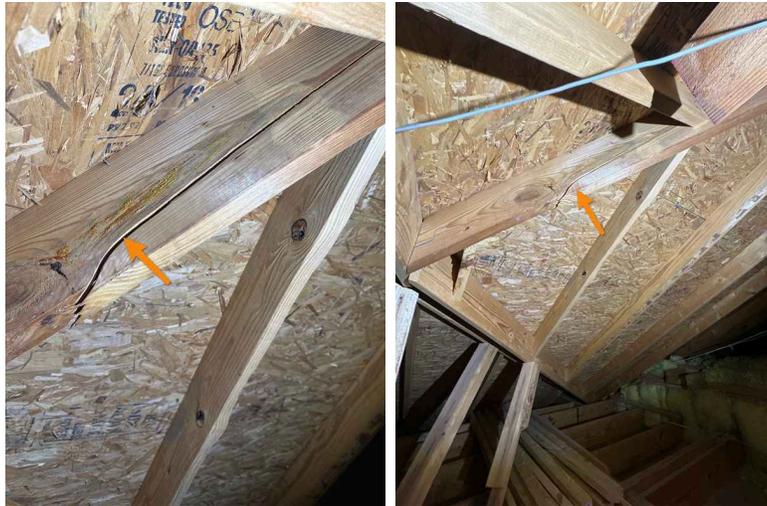
A crack was noted in one of the roof framing members. I recommend reinforcing the damaged board by sistering it with a new framing member of the same dimensions, secured using structural-grade fasteners.

Recommendation: Contact a qualified carpenter.

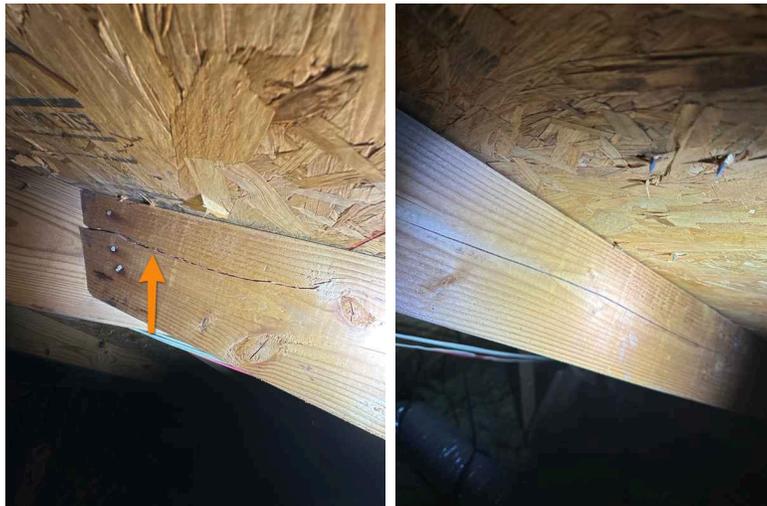
**2: Framing- Rafter Cracked**

There are one or more rafter boards in the attic framing of this home that are cracked. These areas will need replacement in the future.

Recommendation: Contact a qualified professional.

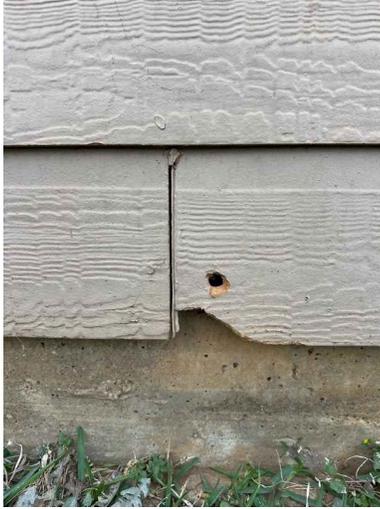
There are one or more areas of the home where the siding is damaged and should be repaired.

Recommendation: Contact a qualified siding specialist.

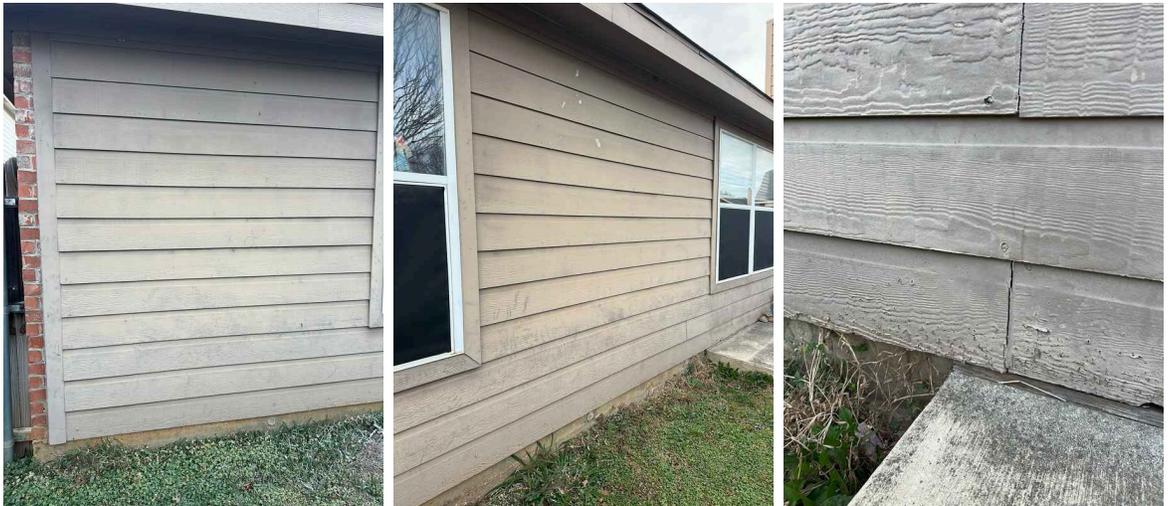
**2: Siding needs paint**

There are areas of the siding that are in need of paint and/or caulking.

Recommendation: Contact a qualified painting contractor.

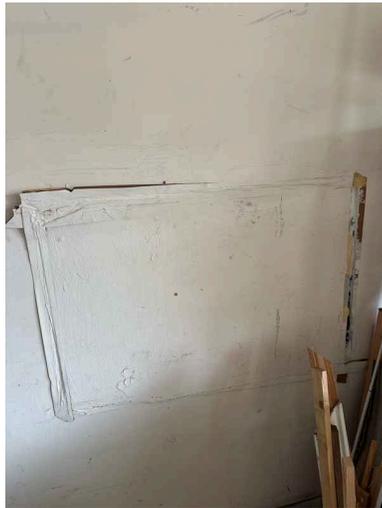
**4: Wall Damage**

There are one or more walls that are damaged in/on this home which will need repair.

Recommendation: Contact a qualified professional.

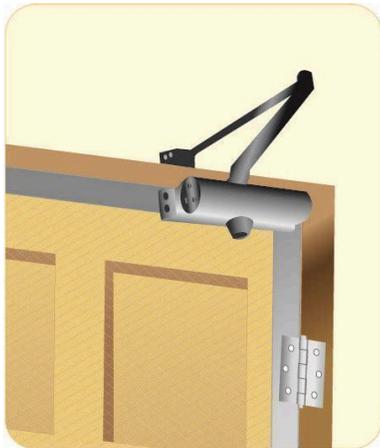
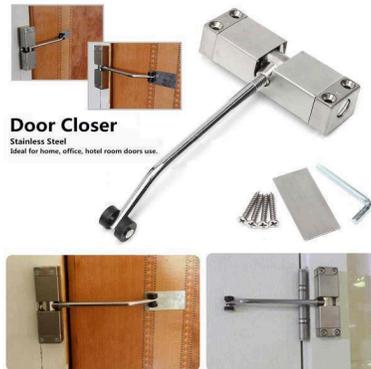
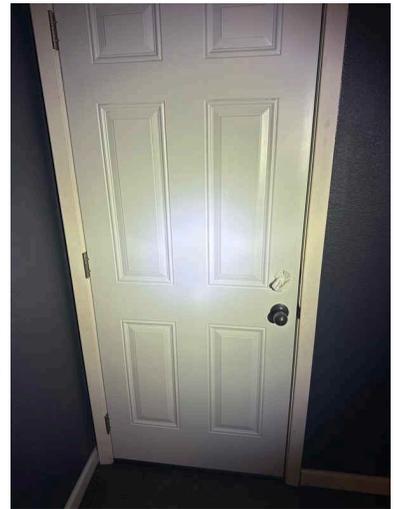
**2: No garage service door auto closing device**

The door between the garage and the interior of the house (garage entry door) should be equipped with an [auto-closer](#) device to prevent automobile fumes from entering the house. This is a good upgrade

Recommendation: Contact a handyman or DIY project

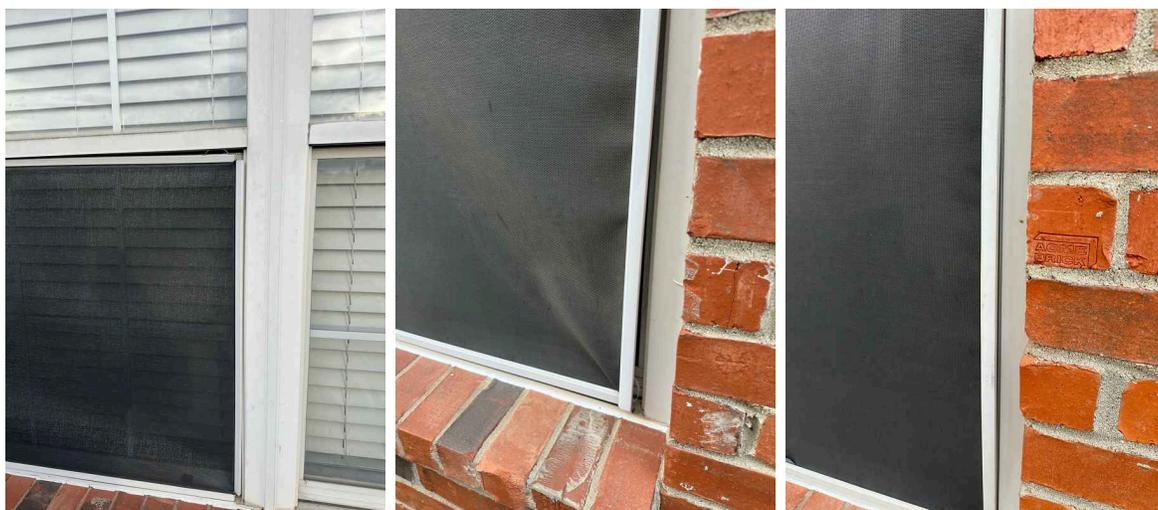
**2: Damaged Screens**

There are one or more screens around the home that are damaged.

Recommendation: Contact a qualified window repair/installation contractor.

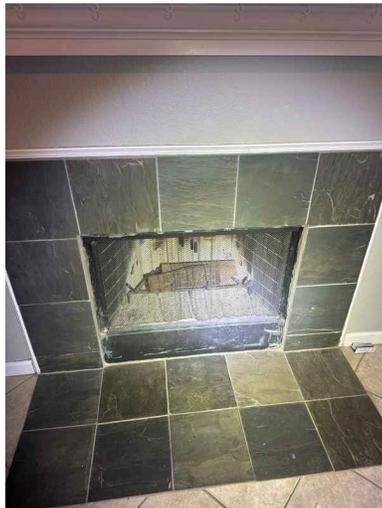
*Chimney photo:*  
Chimney photo.

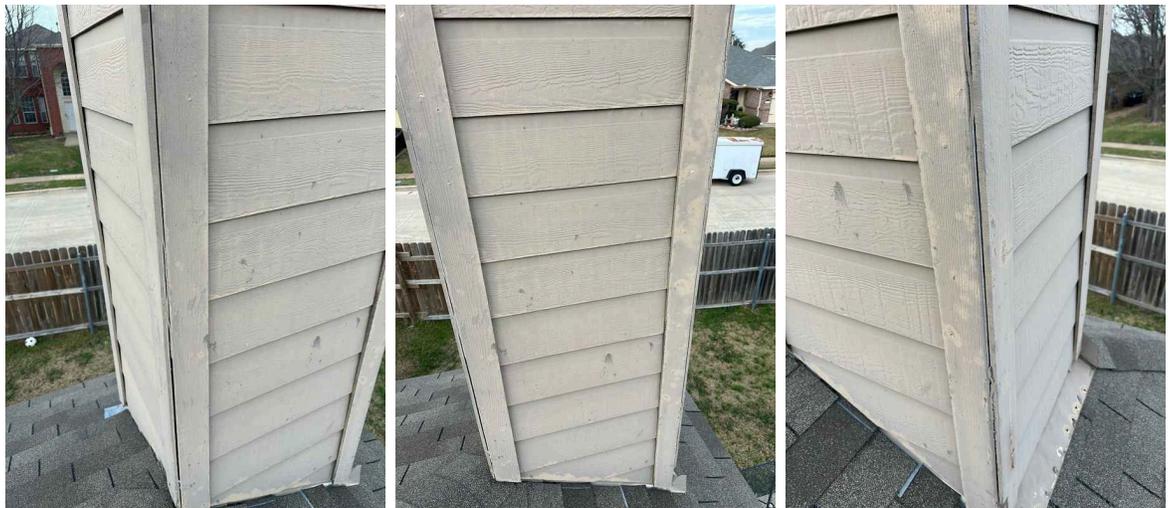
**2: Chimney siding/trim needs paint touch up**

The siding/trim around the chimney is in need of paint/repair.

Recommendation: Contact a qualified painting contractor.

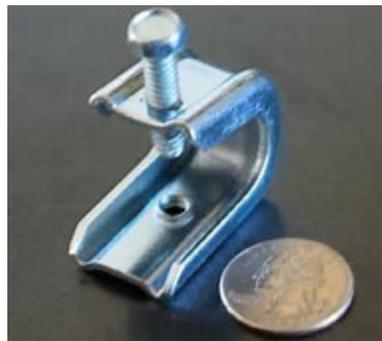
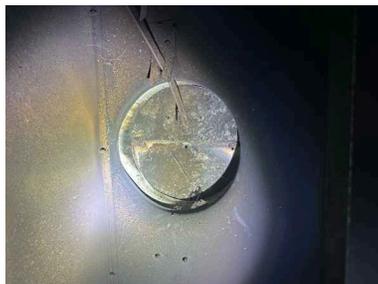
**3: No damper clamp**

No damper clamp was installed on the chimney flue. We recommend that, as a safety upgrade, a damper clamp be installed on the damper to keep it open a little so that if the gas were to be turned on accidentally, it would have somewhere to go.

Recommendation: Contact a handyman or DIY project

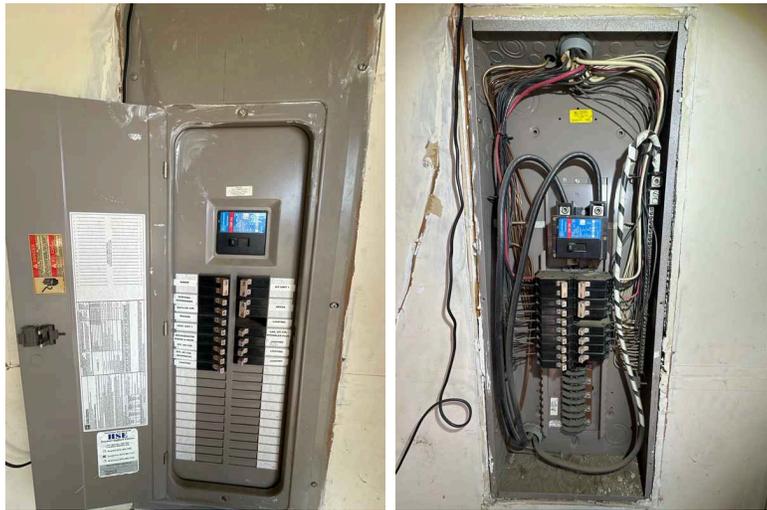
*Main Service Panel Amperage:* 200 Amp

*Panel Photos :*

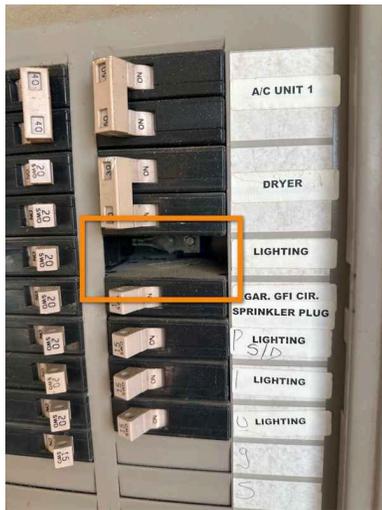
**2: Knock outs need covers**

There are areas in the electrical panel where knockouts are missing. These areas should have a cover over them to prevent debris and vermin from entering the panel.

Recommendation: Contact a qualified electrical contractor.

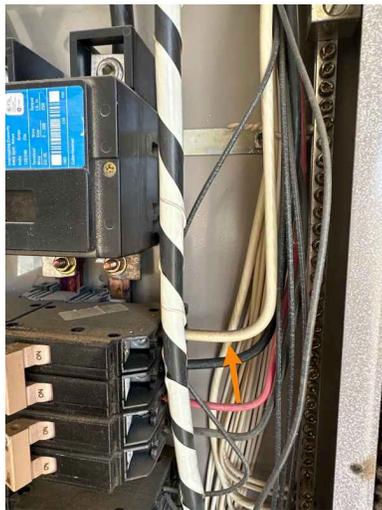
#### 4: White wires require proper re-identification

This is a "newer" requirement; however, it is a good safety upgrade that should be considered.

Recommendation: Contact a qualified electrical contractor.

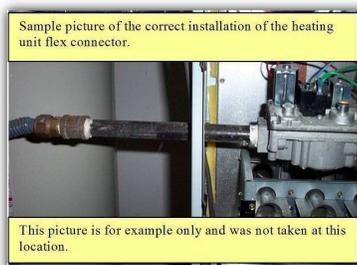
**1: Flex line into cabinet**

The gas supply flex connector was observed to be passing through the heating unit cabinet. Under current mechanical installation standards, this is no longer an accepted practice. Only rigid black gas pipe is allowed to pass through the heating cabinet.

Recommendation: Contact a qualified professional.

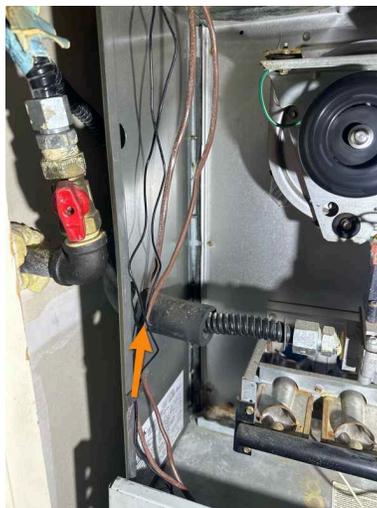
Example of how furnace gas line should be installed

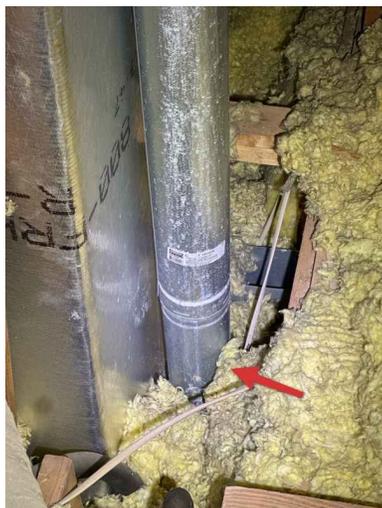
## 2: Flue in contact with combustibles

The furnace flue (vent pipe) has inadequate clearance from combustible materials. Double-walled vent pipes (type B) should have at least 1 inch, single-walled vent pipes should have at least 6 inches of clearance.

Recommendation: Contact a qualified HVAC professional.

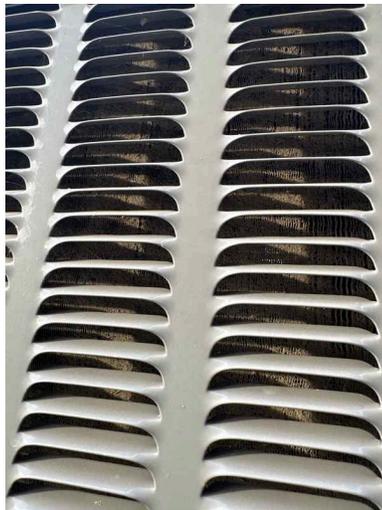
**1: Coils are dirty**  
 Maintenance Items

We recommend the condensing coils on all units be cleaned to help achieve proper air flow.

Recommendation: Contact a qualified HVAC professional.

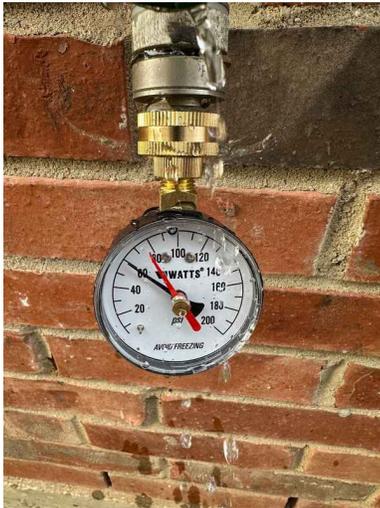
*Water Pressure Photo:*

*Static Water Pressure Reading:* 55 to 60 psi

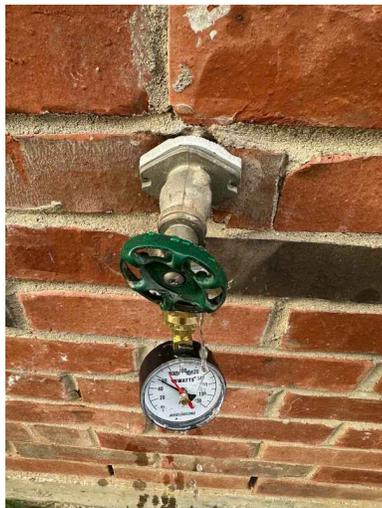
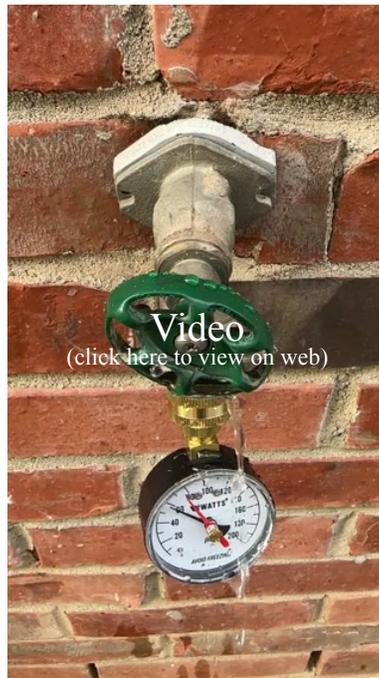
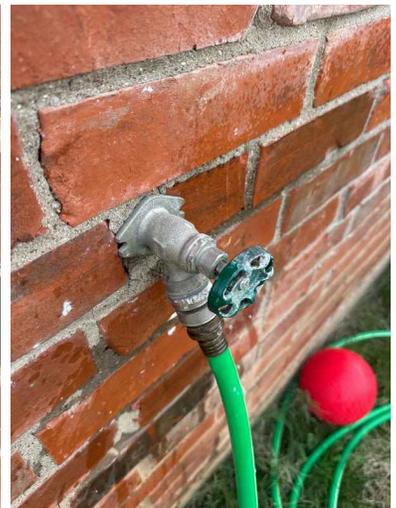
**2: Hose bib valve handle is leaking**

There are one or more hose bib valve panels that are leaking and should be repaired.

Recommendation: Contact a qualified plumbing contractor.

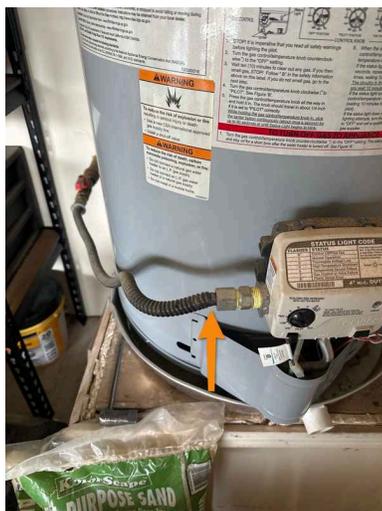
## 2: Missing Sediment Trap

🚩 Items To Monitor, Further Evaluation Recommended

The sediment trap shall be either a tee fitting having a capped nipple of any length installed vertically in the bottommost opening of the tee as illustrated in Figure G2419.4 or another device approved as an effective sediment trap. Illuminating appliances, ranges, clothes dryers, decorative vented appliances for installation in vented fireplaces, gas fireplaces, and outdoor grills need not be so equipped.

Recommendation: Contact a qualified plumbing contractor.

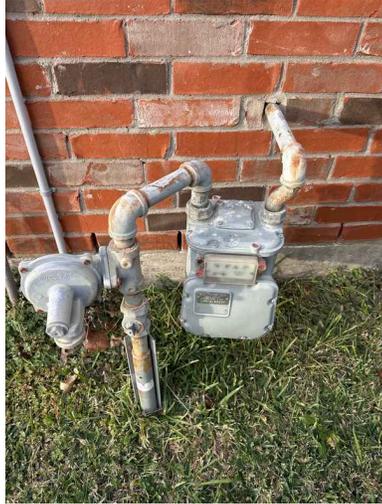
*Gas Meter Photo:*

*Type of Gas Distribution Piping:* Cast Iron (Black Pipe)

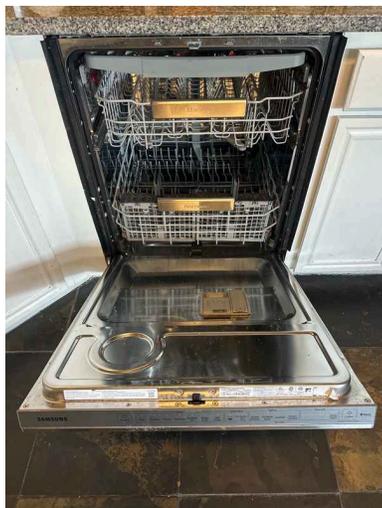
The dishwasher was operated by running a wash cycle and was functional at the time of inspection. No leaks or water was present at the base of the unit at the completion of the cycle. The unit's efficiency of cleaning dishes is not tested. No deficiencies were observed with the unit unless otherwise noted in this report.

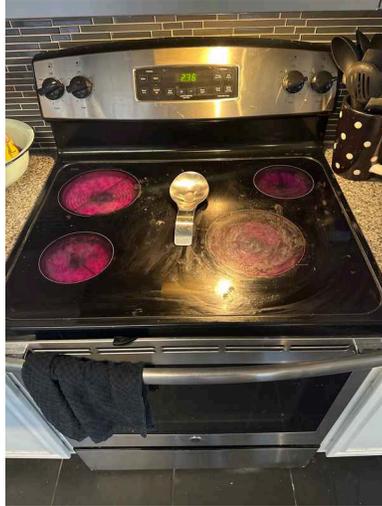
*Oven is operable.:*

The oven was tested at 350 F and was within the +/- 25 range deemed appropriate by the Texas Real Estate Commission.

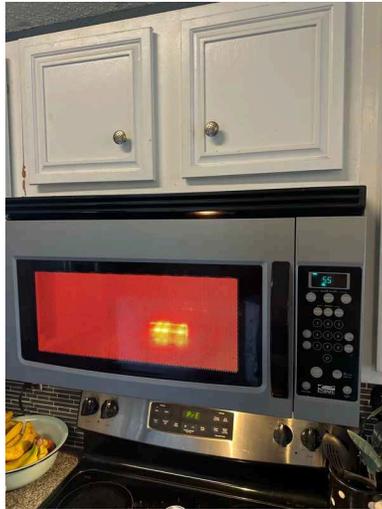
The microwave was tested by running on "Cook" mode and was functional at the time of inspection. The efficiency of the unit or other functions are not tested for. No reportable conditions were present unless otherwise noted in this report.

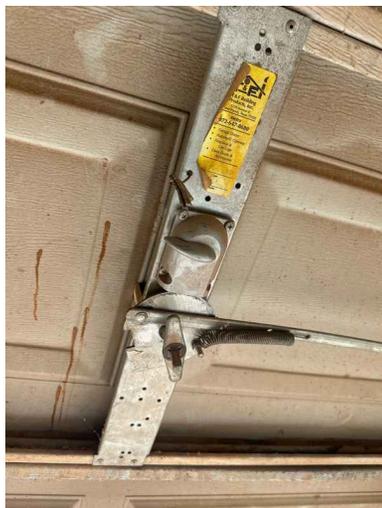
**1: Locks need to be disabled**

The garage door lock(s) is/are still in service; we strongly recommend that the locks on the garage door be disabled.

Disabling the garage door locks will ensure that the door does not get locked from the inside and someone does not accidentally hit the garage door opener and damage the door's components.

Recommendation: Contact a qualified professional.

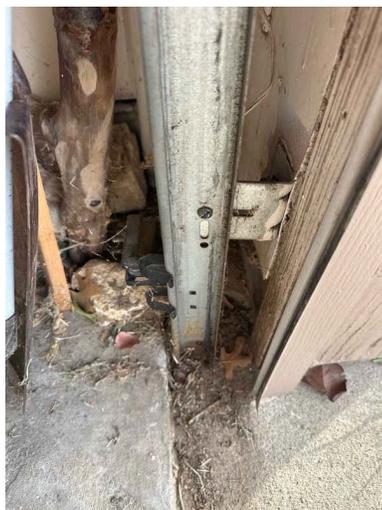
**2: Photo electric sensors need adjustments**

The photoelectric sensors on the garage door are in need of adjustment so that they work properly.

Recommendation: Contact a qualified garage door contractor.
