CONCERNING THE PROPERTY AT 14309 Serrano Ridge Road, Haslet, Texas 76052

Ryan Beattie - Professional Inspector  
TREC # 22464  
214.566.1900  
Ryan@NotableInspections.com

14309 Serrano Ridge Road | Ft Worth | TX | 76052  
4/3/2017 @ 10am  
Sunny, 66°F

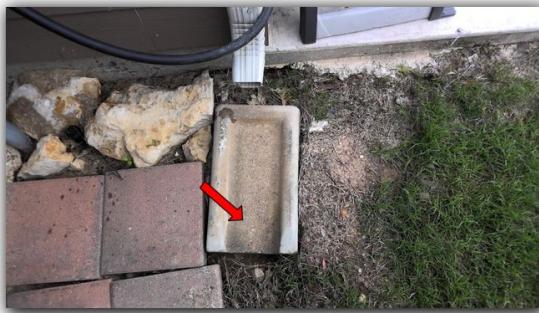
- Turn splash blocks around to be proper direction

Note: Any area where the ground or grade does not slope away from the structure is to be considered an area of improper drainage. A minimum slope downward of six inches per 10 feet is recommended.

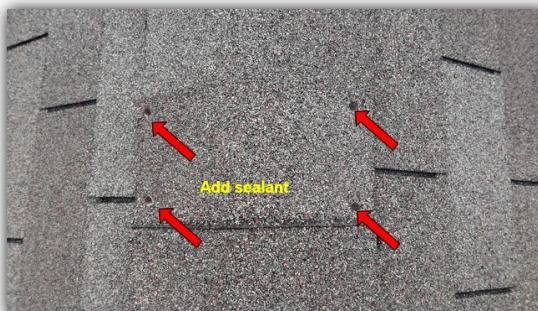
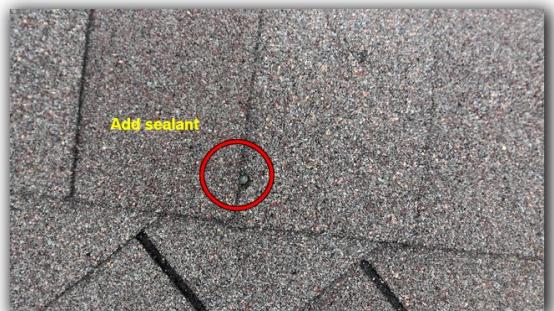
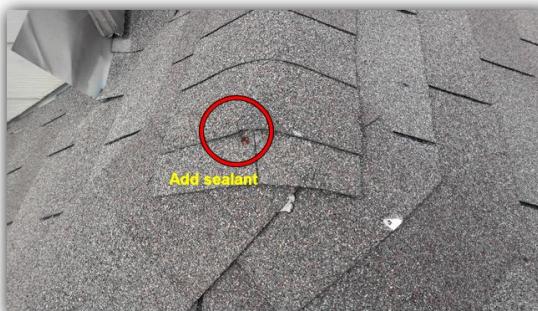
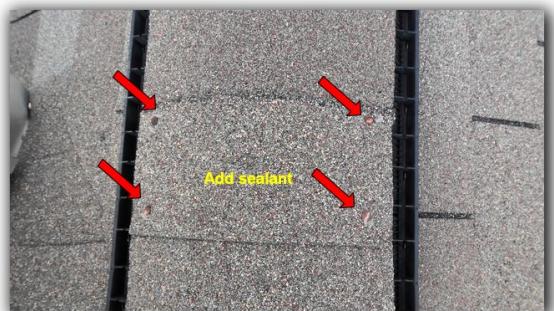
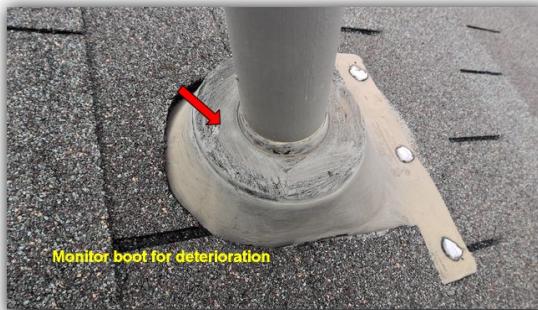
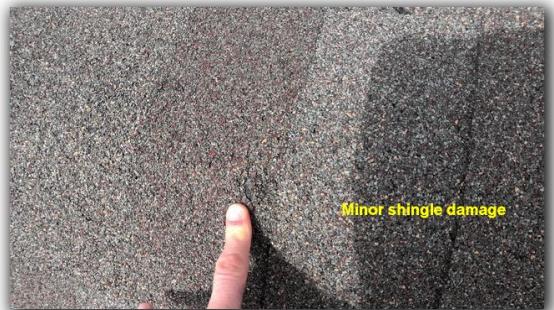
- Minor (normal) shingle damage observed
- Recommend touching up sealant on exposed nails throughout
- Recommend monitoring plumbing vent boots for deterioration

**Note:** Roof Level Satellite dish installations can cause damage to the shingles and allow moisture penetration. Roof penetration(s) not properly flashed / sealed Satellite dish installations can cause damage to the shingles and allow moisture penetration.

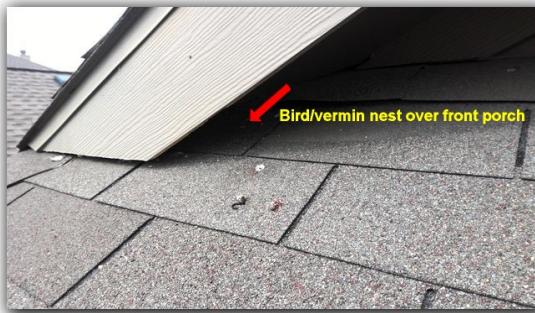
- Bird or vermin nest observed over front porch

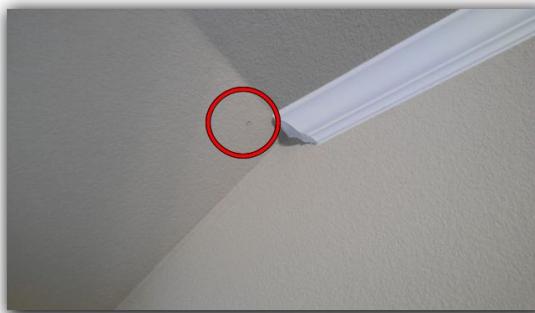
- Nail pop observed in breakfast nook
- Previous repairs observed near fireplace
- Minor settling cracks near kitchen sink

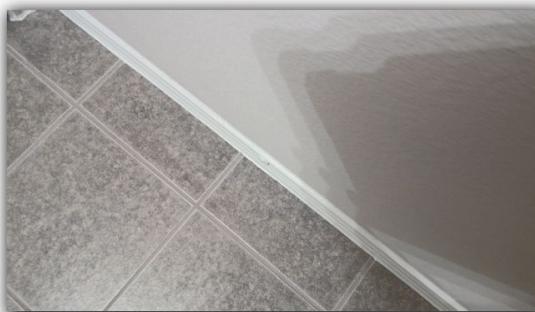
- Multiple missing door stoppers

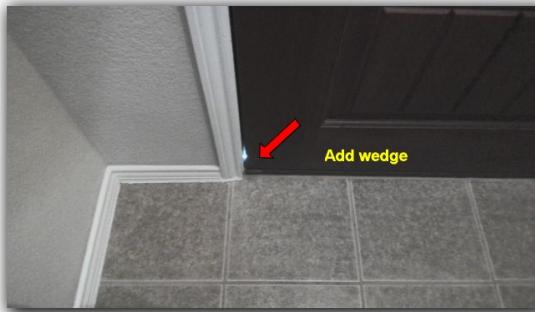
- Entry door from garage is not self-closing type
- Front and back door need insulation wedges

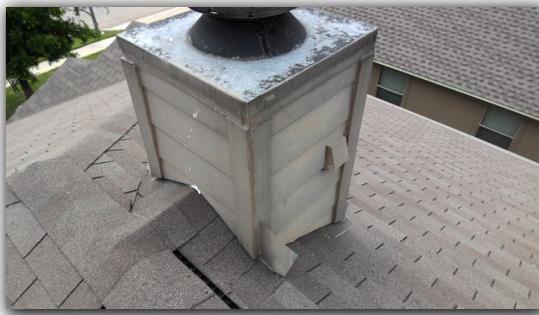
- Inspected. No visible deficiencies observed at the time of the inspection.
- Note: Fireplace is woodburning. It is unknown when the sellers last had the chimney cleaned therefore it is recommended to have the chimney cleaned prior to initial use
- Chimney siding sealant maintenance needed

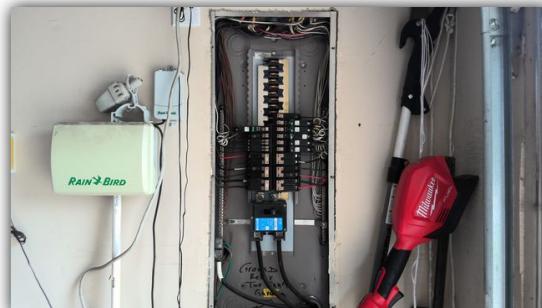
- Note: Inspectors do not validate accuracy of breaker labeling
- Main off not in separate breaker box
- No GFCI protection for Oven
- No GFCI protection for Dryer
- No Whole Home Surge Protector present

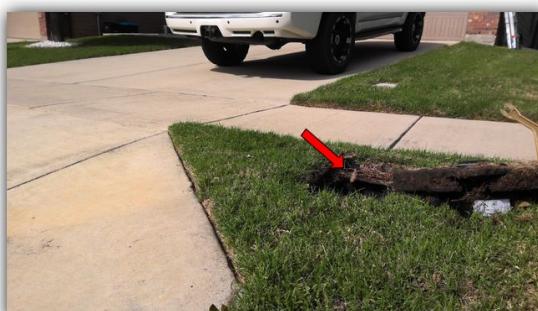
*Location of water meter:* Right of drive way / left of mailbox

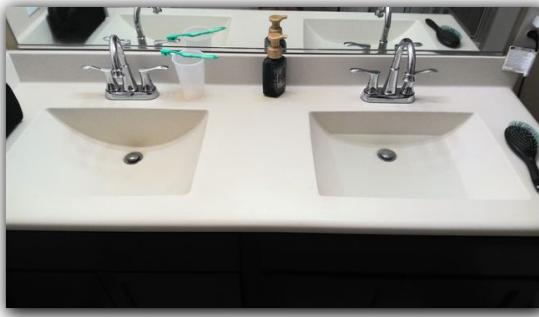
- Right master sink slow to drain

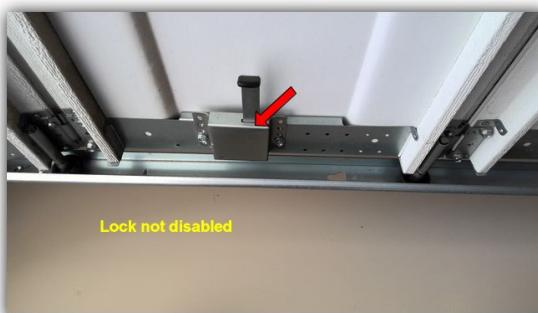
- No safety warning labels observed
- Unit was operating properly at the time of the inspection.
- Locks not disabled when automatic opener present
