CONCERNING THE PROPERTY AT **14877 Snowhill Drive, Frisco, Texas 75035**

TEXAS REAL ESTATE CONSUMER NOTICE CONCERNING HAZARDS OR DEFICIENCIES

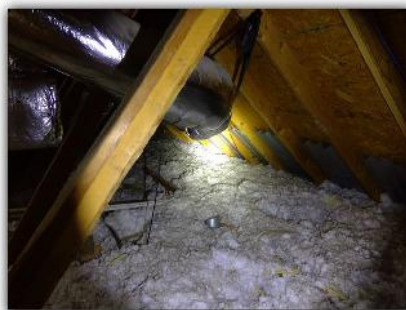
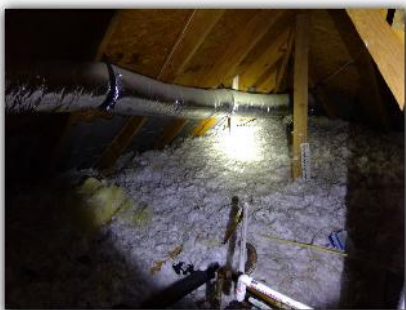
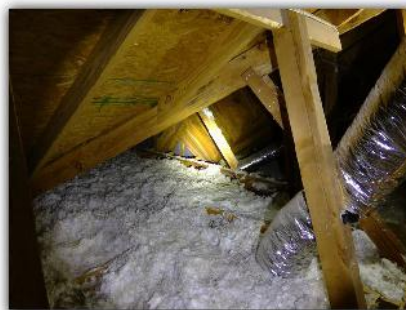
Attic Insulation:

Insulation in the attic appears to be about 10" to 13" deep of Loose Filled, Batt or Blanket type insulation. The suggested depth for an "R" value of 30 is about 8 to 10 inches. Adding un-faced blankets of insulation or blown in insulation may be a good idea. Other materials are available such as thermal barrier plastic sheeting. There is no T.R.E.C. standard in the inspection guidelines for insulation depth.

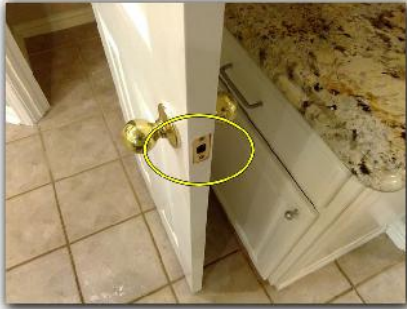
Exterior Doors

- Weather stripping improvements are recommended for exterior doors.

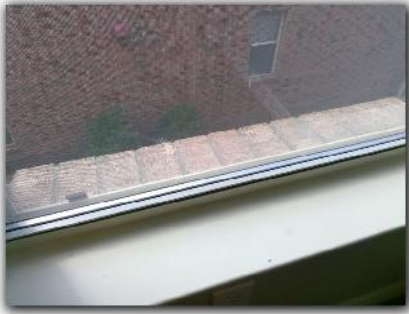
Windows:

- The window weather-stripping is damaged and/or missing at one or more of the windows and improvements are recommended.

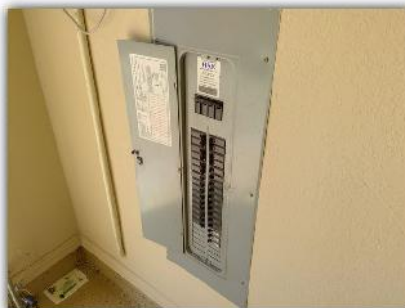
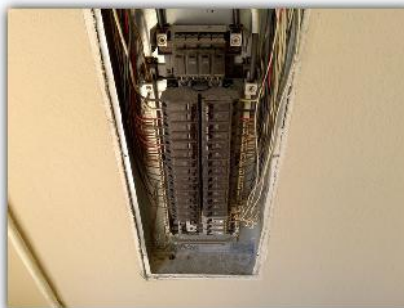
- The neutral bar was observed to be double lugged (two or more wires under one screw). Each neutral wire should have it's own

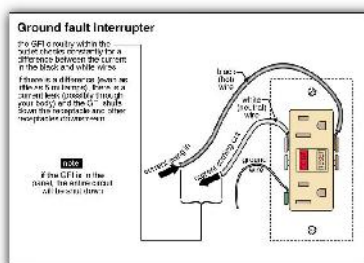
- The laundry room receptacle(s) do not appear to be connected to a ground fault circuit interrupter (GFCI) device. Under current electrical standards, all laundry room receptacles should have GFCI protection.

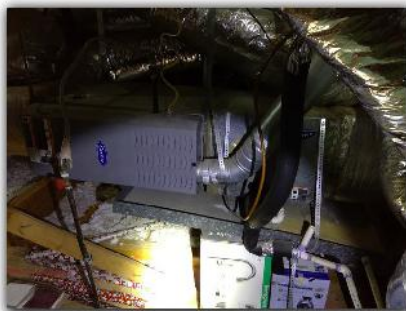
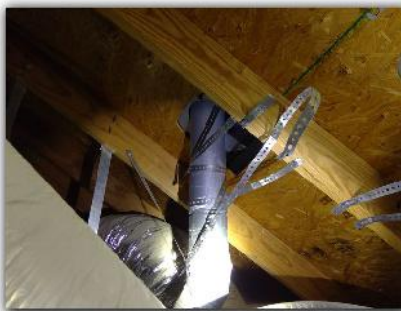
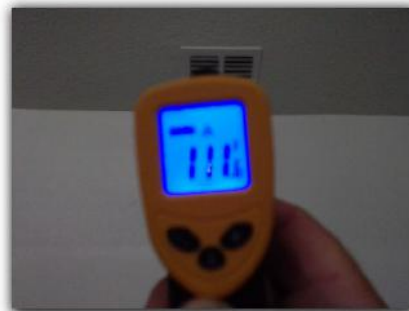
On the day and time of the inspection it is my opinion the heating system & equipment appears to be functioning as intended, with the following observations, deficiencies and/or exceptions if any associated with Unit 2 of the Heating System that were observed on this structure:

- The heater gas supply line is not equipped with a sediment trap just before the gas appliance connector. This condition does not meet current installation requirements and should be corrected.

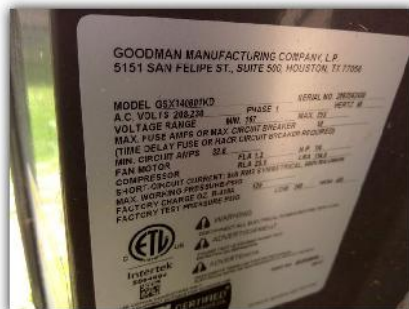
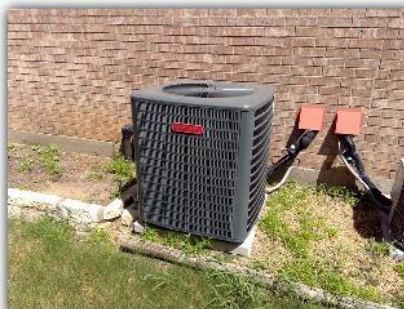
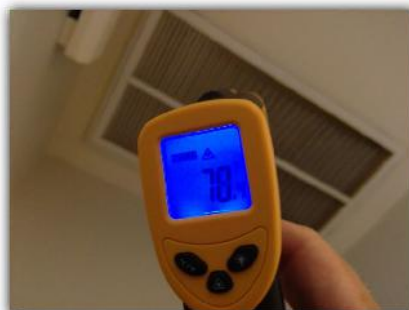
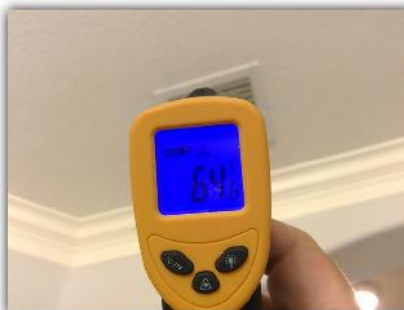
On the day and time of the inspection it is the inspector's opinion the cooling system & equipment appears to be functioning as intended, with the following observations, deficiencies and/or exceptions if any associated with Unit 1 of the Cooling System that were observed on this structure:

- Damaged, deteriorated and/or missing insulation on the refrigerant lines should be repaired or replaced at the outside condenser.

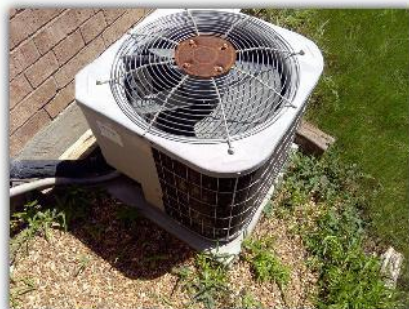
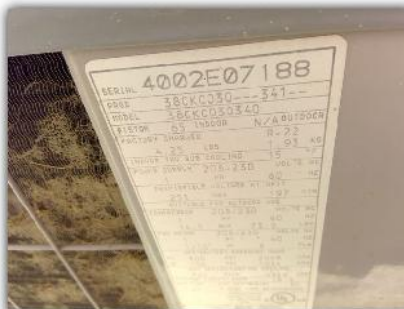
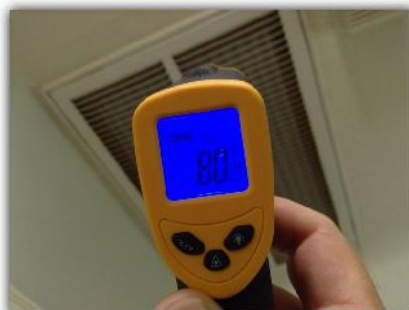
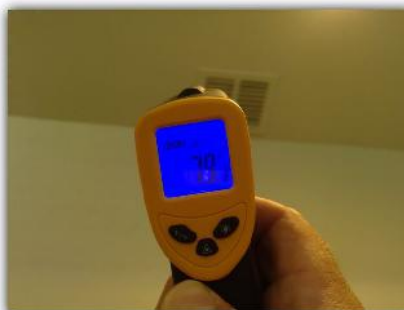
On the day and time of the inspection it is the inspector's opinion the cooling system & equipment appears to be not functioning as intended, with the following observations, deficiencies and/or exceptions if any associated with Unit 2 of the Cooling System that were observed on this structure:

- Damaged, deteriorated and/or missing insulation on the refrigerant lines should be repaired or replaced at the outside condenser.

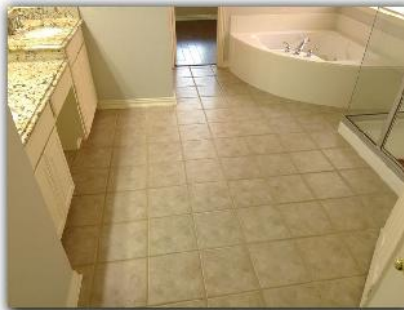
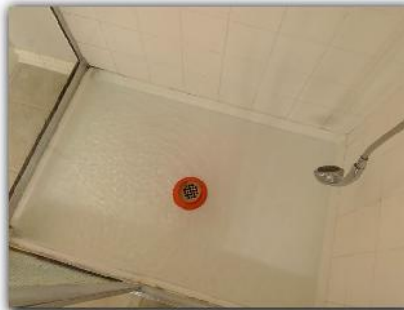
Shower

- The shower fiberglass enclosure glass is damaged.

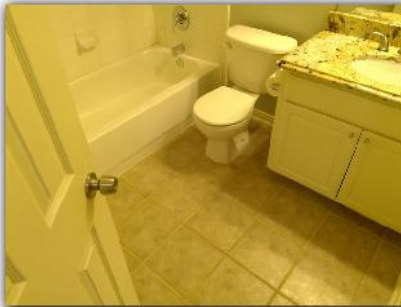
Bathtub

- The bathtub was observed to drain slowly, suggesting that an obstruction may exist.

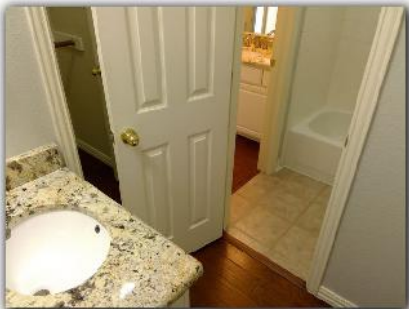
Bathtub

- The shower spout is leaking at the neck connection.

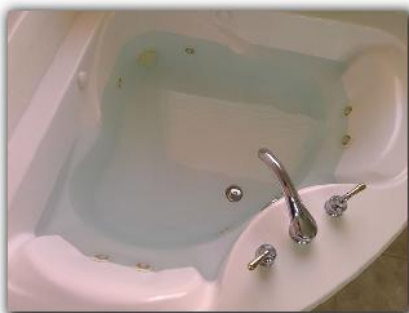
Hydro-Massage Therapy Spa:

- The access to the hydro-massage therapy equipment motor is not readily accessible and inspection of the equipment lines and motor could not be performed. This does not meet current installation standards.

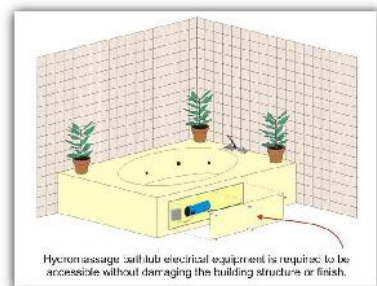
- The hydro-massage therapy equipment appears to be inoperative at the time of this inspection. This condition should be further evaluated and corrected as necessary.

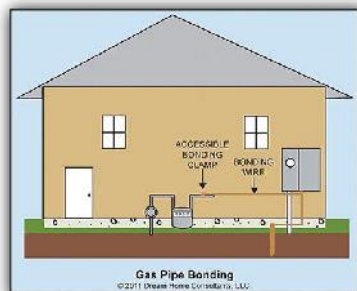
- The gas system did not appear to be bonded back to the electrical system. This is an "*as built*" condition, but per the TREC standards, I am required to report it as a deficiency.

Buyer's Advisory Notice: The gas lines were not pressure tested by a licensed plumber. This was a limited TREC visual gas line inspection. The gas piping in this house may include corrugated stainless steel tubing (CSST). Typically electrical bonding connections are not present or are not properly installed on these installations, especially systems installed before 2009. Several lightning fires have recently been attributed to CSST gas plumbing systems. The lack of a strong electrical bonding may increase the potential for lightning strikes causing arcing at the CSST gas piping that can result in perforation of the piping creating gas leaks, and fires. Even if electrical bonding is apparent at the CSST system, the adequacy and operation is beyond the scope of this inspection. It is recommended that the installation of any CSST gas piping system be evaluated further by a qualified electrician licensed by the State of Texas.

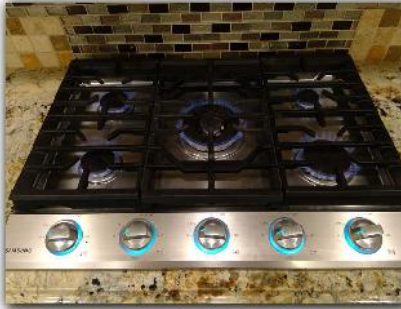
- This component appears to be performing adequately at the time of this inspection.

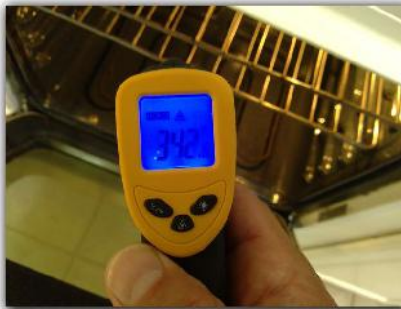
Built-in Oven: General Electric – GE

- This component appears to be performing adequately at the time of this inspection.

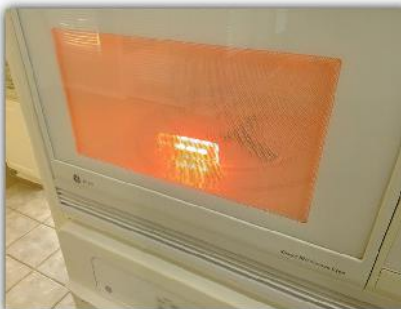
Brand Name: General Electric – GE

- This component appears to be performing adequately at the time of this inspection.

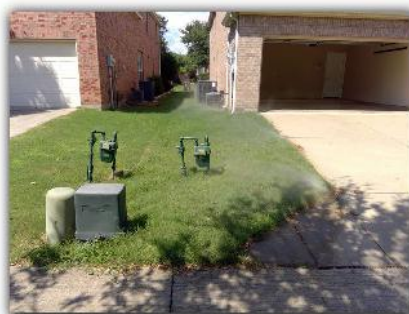
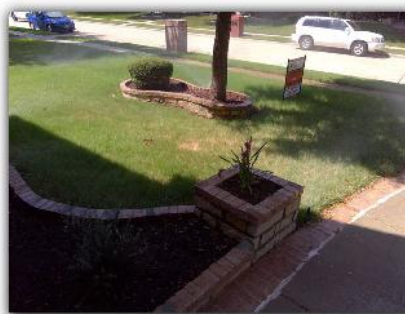
- The conduit that is protecting the sprinkler system wires is damaged.
