124 Norman Road
Aptos CA 95003

Country Home Inspection and Termite Inc.

Inspection Date: 4/12/2021
Report ID: 20210412-124-Norman-Rd

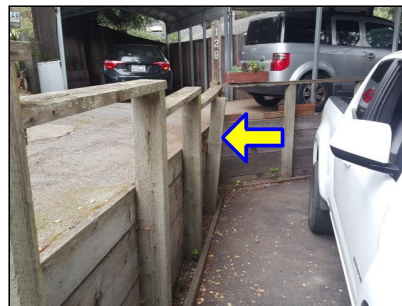
1.0 Item 2(Picture)

Retaining wall tilted at various areas of the yard. Recommend monitoring the retaining walls and have them further evaluated when needed by a Landscape Contractor.

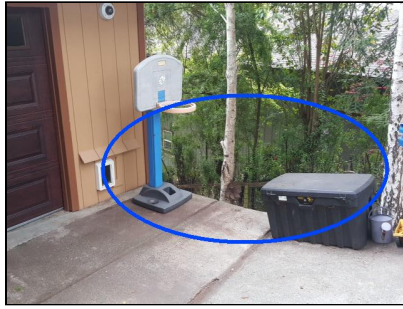
1.1 Item 2(Picture)

(1) The guard-rail(s) is missing on the right side of the driveway and around the hot tub. This is considered a safety hazard. Recommend installing a proper guardrail as needed by a qualified licensed contractor.

(2) Wood deck has signs of dry-rot and fungus damage on various areas of the decks, recommend refer to pest inspection or licensed Contractor for further information.

(3) The left side deck ledger board that is attached to the home has been installed without flashing, creating a condition conducive to deterioration. We recommend this board be flashed or properly sealed by a qualified licensed contractor to help prevent deterioration at this location.

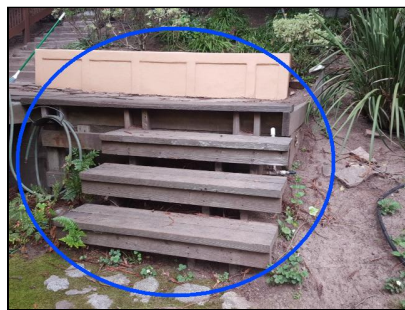
1.2 Item 4(Picture)

(1) Exterior steps handrail(s) improper. Noted on various stairs around the home. Although there is a handrail installed. Recommend installing a handrail that can be grasped with one hand. 1 1/2 width is recommended for the handrail(s).

(2) Exterior stairway riser varies more than 3/8 of an inch and or over 8 inches in height. Noted on various stairs around the home. Improper rise or run was noted at the stairs. This means that one or more of the stairs was higher or longer than the others or that the length of the stairs does not meet current standards. This should be considered a tripping hazard and correction is recommended.

(3) The handrail on various stairs around the home is missing. Handrails are required on at least one side of stairs with 4 or more risers. The height of the handrail must at least 34 inches but cannot be more than 38 inches above nosing of the stair. The hand grip portion of handrail must be at least 1 1/4 inches but not more than 2 inches in circular cross section. A handrail should be installed for safety by a licensed qualified contractor.

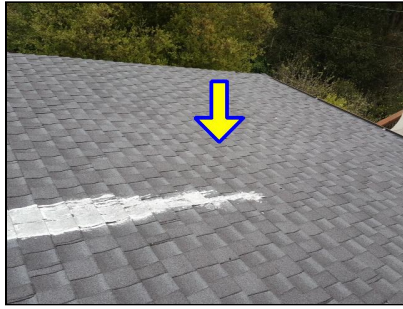
2.0 Item 2(Picture)

Roof weathering, showing signs of aging. Typical granule loss is noted on areas of the composition shingles. Appears to be normal wear. The exact age of the roof is uncertain. Recommend periodic inspections by a Qualified Roofing Contractor.

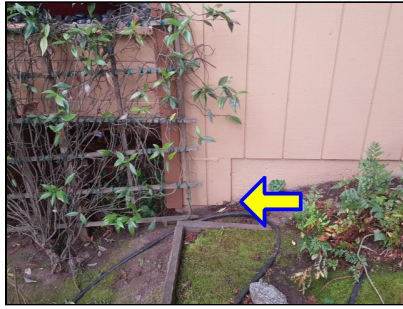
2.3 Item 2(Picture)

Exterior siding has signs of dry-rot or fungus damage. Noted on the home at various locations. Recommend refer to pest inspection for all locations of damaged siding.

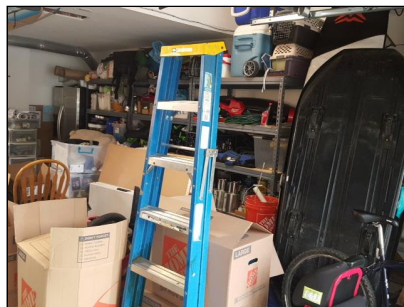
2.6 Item 1(Picture)

Access impaired. The garage was full of storage at the time of the inspection. The garage was not fully inspected. We recommend the storage be removed and the garage be fully inspected before the close of escrow.

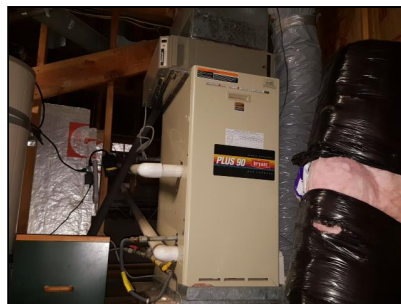
5.0 Item 1(Picture)

The forced air furnace is no longer in use. The forced air furnace is disconnected. Electric radiant floor heating has been installed. Recommend refer to the current home owner for further information.

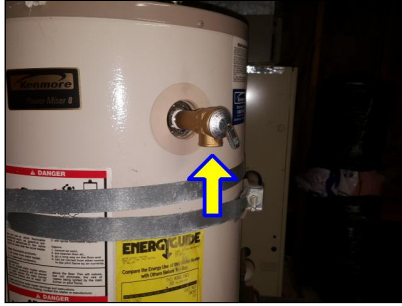
6.0 Item 1(Picture)

Water heater pressure / temperature relief valve discharge not terminated within 6" of the floor. Recommend installing a metal pipe on the water heater relief valve. Recommend the pipe extend to the floor or exterior of the home and within 6 inches of the ground. Recommend repairs by a qualified person.

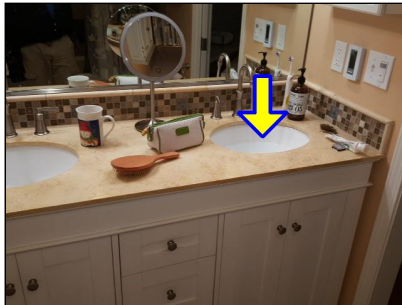
6.1 Item 1(Picture)

Fixture drain slow or possibly clogged in the downstairs bathroom on the sink drain. In most cases this is an indication that there is build up in the p-trap in the sink drain line. We recommend cleaning the p-trap. If there is no change in the drainage we recommend further evaluation and repair by a qualified licensed plumbing contractor.

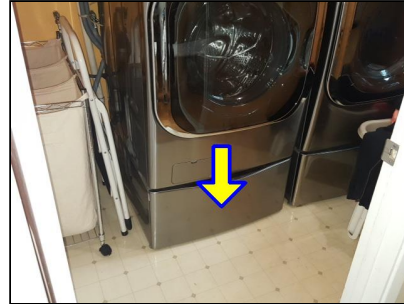
6.7 Item 1(Picture)

Recommend installing a drain pan under the washing machine with a drain to the exterior. This is recommended in case of a water leak at the washing machine. The water will most likely drain to the exterior. Modification or addition is generally considered an upgrade which should improve safety or efficiency. The opinion of a qualified licensed contractor is recommended.

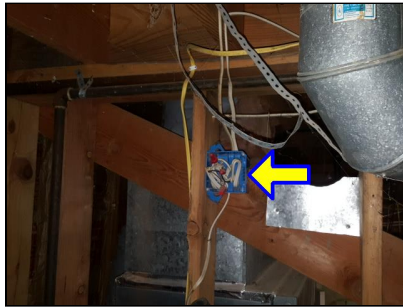
7.4 Item 2(Picture)

(1) Junction box cover plate missing. Noted in the sub-area. Junction box cover plates are required to prevent accidental contact with the splice and to confine heat in the event of an overheated splice. Recommend repair as soon as possible. There may be others missing junction box covers that were not located. It is recommended that the finding be reviewed, and corrected as needed, by a qualified licensed contractor before purchasing the property. A qualified licensed electrical contractor should correct as needed.

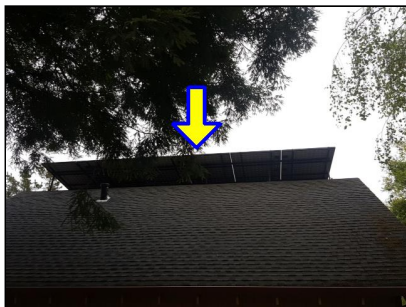
7.8 Item 1(Picture)

The solar panels and the components were not inspected. If needed it is recommended the solar panels and all of its components be fully evaluated by a qualified contractor.

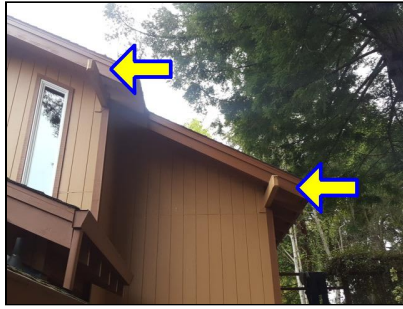
11.1 Item 2(Picture)

(1) Wood deterioration noted in roof beam ends at a number of locations. Recommend refer to pest inspection or a licensed Contractor for further information concerning all possible areas with dry rot, pest or fungus damage.

(2) Wood deterioration noted in barge rafter(s). Recommend further inspection and repair by a qualified licensed contractor.
