# WOOD DESTROYING PESTS AND ORGANISMS INSPECTION REPORT #: 20200533

BUILDING NO. 124	STREET NORMAN ROAD	CITY APTOS	ZIP 95003	Date of Inspection 11/04/2020	NUMBER OF PAGES 1 of 6
---------------------	-----------------------	---------------	--------------	----------------------------------	---------------------------

GENERAL DESCRIPTION:  
 This is a multi-story, single family residence on a raised foundation. It has an attached garage. It has a composition roof and was occupied and furnished at the time of inspection.

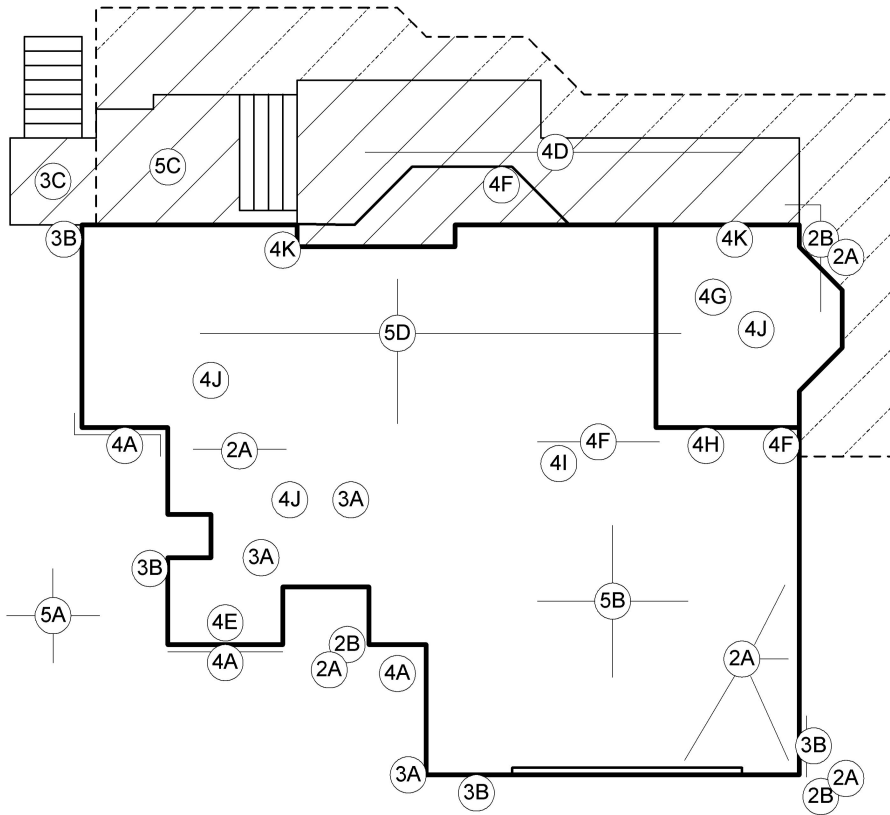
FINDING AND RECOMMENDATION: 4K EVIDENCE OF FALSE POWDER POST WOOD BORING BEETLES WAS NOTED IN THE SUBSTRUCTURE FRAMING AS INDICATED ON THE DIAGRAM. VARIOUS AREAS WERE PROBED AND THE EVIDENCE APPEARS TO BE INACTIVE.
