April 12, 2021

RE: 4316 Valley View LR AR

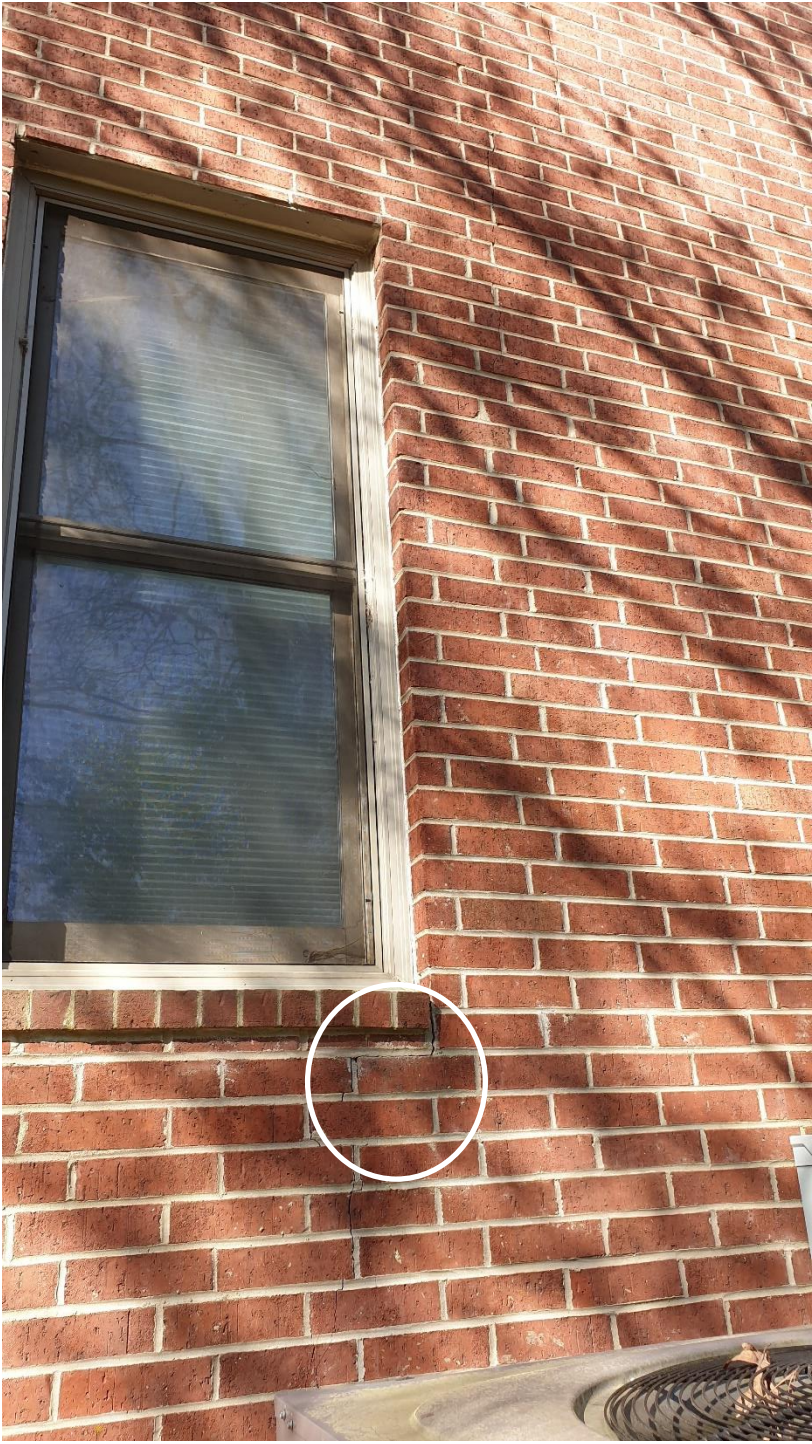
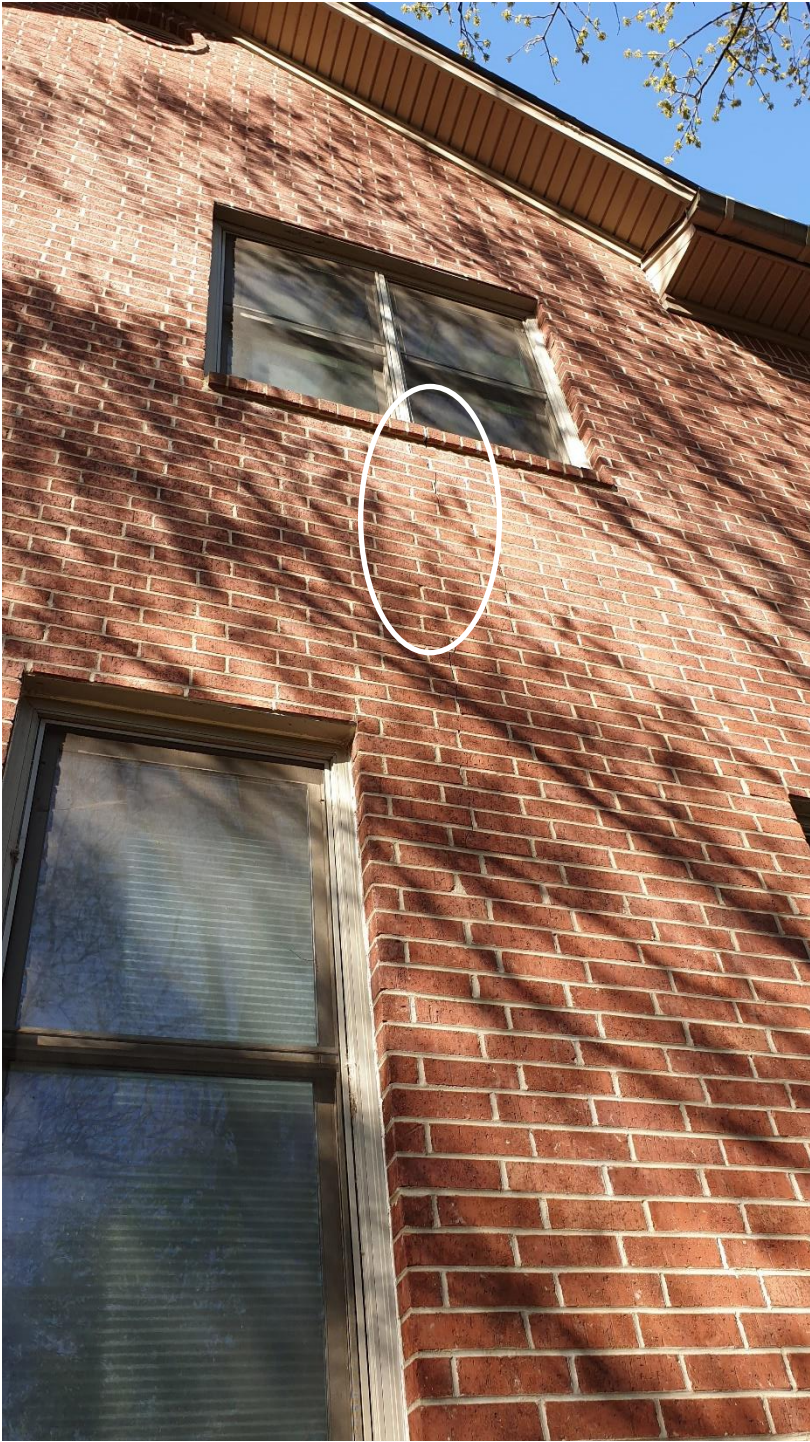
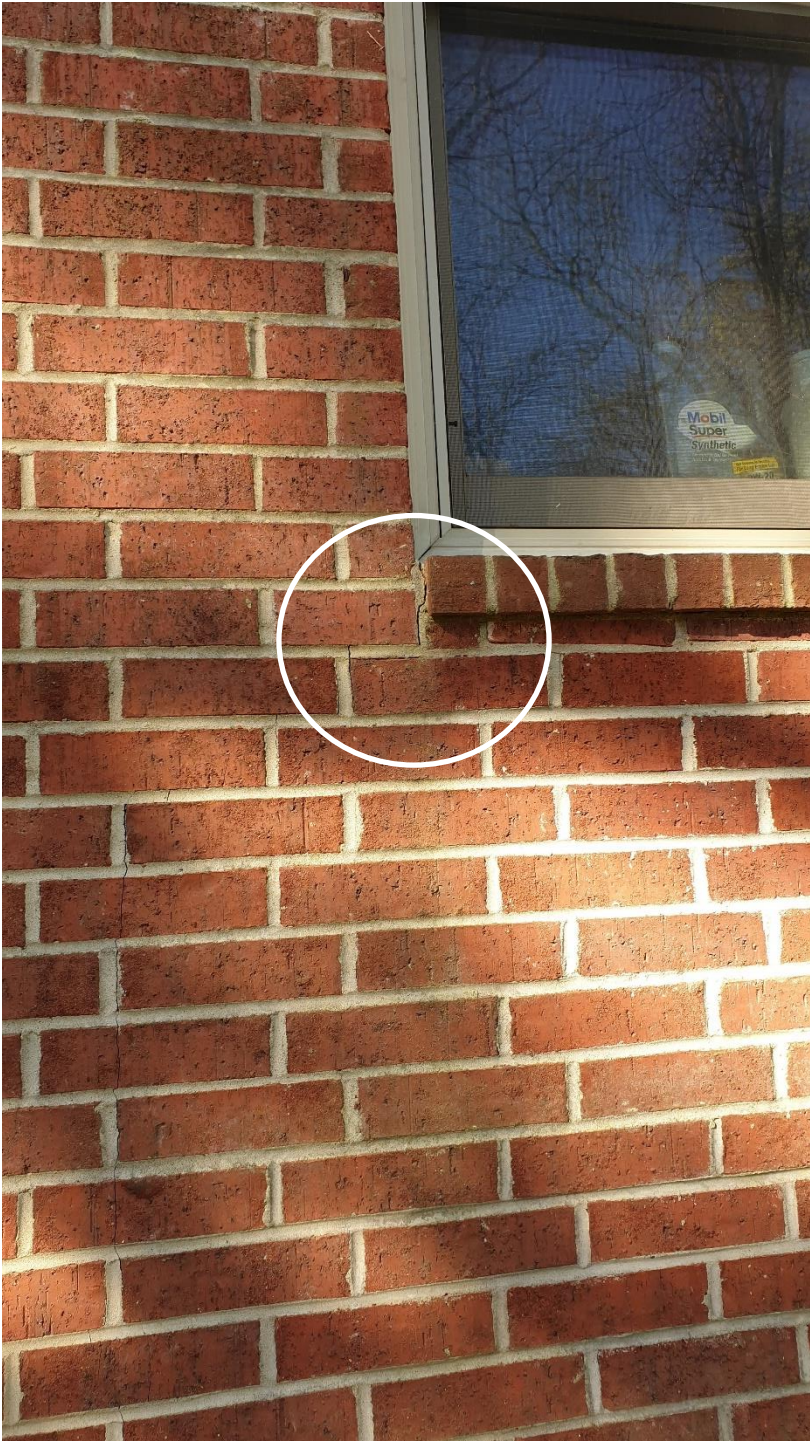
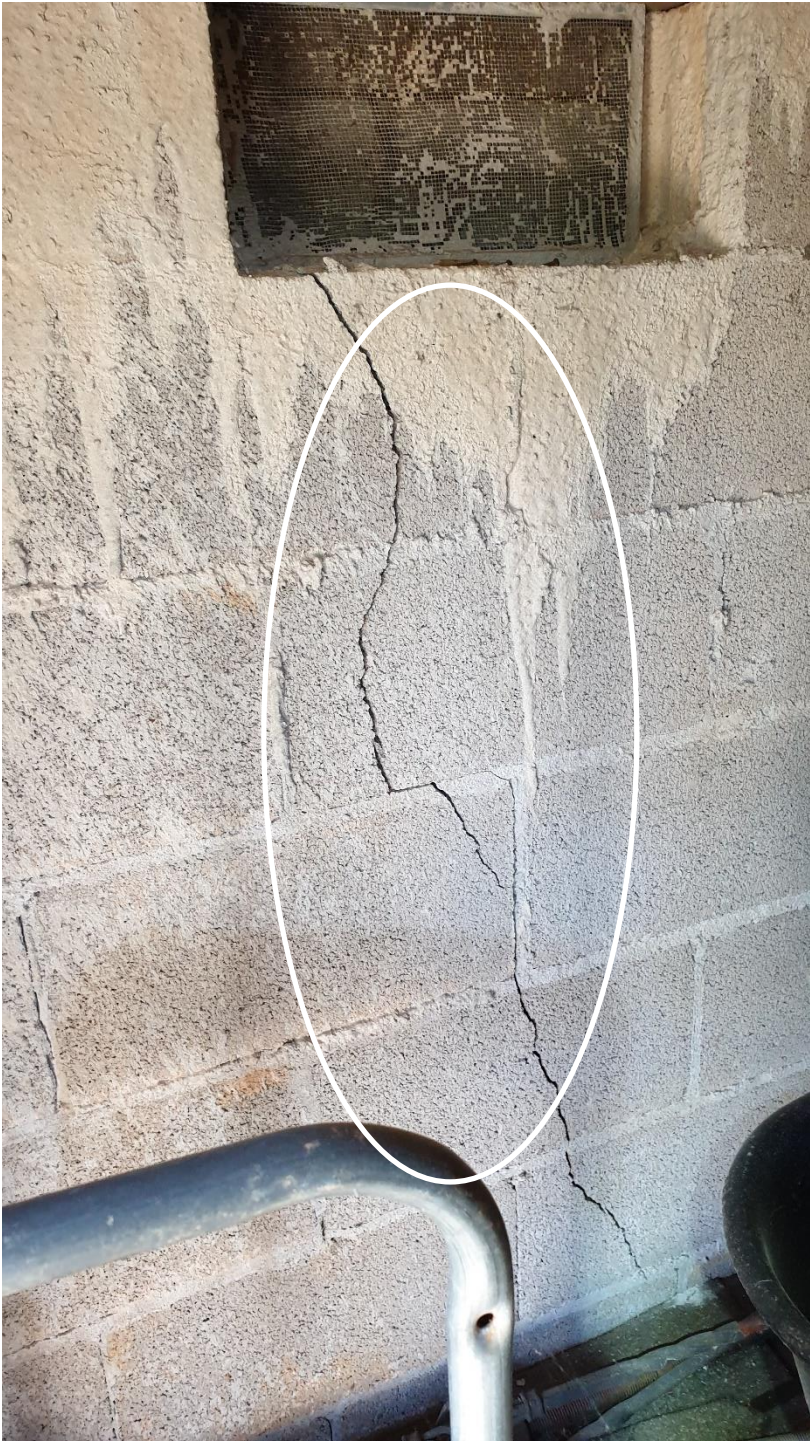
Jane,
I inspected this home at your request. There are some cracks in the exterior brick and mortar. In my opinion these are cosmetic. They can be sealed with matching urethane caulk. I recommend sealing cracks wider than the width of a quarter. There is a crack in the concrete block foundation wall. In my opinion these are typical and no repair is necessary. There is a pair of wooden piers supporting one beam. In my opinion these should be replaced with a concrete block pier on a concrete pad like the other piers. There are some dark spots on the bottom of the crawlspace walls. There is also some white powdery residue called efflorescence. This is harmless chemical salt that results from a reaction between the cement and moisture. The dark spots are wicking action where the block soaks up moisture. In my opinion this is typical and no repair is necessary. The front brick steps have settled very slightly. There is a crack in the concrete porch in front. In my opinion this is typical and cosmetic. No repair is needed.

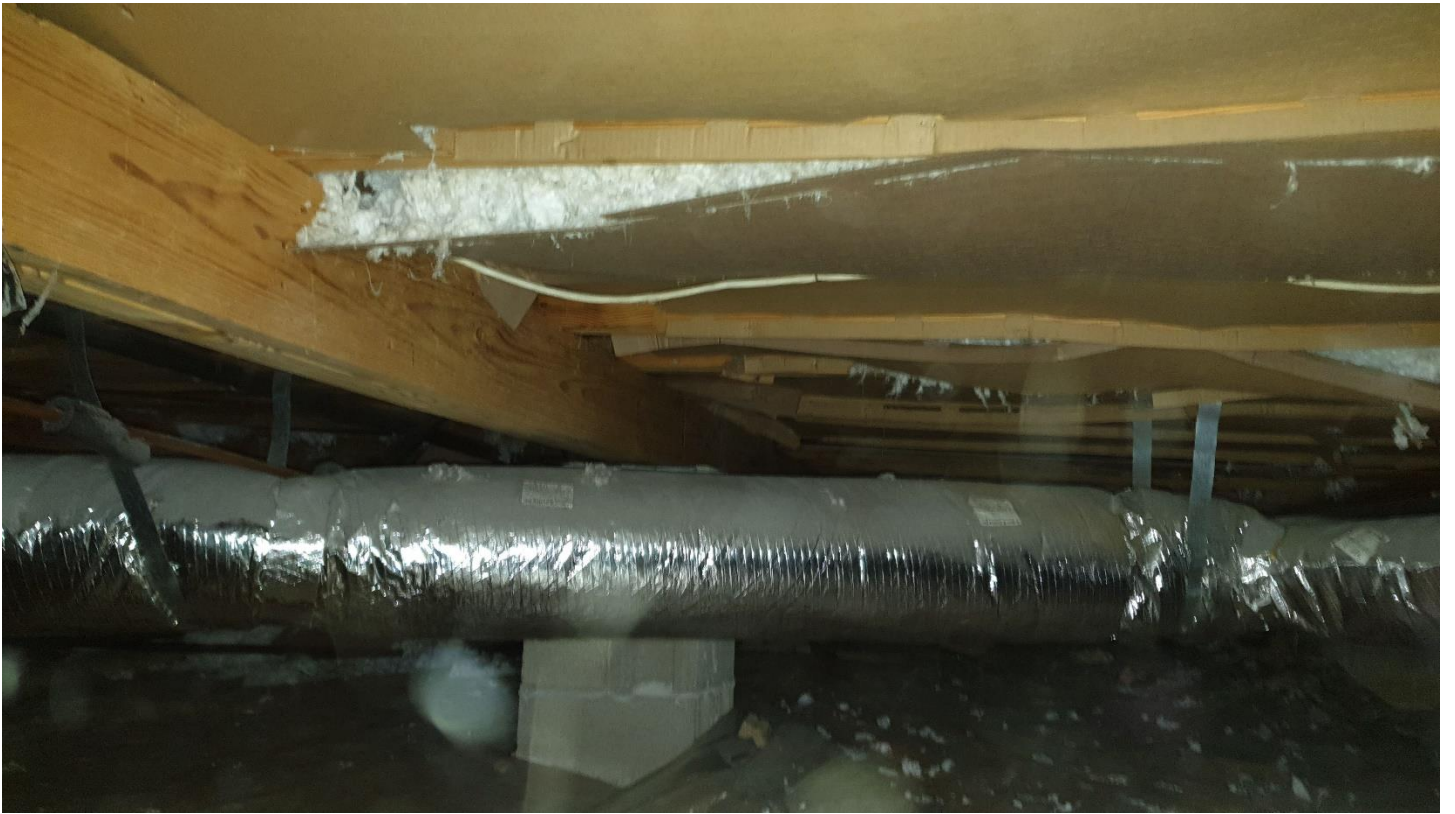
This item has been repaired.

See
Foundation Pro
Invoice
