1365 Brommer St
Santa Cruz CA 95062

Country Home Inspection and Termite Inc.

Inspection Date: 8/16/2021
Report ID: 20210716-1365-Brommer-St

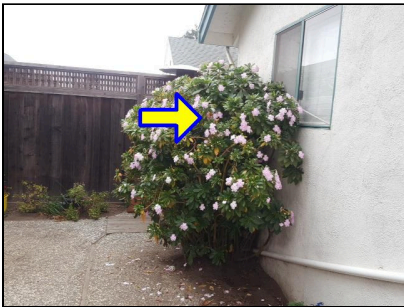
1.3 Item 2(Picture)

Shrubbery against home / siding. Noted at the exterior of the home at various locations. Recommend cutting back all shrubbery from the home to maintain 18 inches of clearance. Correction or modification decreases the probability of continued and excessive deterioration.

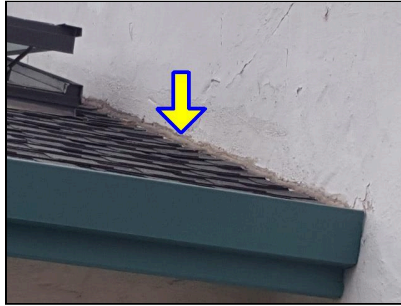
2.0 Item 2(Picture)

Application of "tar" as temporary roof repair noted. Noted on various locations of the roof. Recommend installing the proper flashing or keeping the areas sealed as needed. Correction or modification decreases the probability of continued and excessive deterioration.

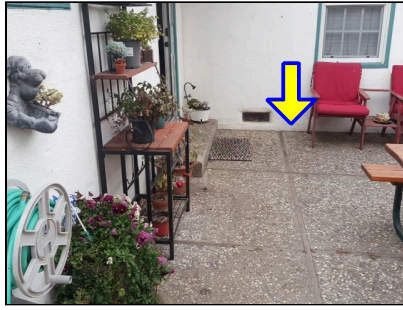
2.3 Item 2(Picture)

Stucco extends into the soil or walkways. This was typical for the era of construction. Current standards require weep screed to be installed above the soil or walkways. Recommend the stucco be cut or chipped away above the soil or walkways.

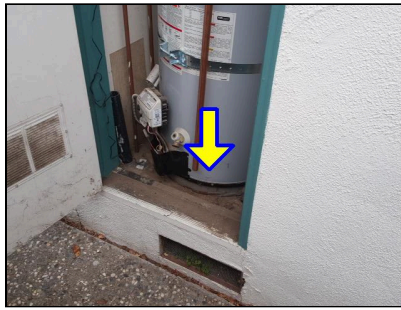
5.0 Item 2(Picture)

(1) Recommend installing a drain pan under the water heaters and washing machine with a drain to the exterior. This is recommended in case of a water leak at the water heaters or washing machine. The water will most likely drain to the exterior. Modification or addition is generally considered an upgrade which should improve safety or efficiency. The opinion of a qualified licensed contractor is recommended.

(2) Water heater seismic restraint system appears insufficient. Although the water heater is strapped with the correct straps, recommend adding bracing behind the water heater to help prevent any movement. Before purchasing the property, further study and corrections, as needed, by a qualified licensed contractor are advised.

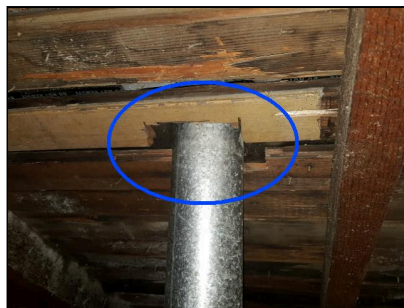
5.0 Item 5(Picture)

(3) Water heater vent is too close to combustible material. This was noted in the attic at the roof framing or sheathing. Manufacture recommends at least 1 inch of clearance. A qualified person should repair as necessary.

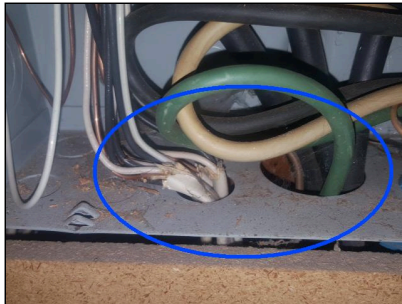
6.1 Item 1(Picture)

Box wire clamp not installed. Noted inside the sub-panel. Box clamps prevent the wires from possibly rubbing the metal edge. Recommend installing box clamps as needed. A qualified licensed electrical contractor should correct as needed.

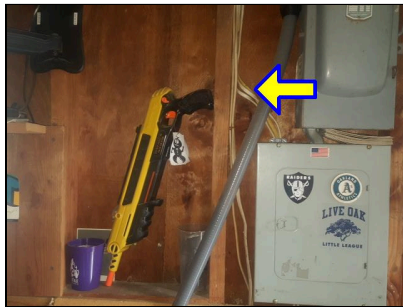
6.3 Item 2(Picture)

Romex sheathed cable exposed where could be damaged in the garage. Recommend the wiring be installed inside conduit or behind walls. A qualified licensed electrical contractor should correct as needed.

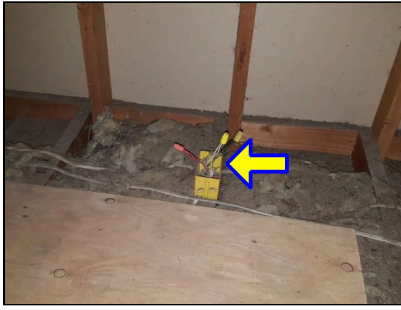
6.4 Item 2(Picture)

(1) Junction box cover plate missing. Noted in the garage, the sub-area and in the attic. Junction box cover plates are required to prevent accidental contact with the splice and to confine heat in the event of an overheated splice. Recommend repair as soon as possible. There may be others missing junction box covers that were not located. It is recommended that the finding be reviewed, and corrected as needed, by a qualified licensed contractor before purchasing the property. A qualified licensed electrical contractor should correct as needed.
