SELLER'S DISCLOSURE NOTICE

CONCERNING THE PROPERTY AT 130 Laverna Lane, Hickory Creek, Texas 75065

Introduction	3
I. STRUCTURAL SYSTEMS	5
A. Foundations	5
B. Grading and Drainage	8
C. Roof Covering Materials	12
D. Roof Structure and Attics	18
E. Walls (Interior and Exterior)	19

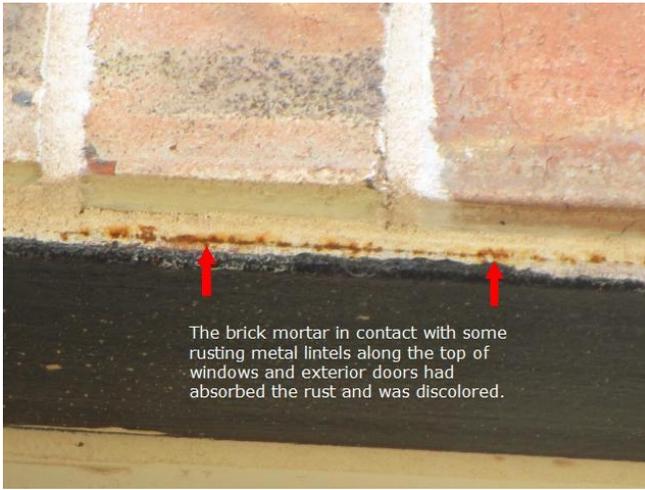
The brick mortar in contact with some rusting metal lintels along the top of windows and exterior doors had absorbed the rust and was discolored.

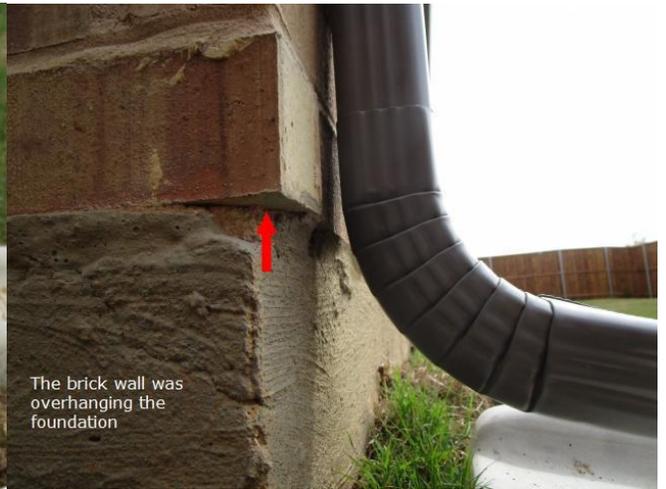
The brick wall was overhanging the foundation

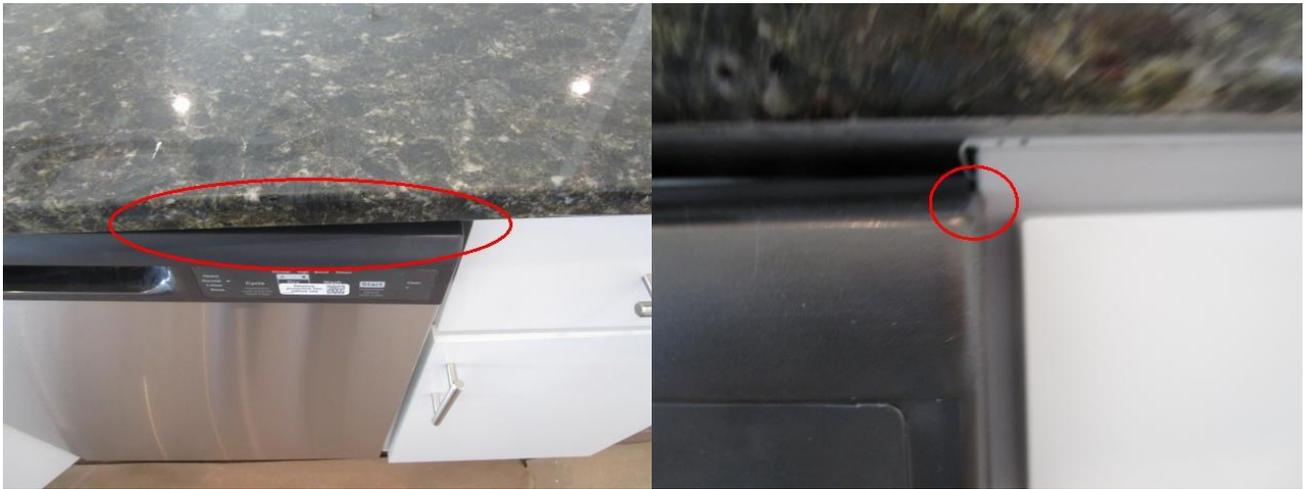
The dishwasher was installed crooked and the door hits the cabinet.

The dishwasher stopped and had to be restarted more than once. A normal cycle was not completed uninterrupted.

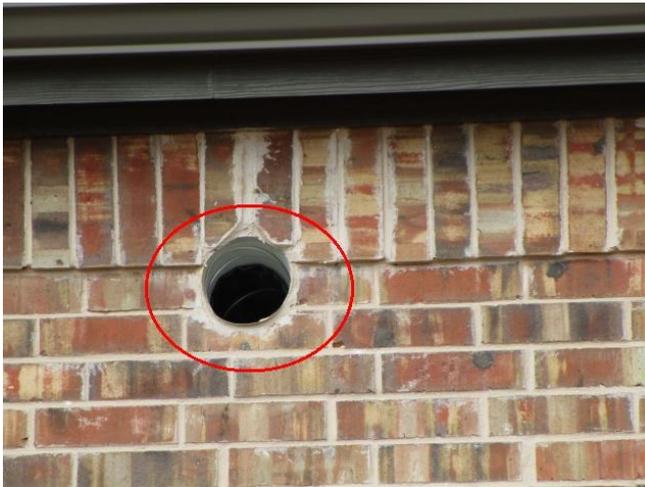
The range vent pipe termination on the left side exterior wall was missing a cover.

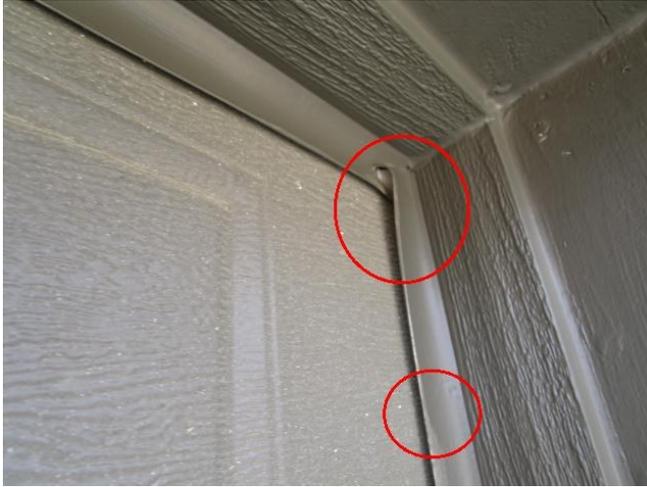
The garage door squeaks and groans while it travels. Lubrication of the rollers and components would be helpful.

The flexible flange around the exterior of the garage door perimeter was loose/ folded/ poorly installed at places.

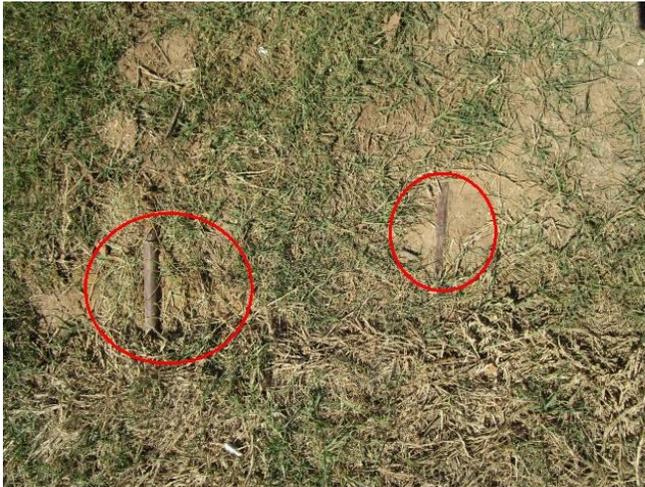
Sprinkler heads need to be adjusted so that the water does not spray siding, sidewalks, or fences, wasting water and contributing to the deterioration of wood components.

Drip hoses were exposed at places.

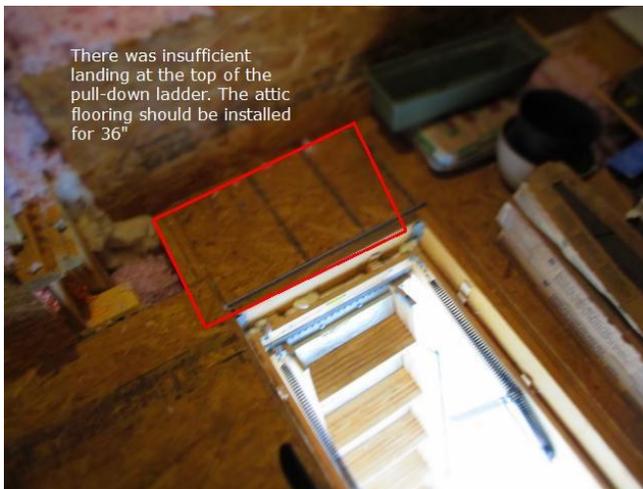
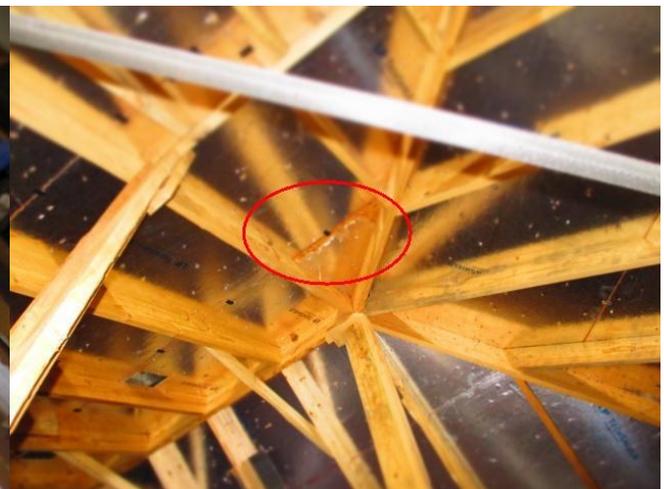
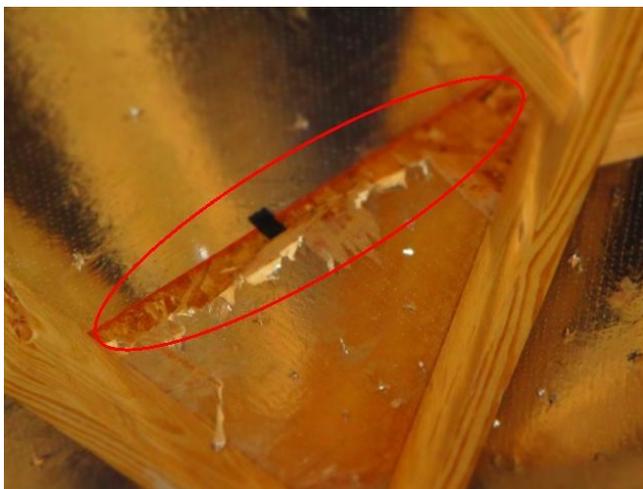
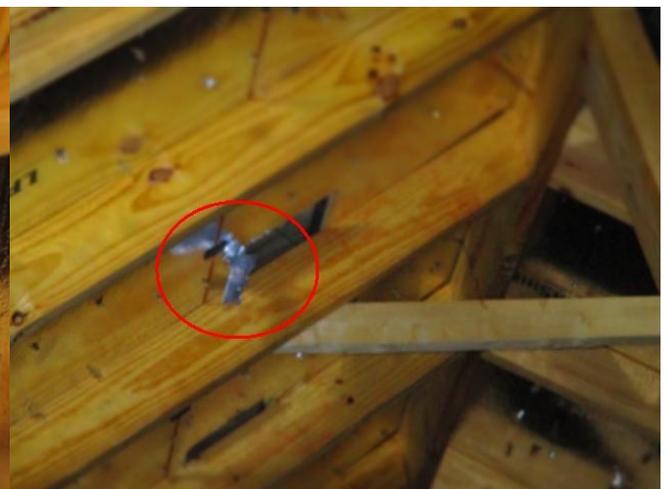
The radiant barrier was damaged at a few areas.

Part of the service flooring in front of the HVAC equipment appeared to bow, appeared thin, and deflected when it was walked on.

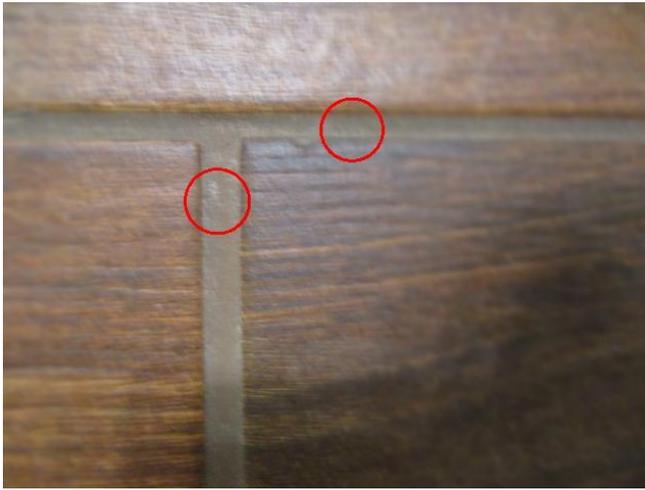
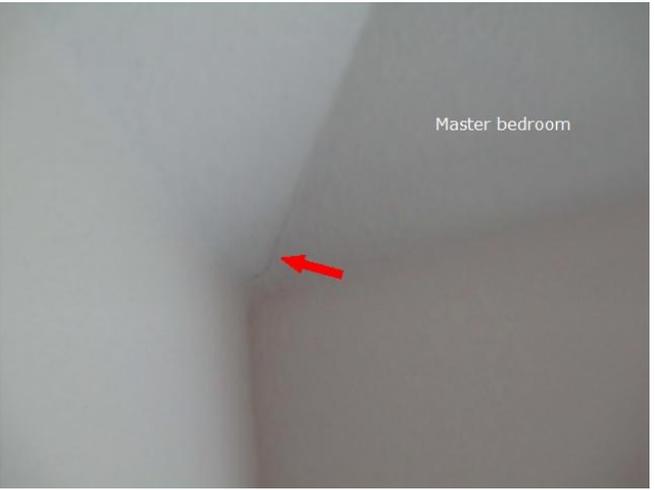
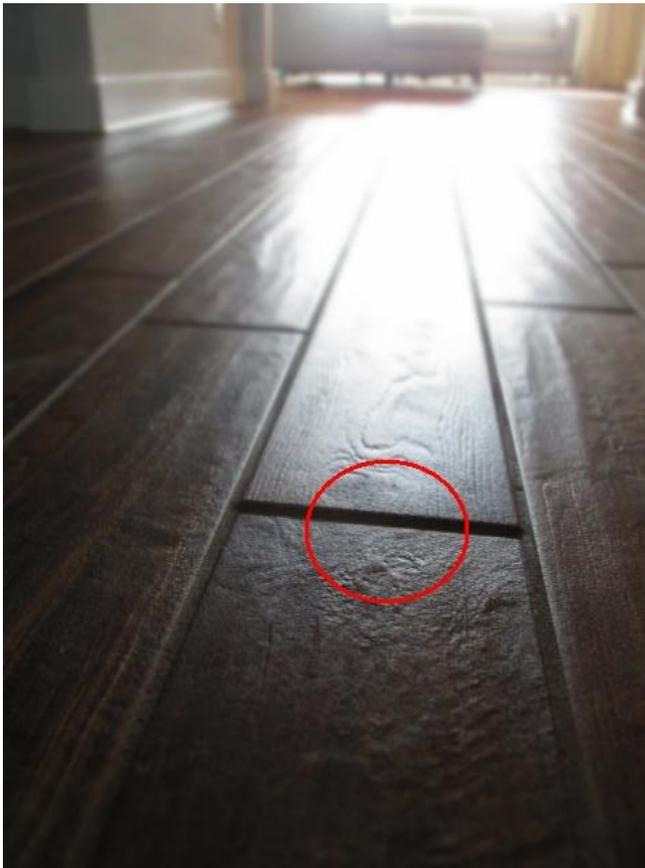
Long, straight, hairline ceiling cracks were found along the joints of drywall sheets, typical of vaulted type ceiling construction, including in the master bedroom.

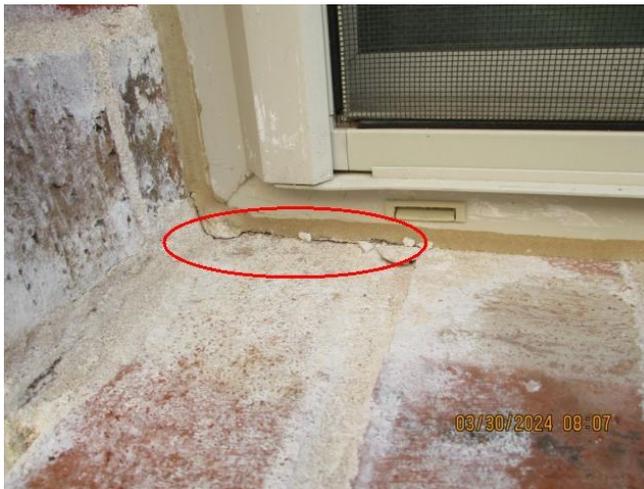
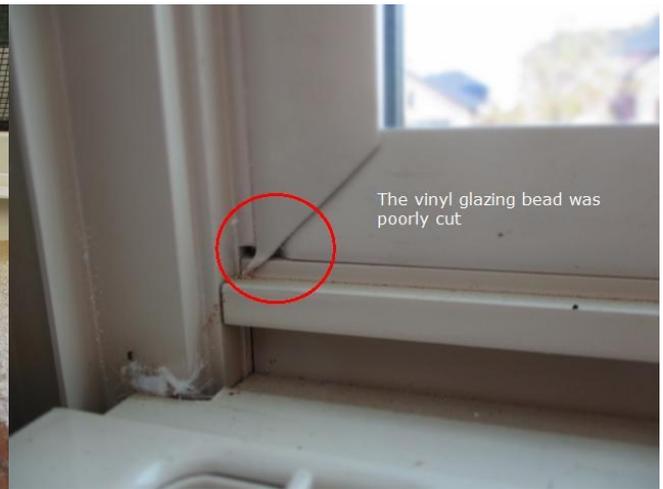
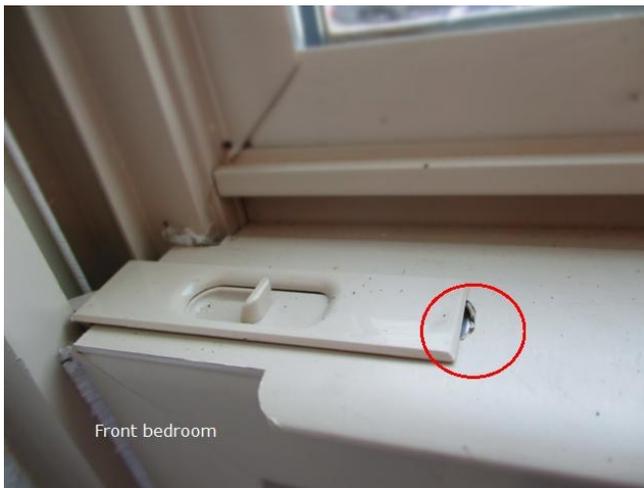
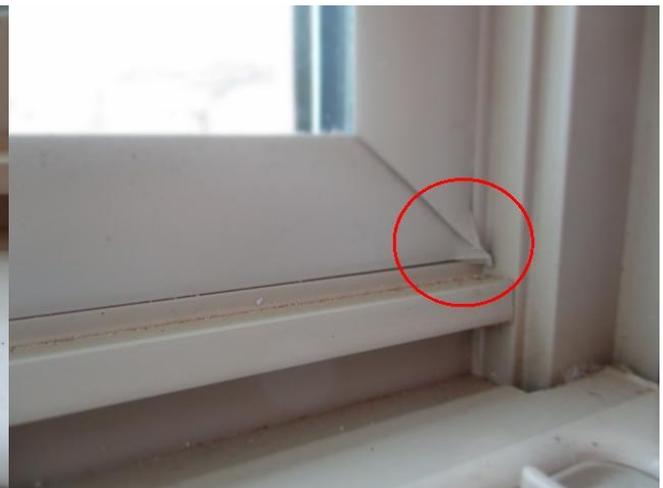
The same master bedroom window was damaged, i.e. it appeared that the glass had separated from the bottom sash frame.

A master bedroom window wobbles in its frame after it has been raised open and then opened inward, and must be straightened out before it can be closed again.

The caulking around some window perimeters was poor/ in need of repair, both exterior and interior. You should walk around the house now and periodically, checking and repairing as needed the caulking around windows, from the inside to keep conditioned air from escaping into the walls, and from the outside to keep moisture from entering the walls. A caulking gun and caulking material are inexpensive and available at hardware stores. This is an issue of on-going regular maintenance.

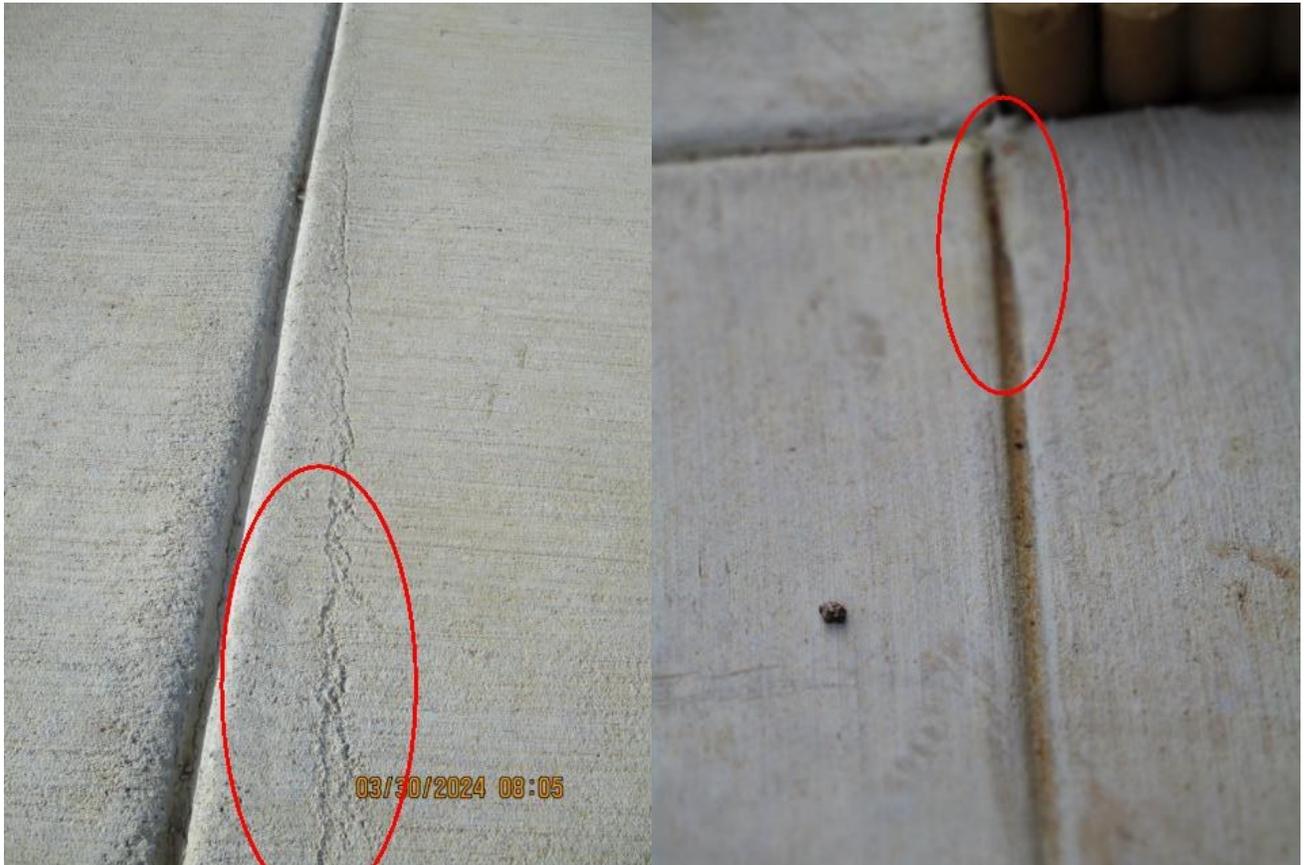
Hairline, flat cracks were noted in the concrete driveway, porch, sidewalk, and garage floor. This is typical for many homes. Monitor all cracks long-term for changes.

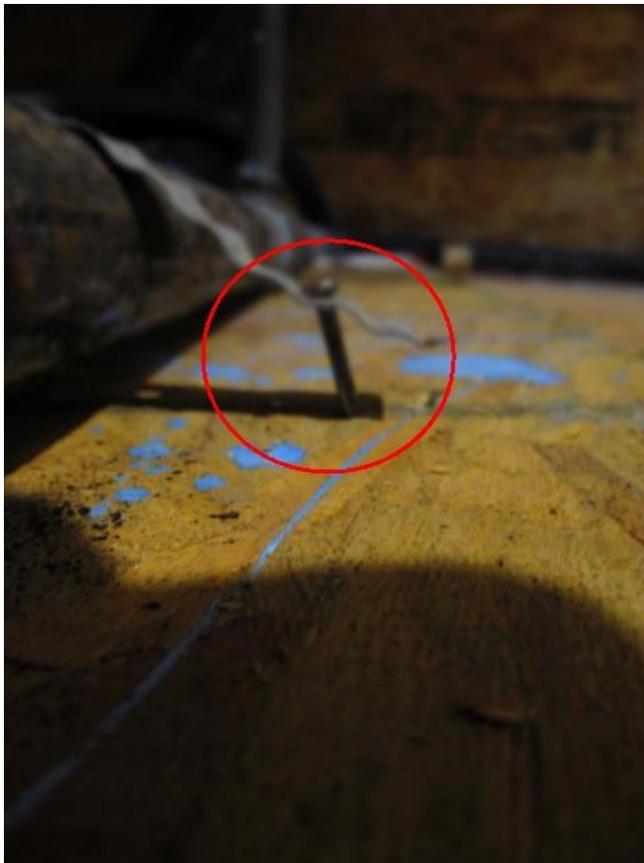
The nail had pulled out from a strap support of an attic gas pipe.

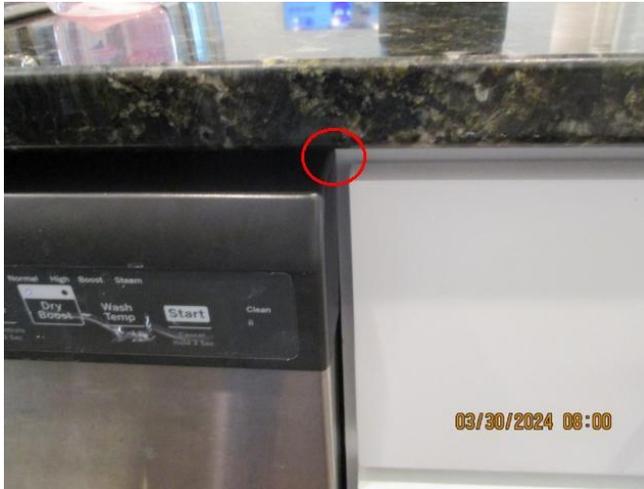
The dishwasher was installed crooked and the door does not close/ hits the cabinet.

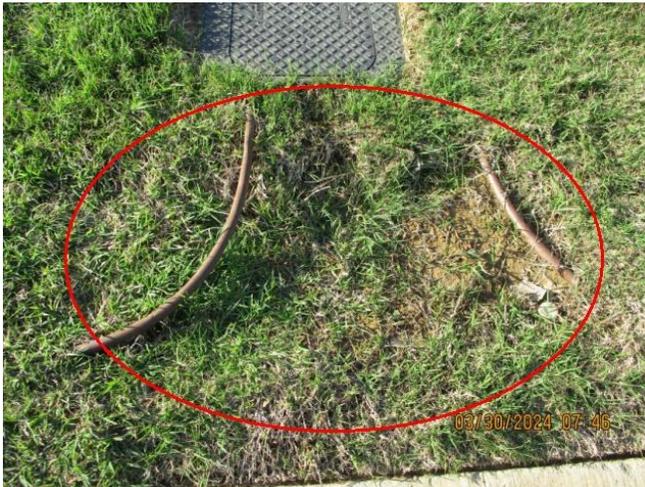
Sprinkler heads need to be adjusted so that the water does not spray siding, sidewalks, or fences, wasting water and contributing to the deterioration of wood components.

Drip hoses were exposed at places, including by the sidewalk.
