## SELLER'S DISCLOSURE NOTICE

CONCERNING THE PROPERTY AT 500 Oakhill Drive, Denton, Texas 76201

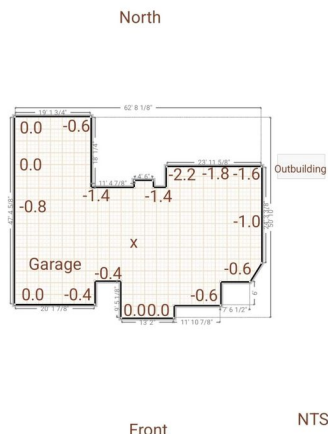
Foundation Elevation Measurements

There are elevation measurements shown on the diagram that are outside of the normal tolerances allowed for normal settlement and structural movement. However, there was no indications of adverse performance based on observations and opinions made by the inspector. If concerns exist about the structural integrity of the foundation beyond this opinion, it is recommended that a structural engineer be consulted.

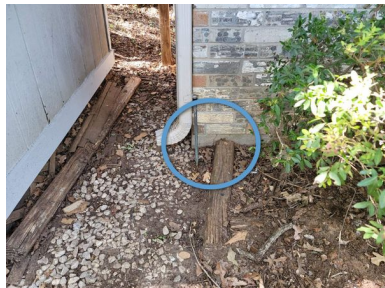
Foundation corner fracture(s) existed, which are generally the result of differential movement between the masonry walls (expanding) and the concrete foundation (shrinking). Although this condition did not appear to adversely affect the structure, sealing these cracks may be desired as they could provide hidden access for wood destroying insects. Please note that the corners should be examined periodically. If the fracturing worsens and the corner(s) break off then the brick veneer may lack proper support and repair would be needed.

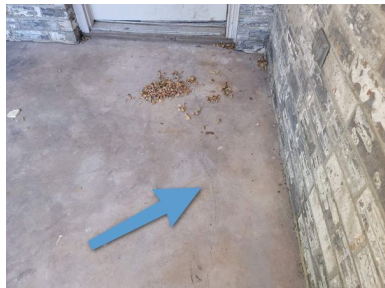
#### 2: Shrinkage Cracks

Common cracks were observed in the exposed areas of the slab. This commonly occurs as the result of settling and/or surface checking. Surface checking occurs when concrete is poured in a dry state, which increases tensile strength. The dry state results in differential curing causing the surface areas to fracture. This is normal with concrete slabs. Cracks should be monitored for disjuncting and/or separations and evaluated if adverse conditions are observed.

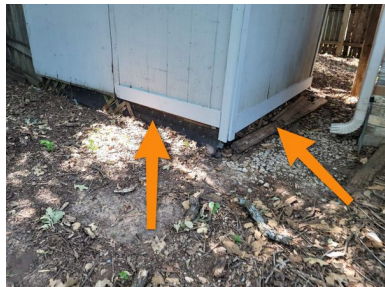
Outbuilding

## 5: Damaged Underpinning

The underpinning is damaged in one or more locations. This may allow pest and moisture to enter the crawl space. Repair is advised.

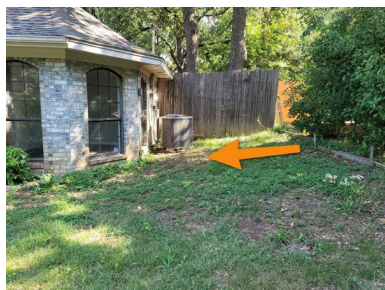
Grading is sloping towards the home in some areas. This could lead to water intrusion and foundation issues. These areas should be monitored over time for such issues. If water is not diverting around the structure, it is recommended that a qualified landscaper or foundation contractor regrade, so water flows away from home.

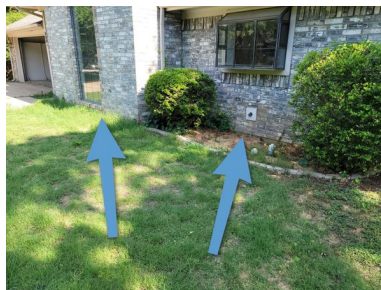
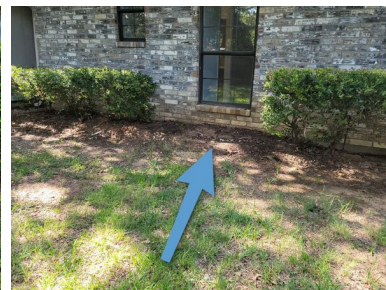
The soil line is at or above the top of the foundation at one or more locations. This may allow moisture to wick into the walls in these areas. The soil line should be lowered to expose 4 to 6 inches of the foundation and sloped away from the foundation for proper moisture runoff.

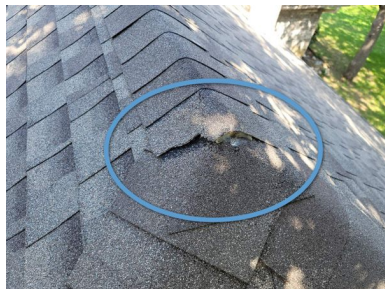
**1: Mechanical surface damage****Maintenance/Recommendation**

Damaged shingles were observed at one or more locations. This appears to be mechanical damage that occurred during installation. Damaged shingles should be monitored and repaired or replaced if necessary.

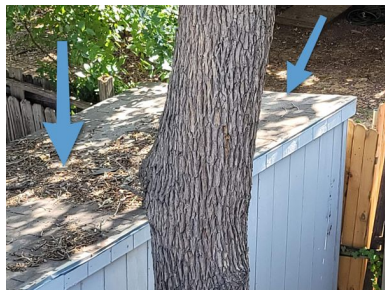
interfere with the ability of the shingles to seal. End laps shall be offset by 6 feet (1829 mm).

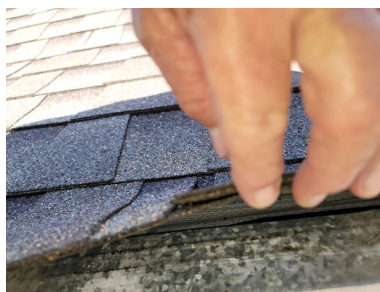
#### 4: Drip edge improperly installed

A drip edge shall be provided at eaves and gables of shingle roofs. Adjacent pieces of drip edge shall be overlapped a minimum of 2 inches (51 mm). Drip edges shall extend a minimum of 0.25 inch (6.4 mm) below the roof sheathing and extend up the roof deck a minimum of 2 inches (51 mm). Drip edges shall be mechanically fastened to the roof deck at a maximum of 12 inches (305 mm) o.c. with fasteners as specified in Section R905.2.5. Underlayment shall be installed over the drip edge along eaves and under the underlayment on gables. Unless specified differently by the shingle manufacturer, shingles are permitted to be flush with the drip edge.

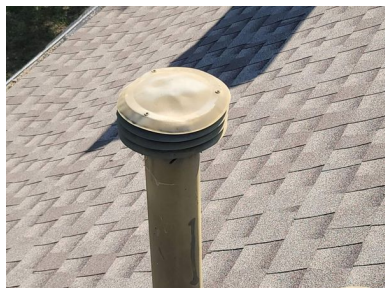
#### 5: Hail strikes on the vent covers

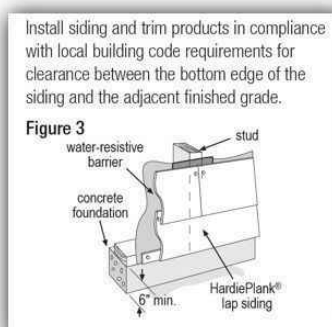
Outbuilding

The cement board and/or composition wood siding does not have adequate ground clearance. This may allow moisture to wick into the siding causing it to delaminate. There should be 4 to 6 inches ground clearance to help prevent moisture from wicking into the siding.

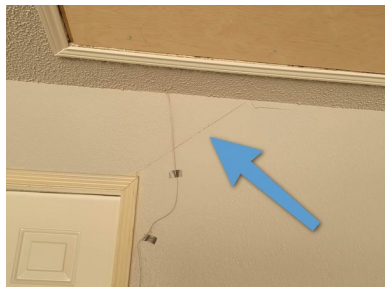
Garage

There are common cracks at one or more interior walls. This may be due to normal settling and/or thermal movement of the building materials. These areas should be monitored for further signs of movement.

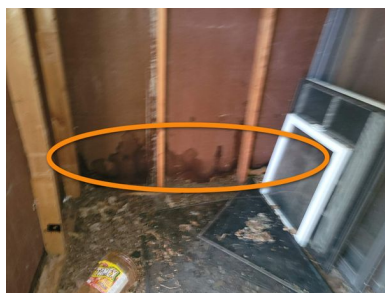
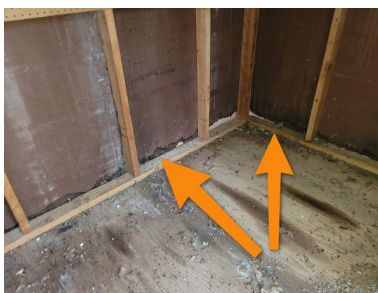
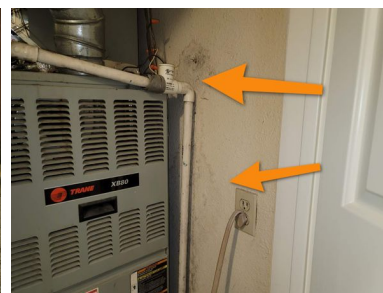
inspection. Further evaluation to determine the cause of the moisture penetration and if repairs have been performed is advised.

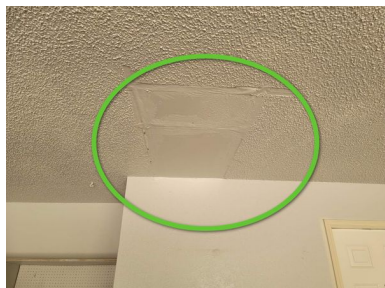
Previous repairs were observed on the ceiling. The cause or reason for repairs are unknown and the quality of the repairs are beyond the scope of this inspection. Contact sellers for more information.

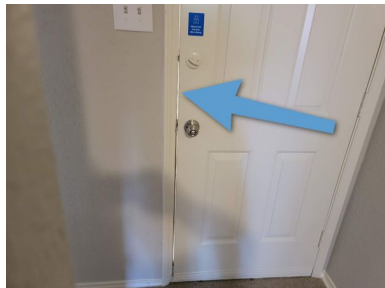
Garage walk door

Door is missing standard weather stripping. This can result in significant energy loss and moisture intrusion. Recommend installation of standard weatherstripping.

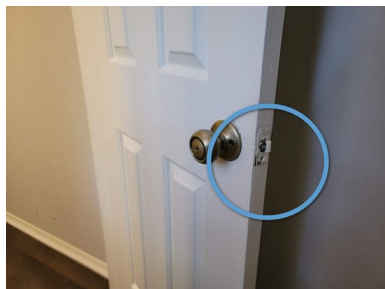
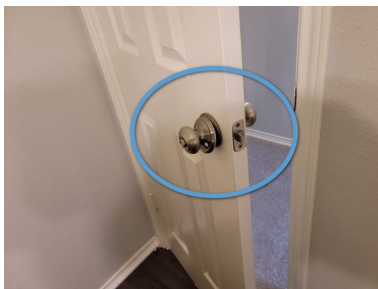
Hall bathroom

One or more doors have loose or missing hardware. Repair or replace as required.

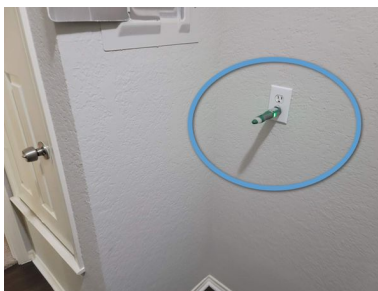
Laundry room

### 1: Loose outlets

There are one or more electrical outlets that are loose to the junction box. The outlets should be properly secured to the junction box to ensure safe operation.

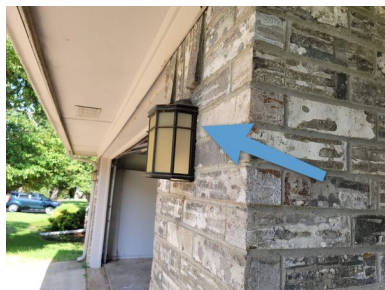
#### 4: Lights did not activate

One or more lights did not activate when tested. This is usually due to a burnt-out bulb in need of replacement but may indicate a faulty ballast. Further evaluation and/or repair by a licensed electrician is recommended.

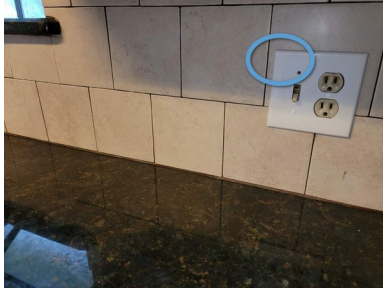
Kitchen

**13: Missing screw in cover plate**

One or more cover plates are missing screws. Replace as required.

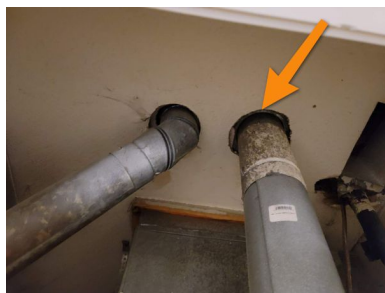
**3: No fire stop****Further Evaluation Required**

There is no installed fire stop at the furnace flue ceiling penetration. A fire stop should be installed to prevent fire from entering the attic from the furnace closet.

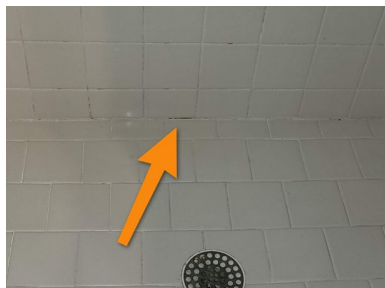
Master bathroom

There are fractured and/or separated caulk and/or grout joints in the shower enclosure(s). It is beyond the scope of this inspection to determine if moisture penetration has occurred and/or is present in non visible areas, such as behind wall coverings. For a more detailed analysis, a professional tile contractor should be consulted. The joints should be sealed to help prevent moisture penetration in those areas.

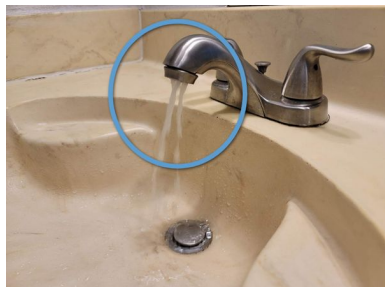
Hall bathroom

One or more faucet aerators are obstructed or missing. As a result, the water spays forcefully. The aerator should be cleaned and/or replaced.

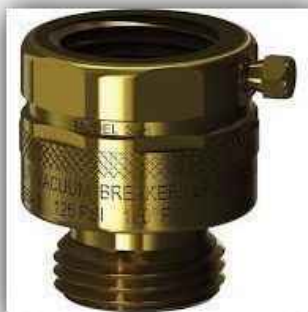
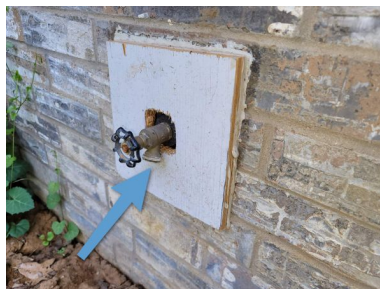
#### 6: Exterior Faucet No Anti-Siphon or Freeze Protection

One or more exterior faucets are not freeze protected or protected from back-siphoning. It is recommended that all exterior plumbing is freeze protected and exterior faucets have an approved anti-siphon device installed to protect the home and public drinking water supply.

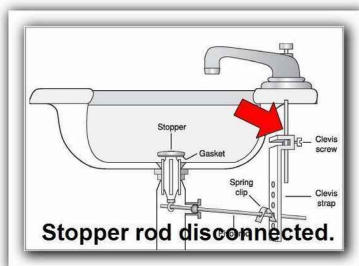
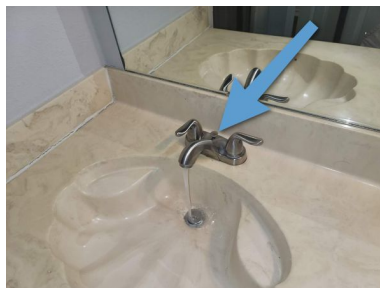
Master bathroom

## 2: Stopper did not function

One or more drain stoppers did not function properly. Repair or adjustment as needed for proper operation of the stopper.

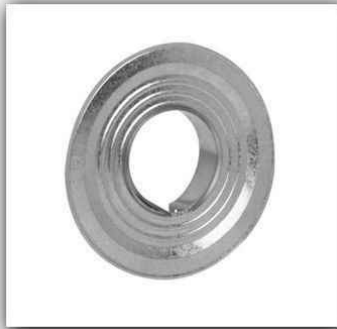
**1: No fire stop****▲Code/Safety Concerns**

There is no attic fire stop at the water heater flue vent ceiling penetration. A fire stop should be installed to help maintain proper fire separation between the water heater closet and attic.

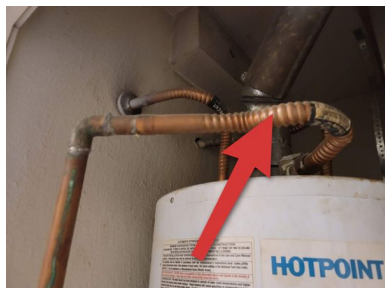
A water supply pipe is installed as part of the water heater relief valve drain. This material is not designed for use as a drain pipe. Drain pipes should be smooth walled material with no reduction in size at the joints. The pipe should be properly replaced to ensure proper drainage.

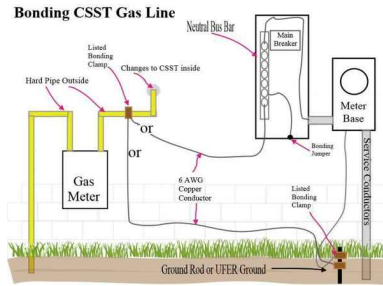
**1: Gas piping not bonded**

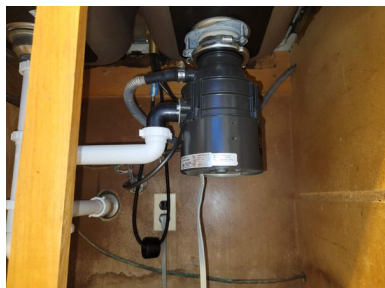
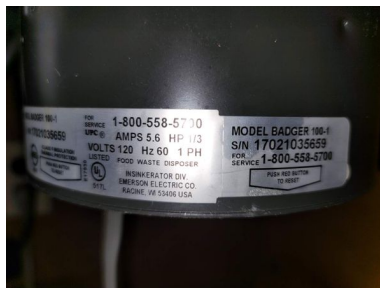
### 1: Unprotected disposal conductors

The conductors feeding the food waste disposer are not properly protected from the food waste disposer housing. A bushing with a clamp should be installed to help prevent the housing cutting into the conductor casing. Further evaluation and/or repair by a licensed electrician is advised.

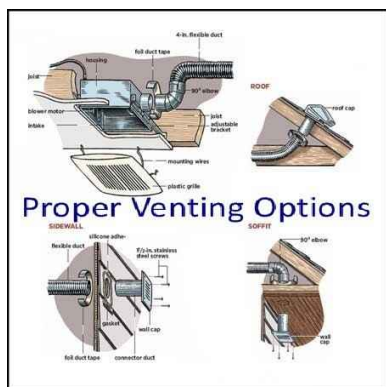
**1: Fans vent into the attic** **Maintenance/Recommendation**

The mechanical exhaust fans vent into the attic. The fans should vent outside to prevent moist air buildup in the attic. Venting to the attic was common practice when this house was built. Standards changed to require the vents to terminate outside the building envelope. Later standards were further clarified to require the vents to be directly vented to the exterior. Vents terminating into the attic can result in moisture build up in attic. This standard is reflected in the 2015 International Residential Code as follows: M1501.1 Outdoor discharge. The air removed by every mechanical exhaust system shall be discharged to the outdoors in accordance with Section M1506.3. Air shall not be exhausted into an attic, soffit, ridge vent or crawl space.

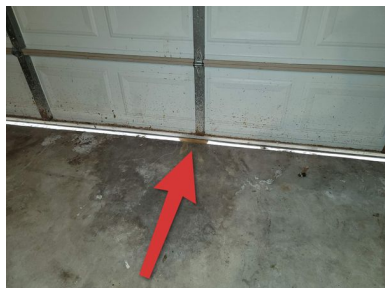
**1: Door did not pressure reverse** **Code/Safety Concerns**

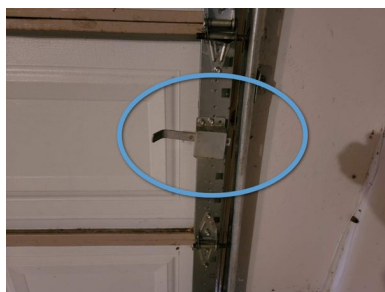
## 2: Manual door lock not disabled

The overhead door lock should be disabled because there is an automatic garage door operator in place. This will help prevent accidentally activating the automatic opener when the door is locked, which may result in damage to the door and/or the automatic operator.

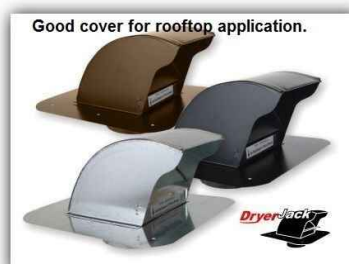
Approved Vent covers

## 1: Wrong dryer vent cover used

duct terminations shall be equipped with a backdraft damper. Screens shall not be installed at the duct termination. Replacement is advised. The construction of this house may predate this standard.
