INSPECTION REPORT

**21746-9794
Dustin & Sarah Reed
422 Village Commons Blvd
Georgetown, TX 78633**

PROPERTY INSPECTION REPORT FORM

422 Village Commons Blvd, Georgetown, TX 78633

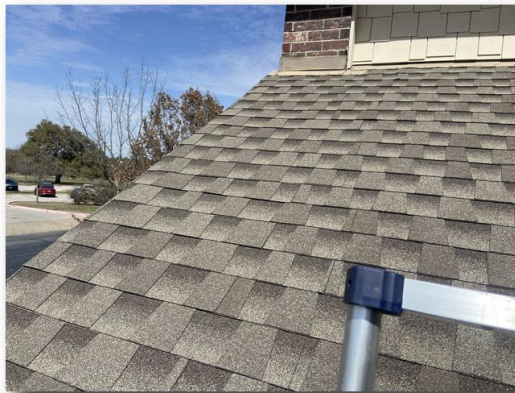
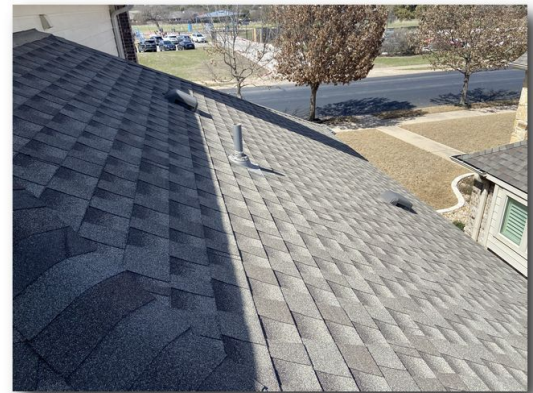
The roof appears to be in serviceable condition at time of inspection.

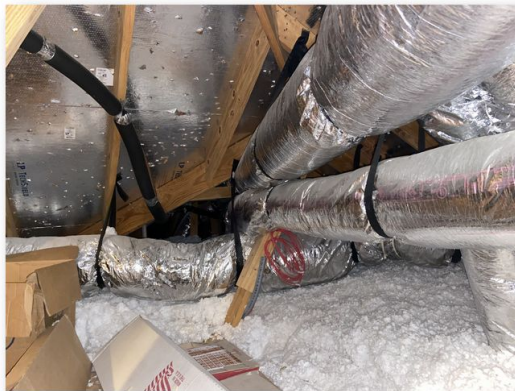
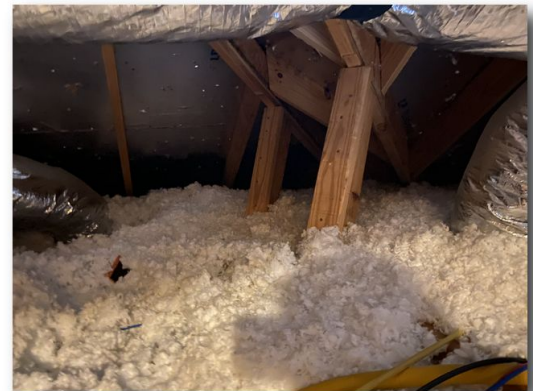
All visible components were in serviceable condition at the time of our inspection.

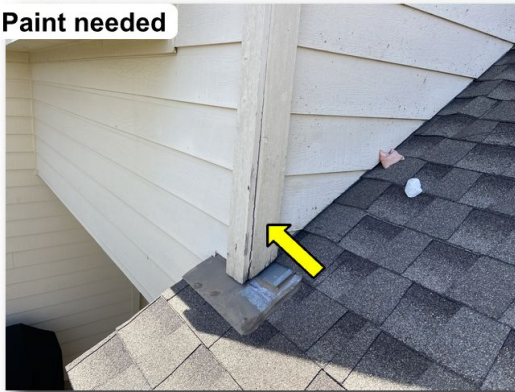
Paint needed

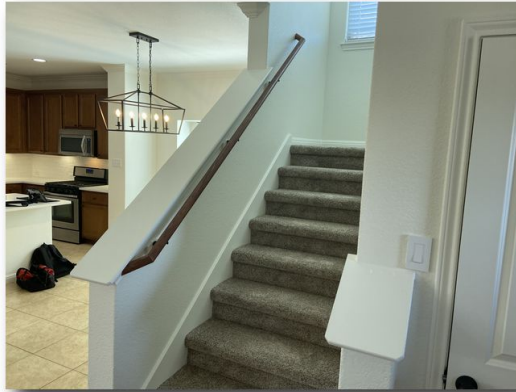
The interior stairways/steps were in serviceable condition at the time of our inspection.

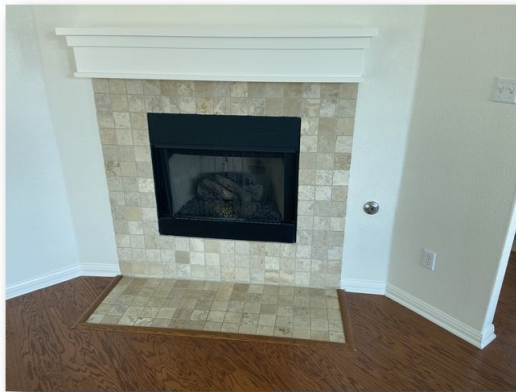
The fireplace(s) appear to be operating as intended and all visible components appear to be in serviceable condition.

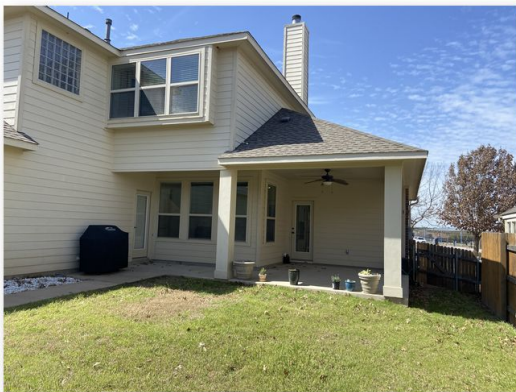
Porch:

All visible components were in serviceable condition at the time of our inspection.

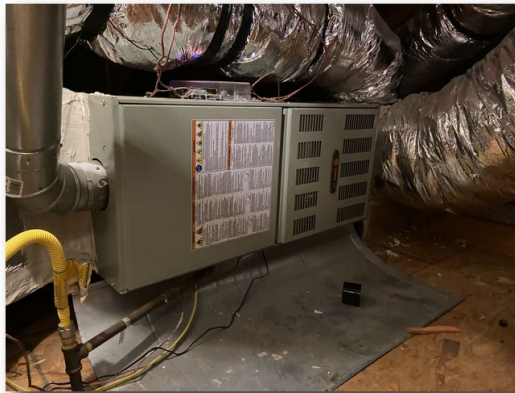
The furnace(s) operated as intended and all visible components were in serviceable condition at the time of our inspection.

A slave thermostat system was noted. The operation of the duct damper system was outside the scope of our review and was not confirmed.

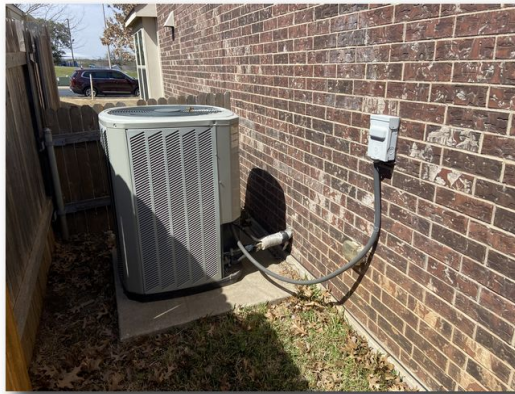
Upstairs unit:

The return air temperature was 53°F and the supply air temperature was 68°F, giving a temperature differential of 15°F, which was within a serviceable range.

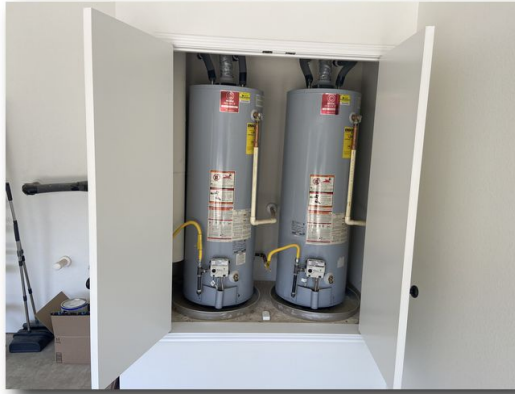
The water heater(s) operated as intended and all visible components were in serviceable condition at the time of our inspection.

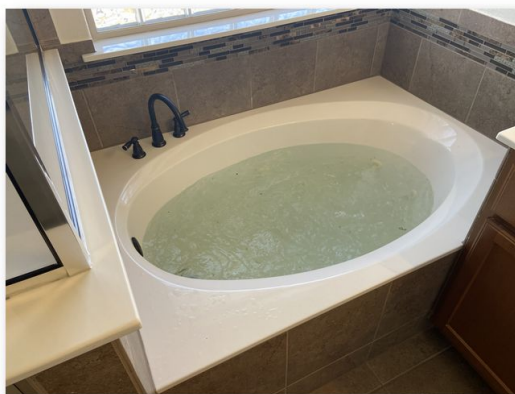
The motor reset button is located in the master closet.

The whirlpool tub operated as intended and all visible components were in serviceable condition at the time of the inspection.

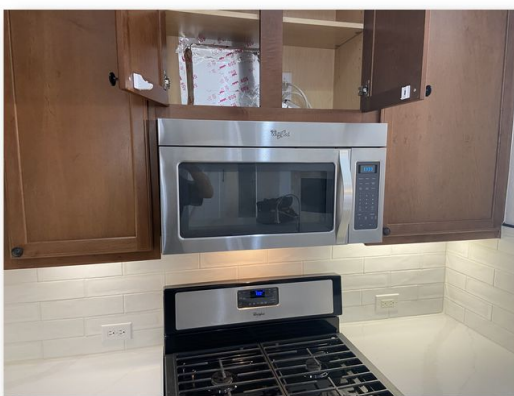
The range vent is a exterior ducted type unit.

The range hood operated as intended and all visible components were in serviceable condition at the time of our inspection.

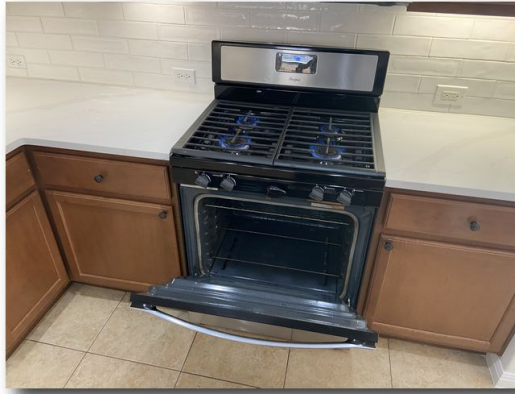
The cook top was operational and all visible components were in serviceable condition at the time of our inspection.

An oven setting of 350°F gives an actual temperature of 350°F which was within a serviceable range.
