# espc::home report

82/6 Ashley Terrace  
Edinburgh  
EH11 1RT  
18/04/2025

# Single Survey

| <b>Property address</b> | 3F2,<br>82 Ashley Terrace,<br>Polwarth,<br>Edinburgh,<br>EH11 1RT |

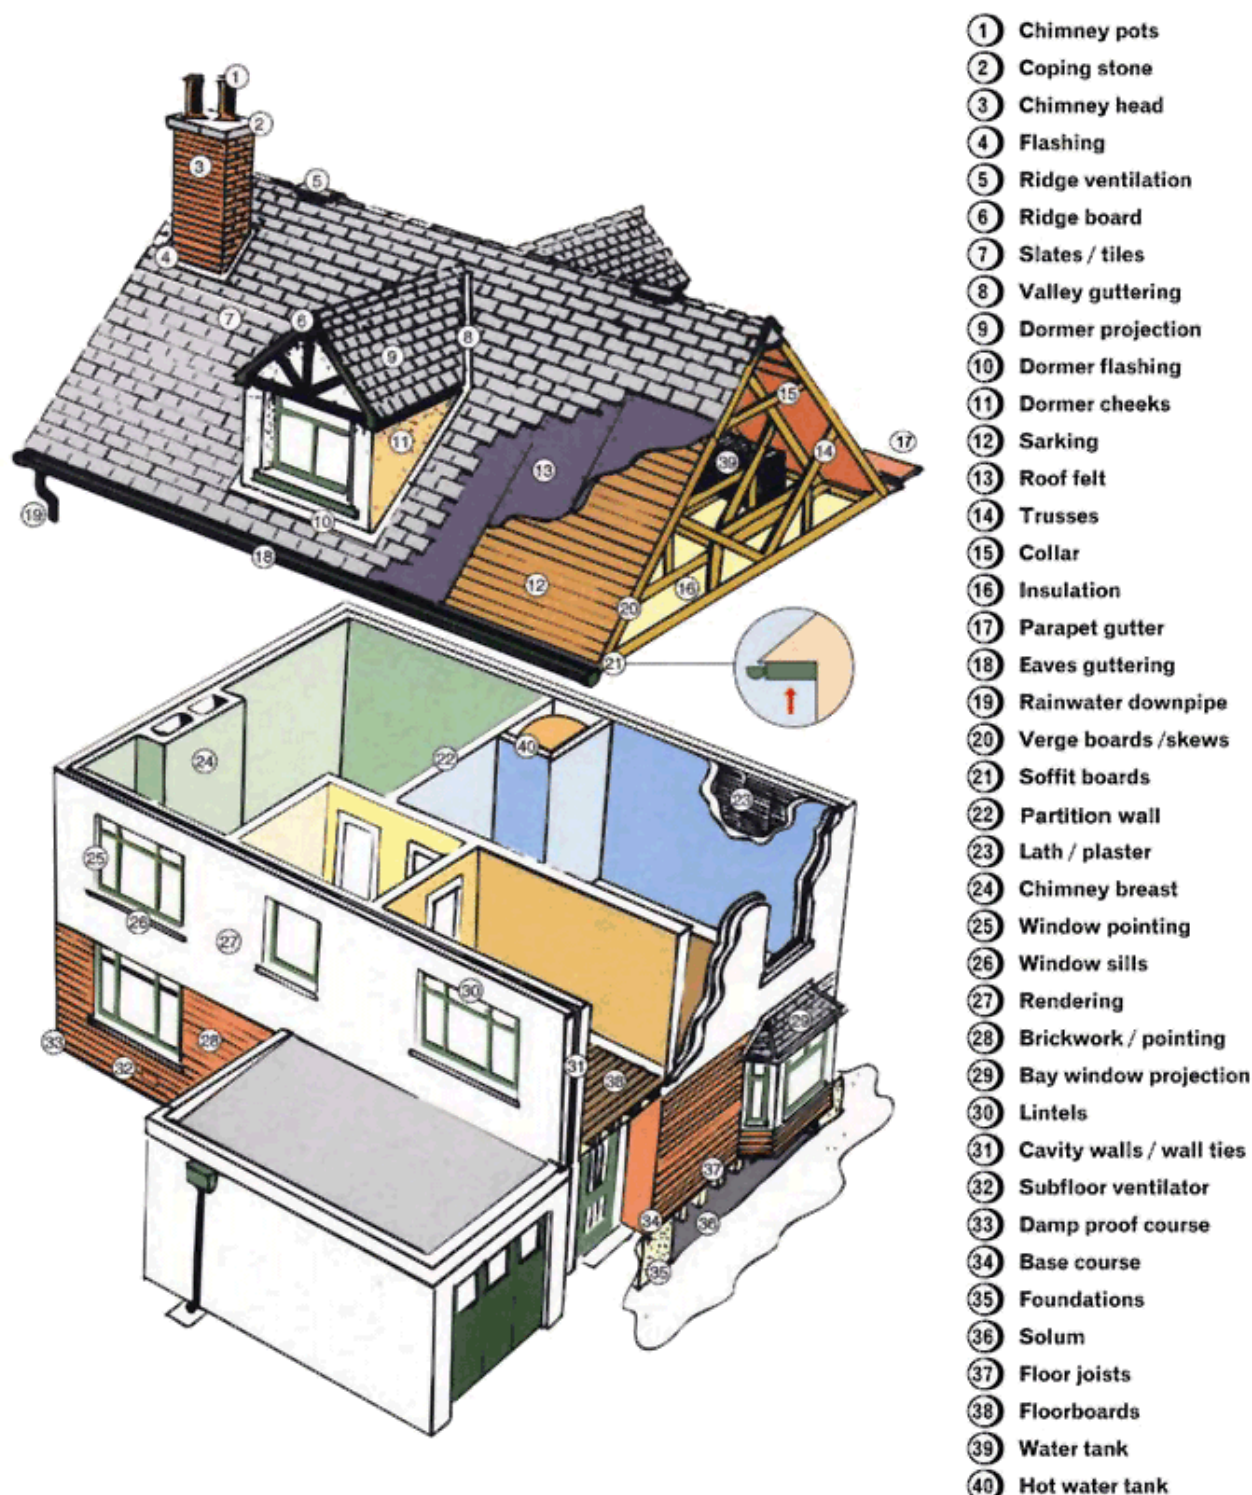
## Sectional Diagram showing elements of a typical house

Reference may be made in this report to some or all of the above component parts of the property. This diagram may assist you in locating and understanding these items.
