Home Report

62 Thirlestane Road Edinburgh EH9 1AR

Single Survey

Survey report on:

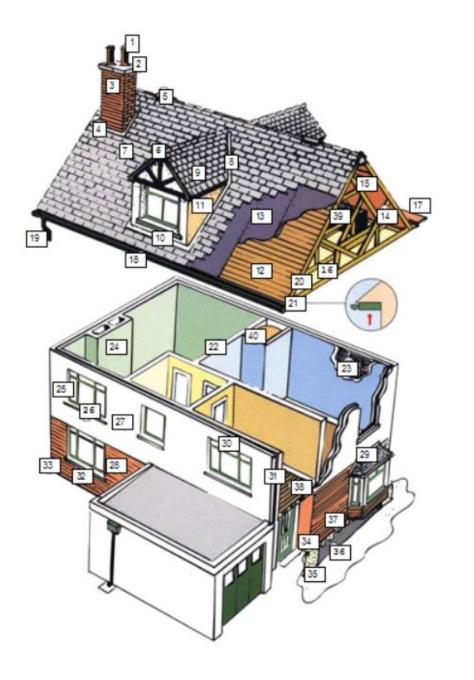
Sectional diagram showing elements of a typical house

_
1	Chimney pots
2	Coping stone
3	Chimney head
4	Flashing
5	Ridge ventilation
6	Ridge board
7	Slates / tiles
8	Valley guttering
9	Dormer projection
10	Dormer flashing
11	Dormer cheeks
12	Sarking
13	Roof felt
14	Trusses
15	Collar
16	Insulation
17	Parapet gutter
18	Eaves guttering
19	Rainwater downpipe
20	Verge boards / skews
21	Soffit boards
22	Partition wall
23	Lath / plaster
24	Chimney breast
25	Window pointing
26	Window sills
27	Rendering
28	Brickwork / pointing
29	Bay window projection
30	Lintels
31	Cavity walls / wall ties
32	Subfloor ventilator
33	Damp proof course
34	Base course
35	Foundations
36	Solum
37	Floor joists
38	Floorboards
39	Water tank
40	Hot water tank

Reference may be made in this report to some or all of the above component parts of the property. This diagram may assist you in locating and understanding these items.
