# espc:home report

47/6 Marchmont Crescent  
Edinburgh  
EH9 1HF  
06/09/2022

# Single Survey

<b>Property address</b>	Flat 6, 47 Marchmont Crescent, Edinburgh, EH9 1HF
-------------------------	--

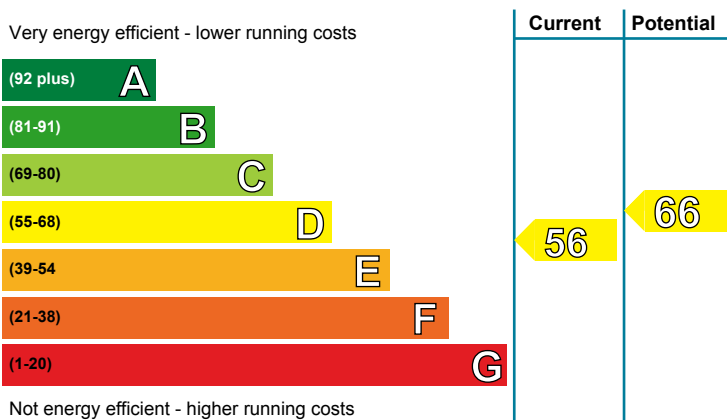
## Energy Efficiency Rating

This graph shows the current efficiency of your home, taking into account both energy efficiency and fuel costs. The higher this rating, the lower your fuel bills are likely to be.

Your current rating is **band D (56)**. The average rating for EPCs in Scotland is **band D (61)**.

The potential rating shows the effect of undertaking all of the improvement measures listed within your recommendations report.
