espc:home report

17 Blinkbonny Grove
Edinburgh
EH4 3HH
18/04/2024

Single Survey

Property address	17 Blinkbonny Grove, Ravelston, Edinburgh, EH4 3HH
-------------------------	---

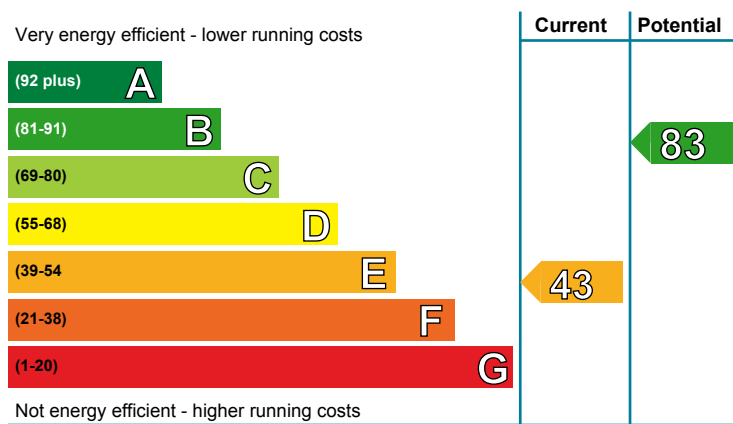
Energy Efficiency Rating

This graph shows the current efficiency of your home, taking into account both energy efficiency and fuel costs. The higher this rating, the lower your fuel bills are likely to be.

Your current rating is **band E (43)**. The average rating for EPCs in Scotland is **band D (61)**.

The potential rating shows the effect of undertaking all of the improvement measures listed within your recommendations report.

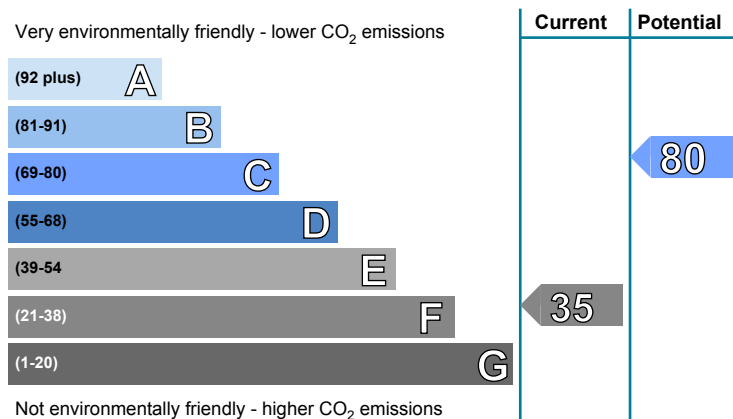
Environmental Impact (CO₂) Rating

This graph shows the effect of your home on the environment in terms of carbon dioxide (CO₂) emissions. The higher the rating, the less impact it has on the environment.
