# espc::home report

26 Clark Avenue  
Edinburgh  
EH5 3AU  
21/05/2024

## **SINGLE SURVEY REPORT**

**26 CLARK AVENUE  
EDINBURGH  
EH5 3AU**

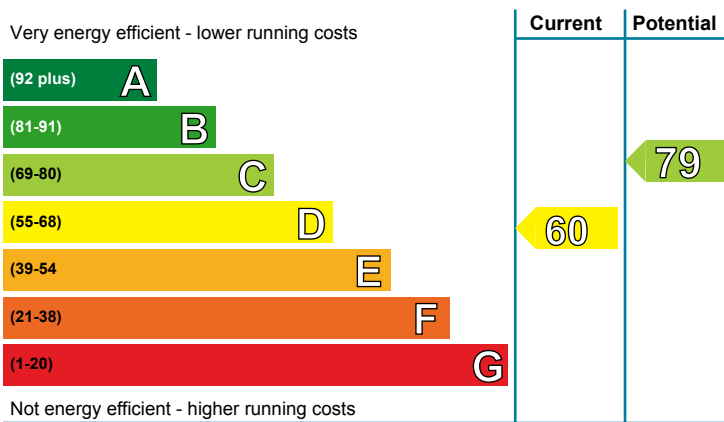
## Energy Efficiency Rating

This graph shows the current efficiency of your home, taking into account both energy efficiency and fuel costs. The higher this rating, the lower your fuel bills are likely to be.

Your current rating is **band D (60)**. The average rating for EPCs in Scotland is **band D (61)**.

The potential rating shows the effect of undertaking all of the improvement measures listed within your recommendations report.

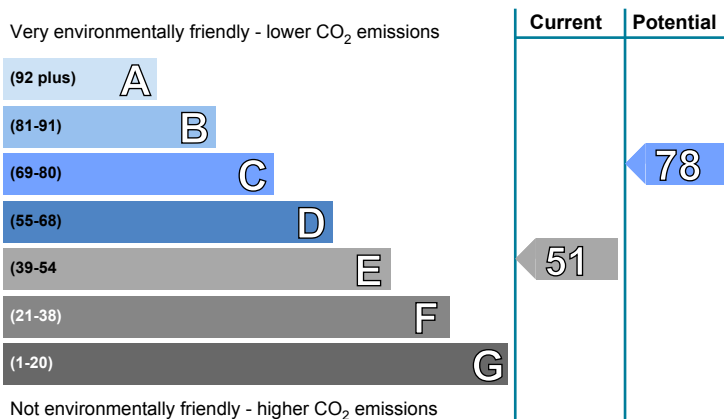
## Environmental Impact (CO<sub>2</sub>) Rating

This graph shows the effect of your home on the environment in terms of carbon dioxide (CO<sub>2</sub>) emissions. The higher the rating, the less impact it has on the environment.
