Home Report

Scottish Single Survey

Property address	13a Inveresk Village Musselburgh EH21 7TD
Customer	Alistair and Chelsea Cooper
Customer address	13a Inveresk Village Musselburgh EH21 7TD
Prepared by	Shepherd Chartered Surveyors
Date of inspection	23/04/2024

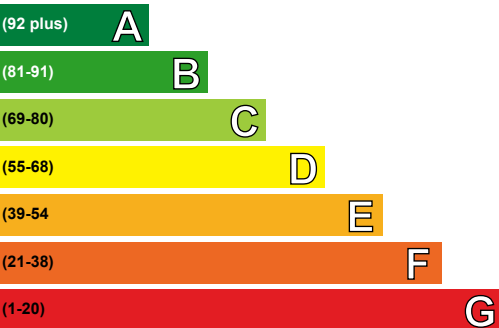
Very energy efficient - lower running costs

Not energy efficient - higher running costs

Current	Potential
79	81

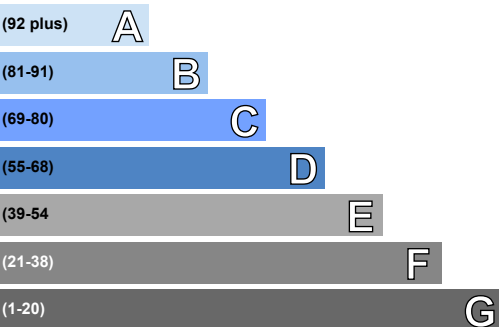
Very environmentally friendly - lower CO₂ emissions

Not environmentally friendly - higher CO₂ emissions

Current	Potential
72	74
