# Home Report

# Single Survey

Property address	65/2 Bonaly Road Edinburgh EH13 0PB
Customer	Jamie Gilbert & Jessica Gilbert
Customer address	65/2 Bonaly Road Edinburgh EH13 0PB
Prepared by	Shepherd Chartered Surveyors
Date of inspection	03/09/2024

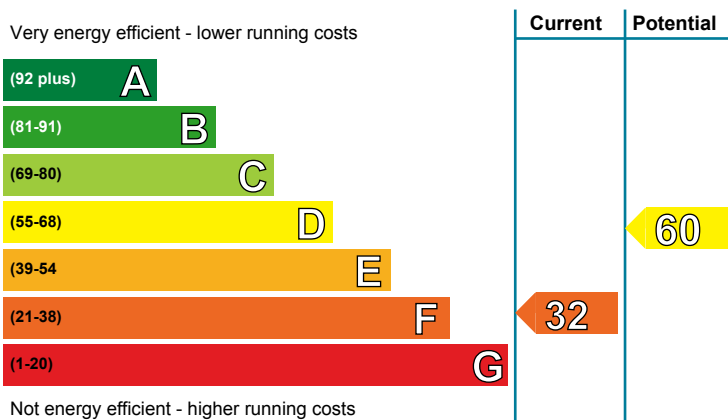
## Energy Efficiency Rating

This graph shows the current efficiency of your home, taking into account both energy efficiency and fuel costs. The higher this rating, the lower your fuel bills are likely to be.

Your current rating is **band F (32)**. The average rating for EPCs in Scotland is **band D (61)**.

The potential rating shows the effect of undertaking all of the improvement measures listed within your recommendations report.
