2 Malcolmstone Farm Cottages
Long Dalmahoy Road
EH14 4AD
02/08/2023

Home Report Index

Single Survey

Property address	2 Malcolmstone Farm Cottages, Long Dalmahoy Road, Dalmahoy, Currie, EH14 4AD
------------------	---

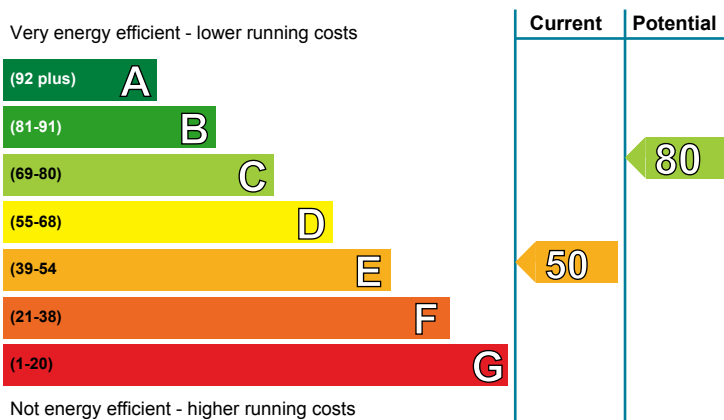
Energy Efficiency Rating

This graph shows the current efficiency of your home, taking into account both energy efficiency and fuel costs. The higher this rating, the lower your fuel bills are likely to be.

The potential rating shows the effect of undertaking all of the improvement measures listed within your recommendations report.

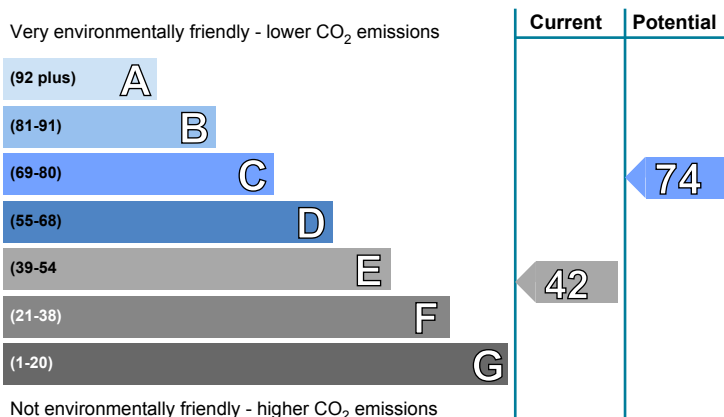
Environmental Impact (CO₂) Rating

This graph shows the effect of your home on the environment in terms of carbon dioxide (CO₂) emissions. The higher the rating, the less impact it has on the environment.
