# Home Report Index

# Single Survey

<b>Property address</b>	40 Shandon Crescent, Polwarth, Edinburgh, EH11 1QF
-------------------------	---

<b>Prepared by</b>	Graham + Sibbald
--------------------	------------------

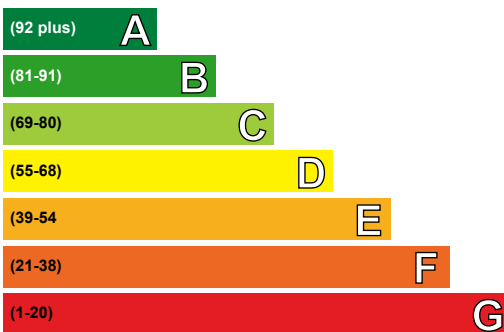
\* based upon the cost of energy for heating, hot water, lighting and ventilation, calculated using standard assumptions

Very energy efficient - lower running costs

Not energy efficient - higher running costs

Current	Potential
63	76
