Home Report

Scottish Single Survey

Property address	Heuk House Abbotsford Road North Berwick EH39 5DB
Customer	John & Emily Goodlad
Customer address	Heuk House Abbotsford Road North Berwick EH39 5DB
Prepared by	Shepherd Chartered Surveyors
Date of inspection	07/05/2024

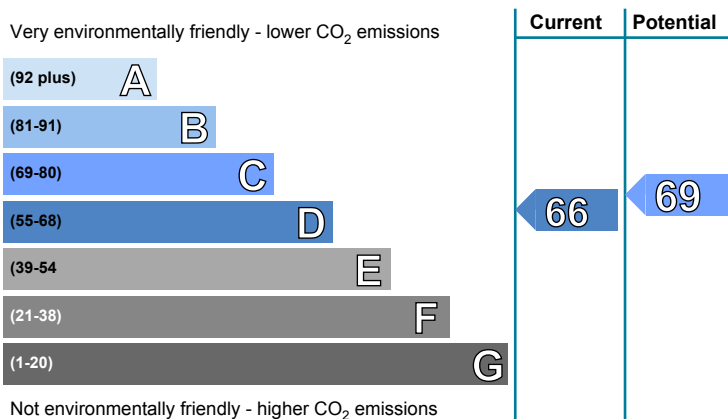
Environmental Impact (CO₂) Rating

This graph shows the effect of your home on the environment in terms of carbon dioxide (CO₂) emissions. The higher the rating, the less impact it has on the environment.
