## Home Report

1 Rose Bank Seton Mains EH32 0PG

# single survey

## survey report on:

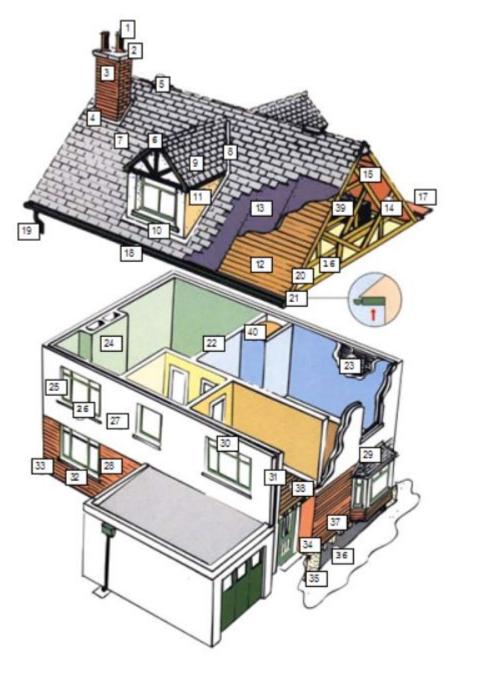
## Sectional Diagram showing elements of a typical house

Chimney pots 1 Coping stone 2 3 Chimney head Flashing 4 Ridge ventilation 5 Ridge board 6 7 Slates/tiles 8 Valley guttering 9 Dormer projection Dormer flashing 10 Dormer cheeks 11 12 Sarking Roof felt 13 Trusses 14 15 Collar 16 Insulation 17 Parapet gutter Eaves guttering 18 Rainwater downpipe 19 20 Verge boards / skews 21 Soffit boards 22 Partition wall Lath / plaster 23 24 Chimney breast 25 Window pointing Window sills 26 Rendering 27 Brickwork / pointing 28 Bay window 29 30 Lintels 31 Cavity walls / wall ties Subfloor ventilator 32 33 Damp proof course 34 Base course 35 Foundations Solum 36 37 Floor joists Floorboards 38 Water tank 39 40 Hot water tank
