espc::home report

15 Dean Terrace
Edinburgh
EH4 1ND
04/10/2024

Single Survey

Property address	15 Dean Terrace, Stockbridge, Edinburgh, EH4 1ND
-------------------------	---

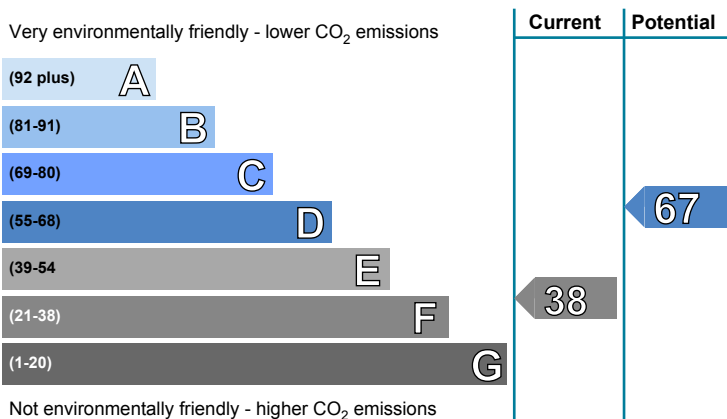
Environmental Impact (CO₂) Rating

This graph shows the effect of your home on the environment in terms of carbon dioxide (CO₂) emissions. The higher the rating, the less impact it has on the environment.
