# espc:home report

141/1 Hutchison Road  
Edinburgh  
EH14 1PG  
08/04/2025

**SCOTTISH SINGLE  
SURVEY**

**141/1 HUTCHISON ROAD  
EDINBURGH  
EH14 1PG**

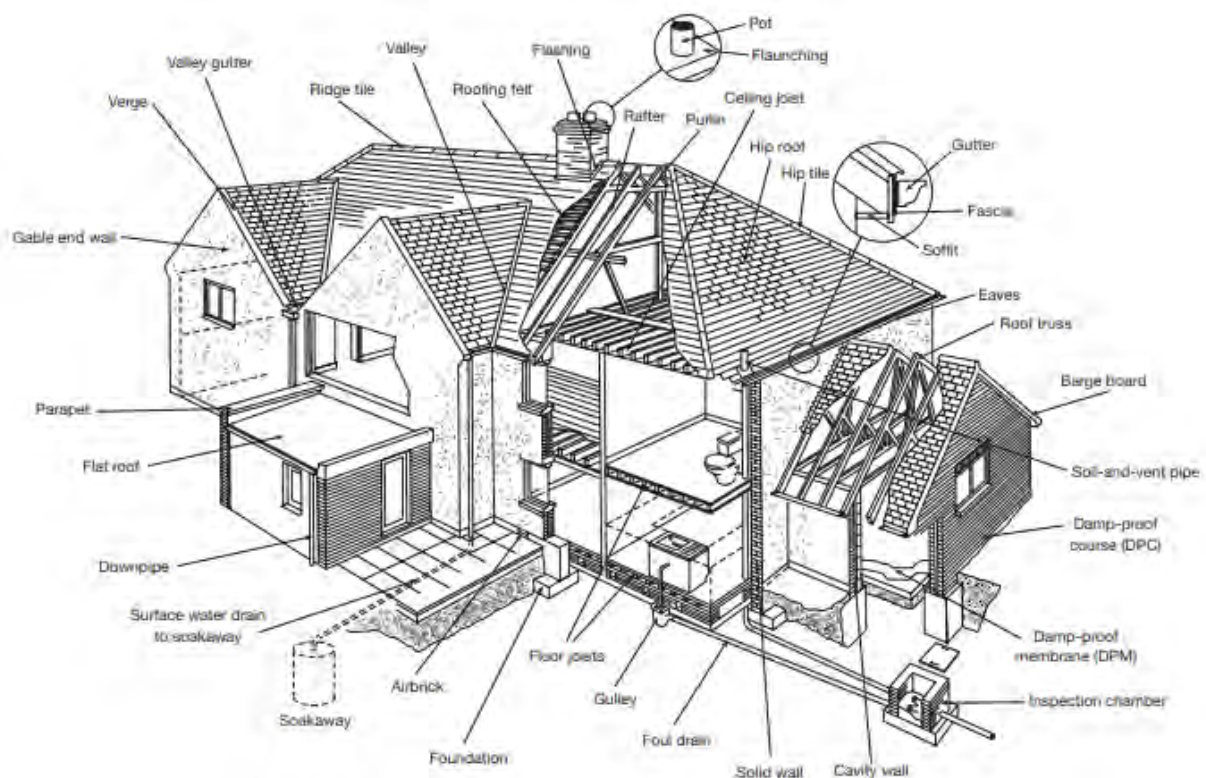
## Sectional diagram showing elements of a typical house

Reference may be made in this report to some or all of the above building elements of the property.

This diagram may assist you in locating and understanding these terms.

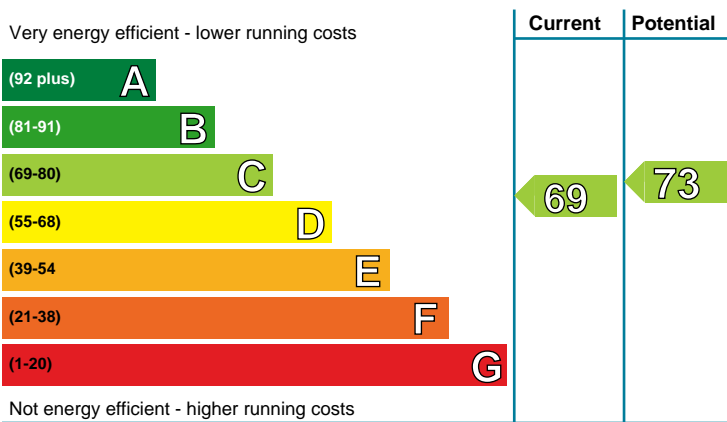
## Energy Efficiency Rating

This graph shows the current efficiency of your home, taking into account both energy efficiency and fuel costs. The higher this rating, the lower your fuel bills are likely to be.

Your current rating is **band C (69)**. The average rating for EPCs in Scotland is **band D (61)**.

The potential rating shows the effect of undertaking all of the improvement measures listed within your recommendations report.

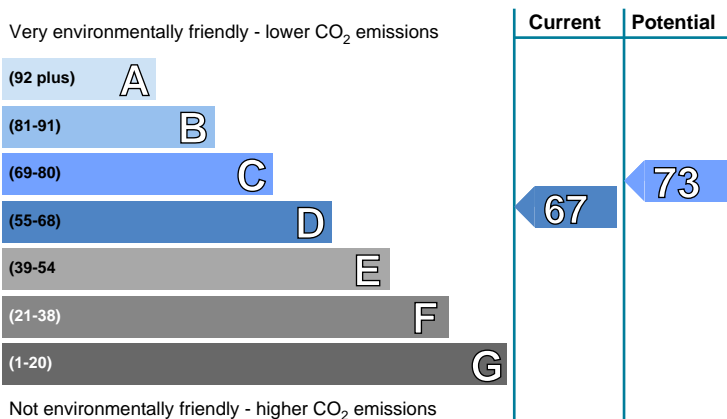
## Environmental Impact (CO<sub>2</sub>) Rating

This graph shows the effect of your home on the environment in terms of carbon dioxide (CO<sub>2</sub>) emissions. The higher the rating, the less impact it has on the environment.
