HOME REPORT

FLAT 3
31 BUCKINGHAM TERRACE
DEAN
EDINBURGH
EH4 3AF

Energy Performance Certificate (EPC)

FLAT 3 , 31 BUCKINGHAM TERRACE, DEAN, EDINBURGH, EH4 3AF

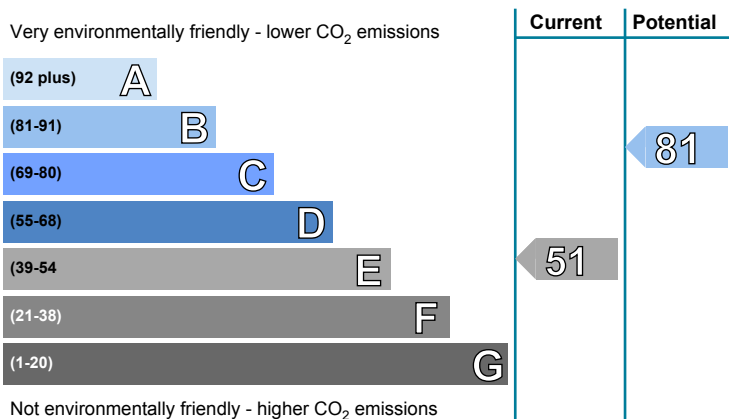
Environmental Impact (CO₂) Rating

This graph shows the effect of your home on the environment in terms of carbon dioxide (CO₂) emissions. The higher the rating, the less impact it has on the environment.

Your current rating is **band E (51)**. The average rating for EPCs in Scotland is **band D (59)**.

The potential rating shows the effect of undertaking all of the improvement measures listed within your recommendations report.
