# espc::home report

# Home Report Index

**52/7 BRUNSWICK STREET  
EDINBURGH  
EH7 5HY**

**LYNDSAY GOWANS, MA (Hons) MRICS**

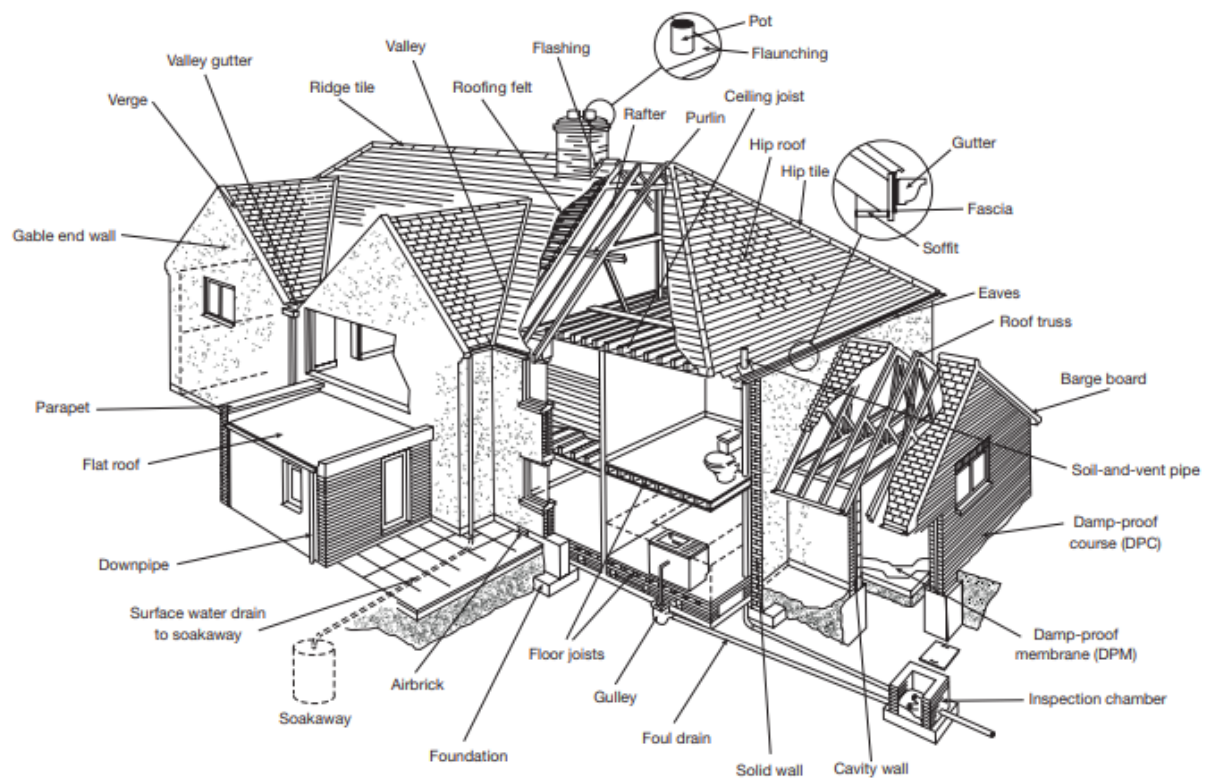
## Sectional diagram showing elements of a typical house

Reference may be made in this report to some or all of the above building elements of the property.

This diagram may assist you in locating and understanding these terms.
