49/5 West Bryson Road, Harrison Park
Apartments
Edinburgh
EH111BQ
23/09/2022

Home Report Index

Single Survey

Property address	Flat 5, 49 West Bryson Road, Polwarth, Edinburgh, EH11 1BQ
-------------------------	--

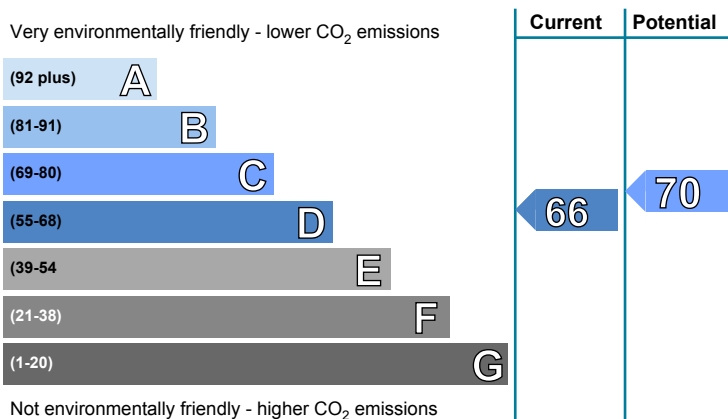
Environmental Impact (CO₂) Rating

This graph shows the effect of your home on the environment in terms of carbon dioxide (CO₂) emissions. The higher the rating, the less impact it has on the environment.
