epoch home report

91 Lanark Road
Edinburgh
EH14 2LZ
25/08/2023

Single Survey

Property address	91 Lanark Road, Kingsknowe, Edinburgh, EH14 2LZ
Customer	Mr Abulhashim & Ms Sigary
Customer address	
Prepared by	Graham & Sibbald
Date of inspection	18th August 2023

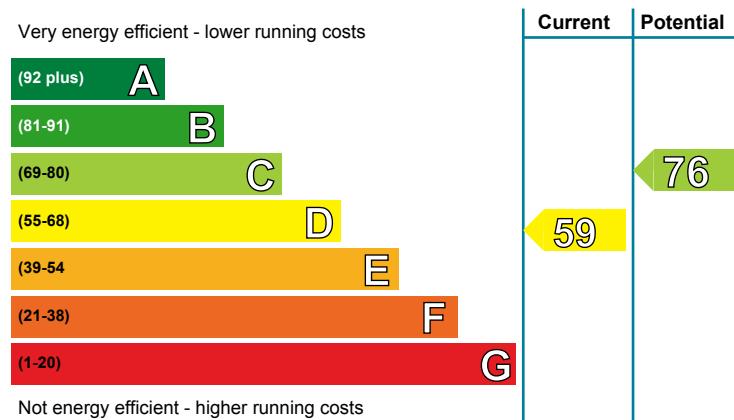
Energy Efficiency Rating

This graph shows the current efficiency of your home, taking into account both energy efficiency and fuel costs. The higher this rating, the lower your fuel bills are likely to be.

Your current rating is **band D (59)**. The average rating for EPCs in Scotland is **band D (61)**.

The potential rating shows the effect of undertaking all of the improvement measures listed within your recommendations report.

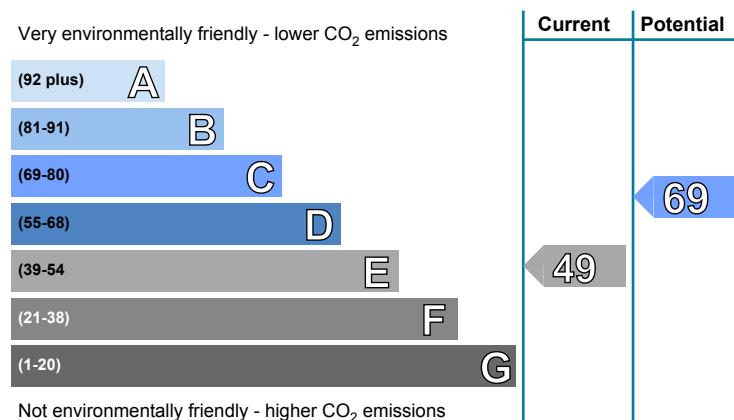
Environmental Impact (CO₂) Rating

This graph shows the effect of your home on the environment in terms of carbon dioxide (CO₂) emissions. The higher the rating, the less impact it has on the environment.
