espc:home report

survey report on:

Property address	GF, 12 Great Stuart Street, New Town, Edinburgh, EH3 7TN
-------------------------	--

Prepared by	Graham + Sibbald
--------------------	------------------

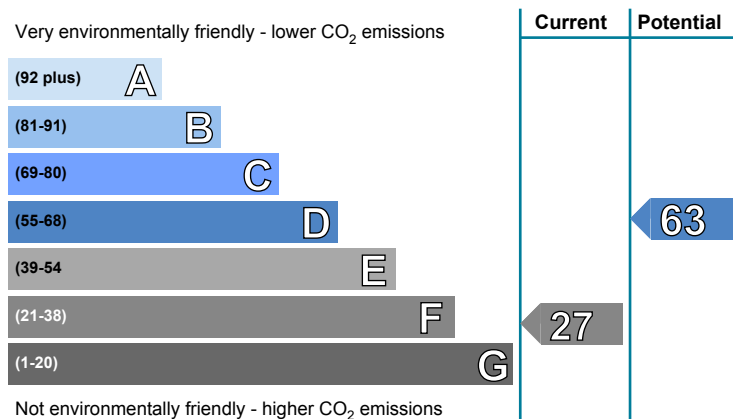
Environmental Impact (CO₂) Rating

This graph shows the effect of your home on the environment in terms of carbon dioxide (CO₂) emissions. The higher the rating, the less impact it has on the environment.
