4 West Pilton March Edinburgh EH4 4JG 10/06/2025

survey report on:

Property address	4 West Pilton March, Pilton, Edinburgh, EH4 4JG
Customer	Mr I Woodcock
Customer address	
Prepared by	Graham & Sibbald
Date of inspection	22nd May 2025

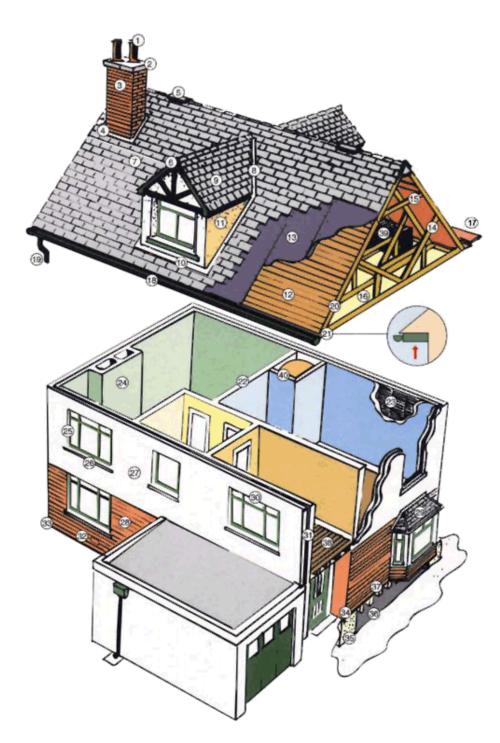
Sectional Diagram showing elements of a typical house

Reference may be made in this report to some or all of the above component parts of the property. This diagram may assist you in locating and understanding these items.

- 1) Chimney pots
- 2) Coping stone
- Chimney head
- 4 Flashing
- 5 Ridge ventilation
- 6 Ridge board
- 7) Slates / tiles
- 8 Valley guttering
- 9) Dormer projection
- 10) Dormer flashing
- 11) Dormer cheeks
- (12) Sarking
- (13) Roof felt
- (14) Trusses
- (15) Collar
- 16 Insulation
- 17) Parapet gutter
- (18) Eaves guttering
- 19) Rainwater downpipe
- 20) Verge boards/skews
- 21) Soffit boards
- 22) Partition wall
- 23) Lath / plaster
- 24) Chimney breast
- (25) Window pointing
 - 6) Window sills
- 27) Rendering
- (28) Brickwork / pointing
- 29) Bay window projection
- 30 Lintels
- (31) Cavity walls / wall ties
- 32) Subfloor ventilator
- 33 Damp proof course
- 34) Base course
- 35) Foundations
- 36) Solum
- 37) Floor joists
- 38) Floorboards
- 39) Water tank
- 40) Hot water tank
