# espc::home report

43/4 Bryson Road  
Edinburgh  
EH11 1DS  
06/11/2024

survey report on:

Property address	1F4, 43 Bryson Road, Polwarth, Edinburgh, EH11 1DS
------------------	--

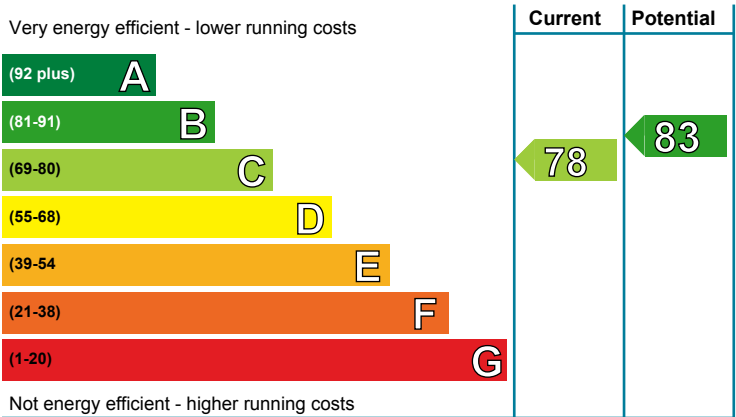
### Energy Efficiency Rating

\* based upon the cost of energy for heating, hot water, lighting and ventilation, calculated using standard assumptions

Very energy efficient - lower running costs

Not energy efficient - higher running costs

The potential rating shows the effect of undertaking all of the improvement measures listed within your recommendations report.

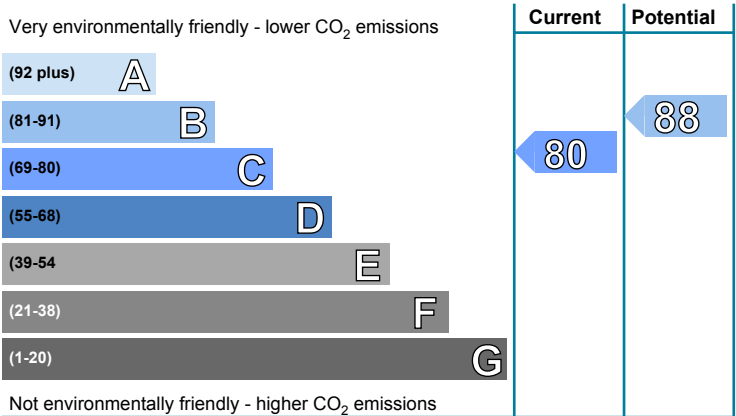
### Environmental Impact (CO<sub>2</sub>) Rating

Very environmentally friendly - lower CO<sub>2</sub> emissions

Not environmentally friendly - higher CO<sub>2</sub> emissions
