Home Report

Scottish Single Survey

Property address	17/4 Arden Street EDINBURGH EH9 1BR
Customer	Mr Scott Cameron
Customer address	17/4 Arden Street EDINBURGH EH9 1BR
Prepared by	Shepherd Chartered Surveyors
Date of inspection	19/12/2022

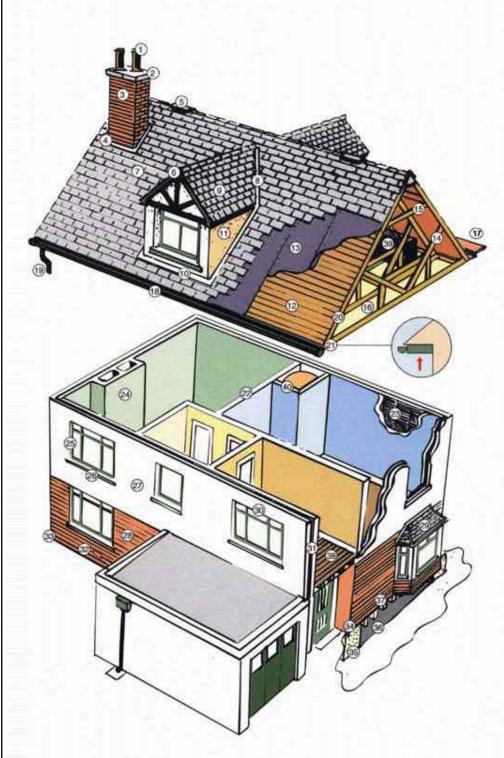
Sectional Diagram showing elements of a typical house

Reference may be made in this report to some or all of the above component parts of the property. This diagram may assist you in locating and understanding these items.

- 1) Chimney pots
- 2) Coping stone
- 3) Chimney head
- (4) Flashing
- 5) Ridge ventilation
- 6) Ridge board
- 7 Slates / tiles
- 8 Valley guttering
- Dormer projection
- 10 Dormer flashing
- 11) Dormer cheeks
- (12) Sarking
- (13) Roof felt
- 14) Trusses
- (15) Collar
- 16) Insulation
- (17) Parapet gutter
- 18) Eaves guttering
- 19) Rainwater downpipe
- 20) Verge boards/skews
- 21) Soffit boards
- 22) Partition wall
- 23) Lath / plaster
- (24) Chimney breast
- 25) Window pointing
- 26) Window sills
- 27) Rendering
- 28) Brickwork / pointing
- 29 Bay window projection
- (30) Lintels
- (31) Cavity walls / wall ties
- 32) Subfloor ventilator
- (33) Damp proof course
- 34) Base course
- (35) Foundations
- 36) Solum
- 37) Floor joists
- 8) Floorboards
- 39) Water tank
- 40) Hot water tank
