# Home Report Index

## **SINGLE SURVEY REPORT**

**38 Hazelbank Terrace  
Edinburgh  
EH11 1SN**

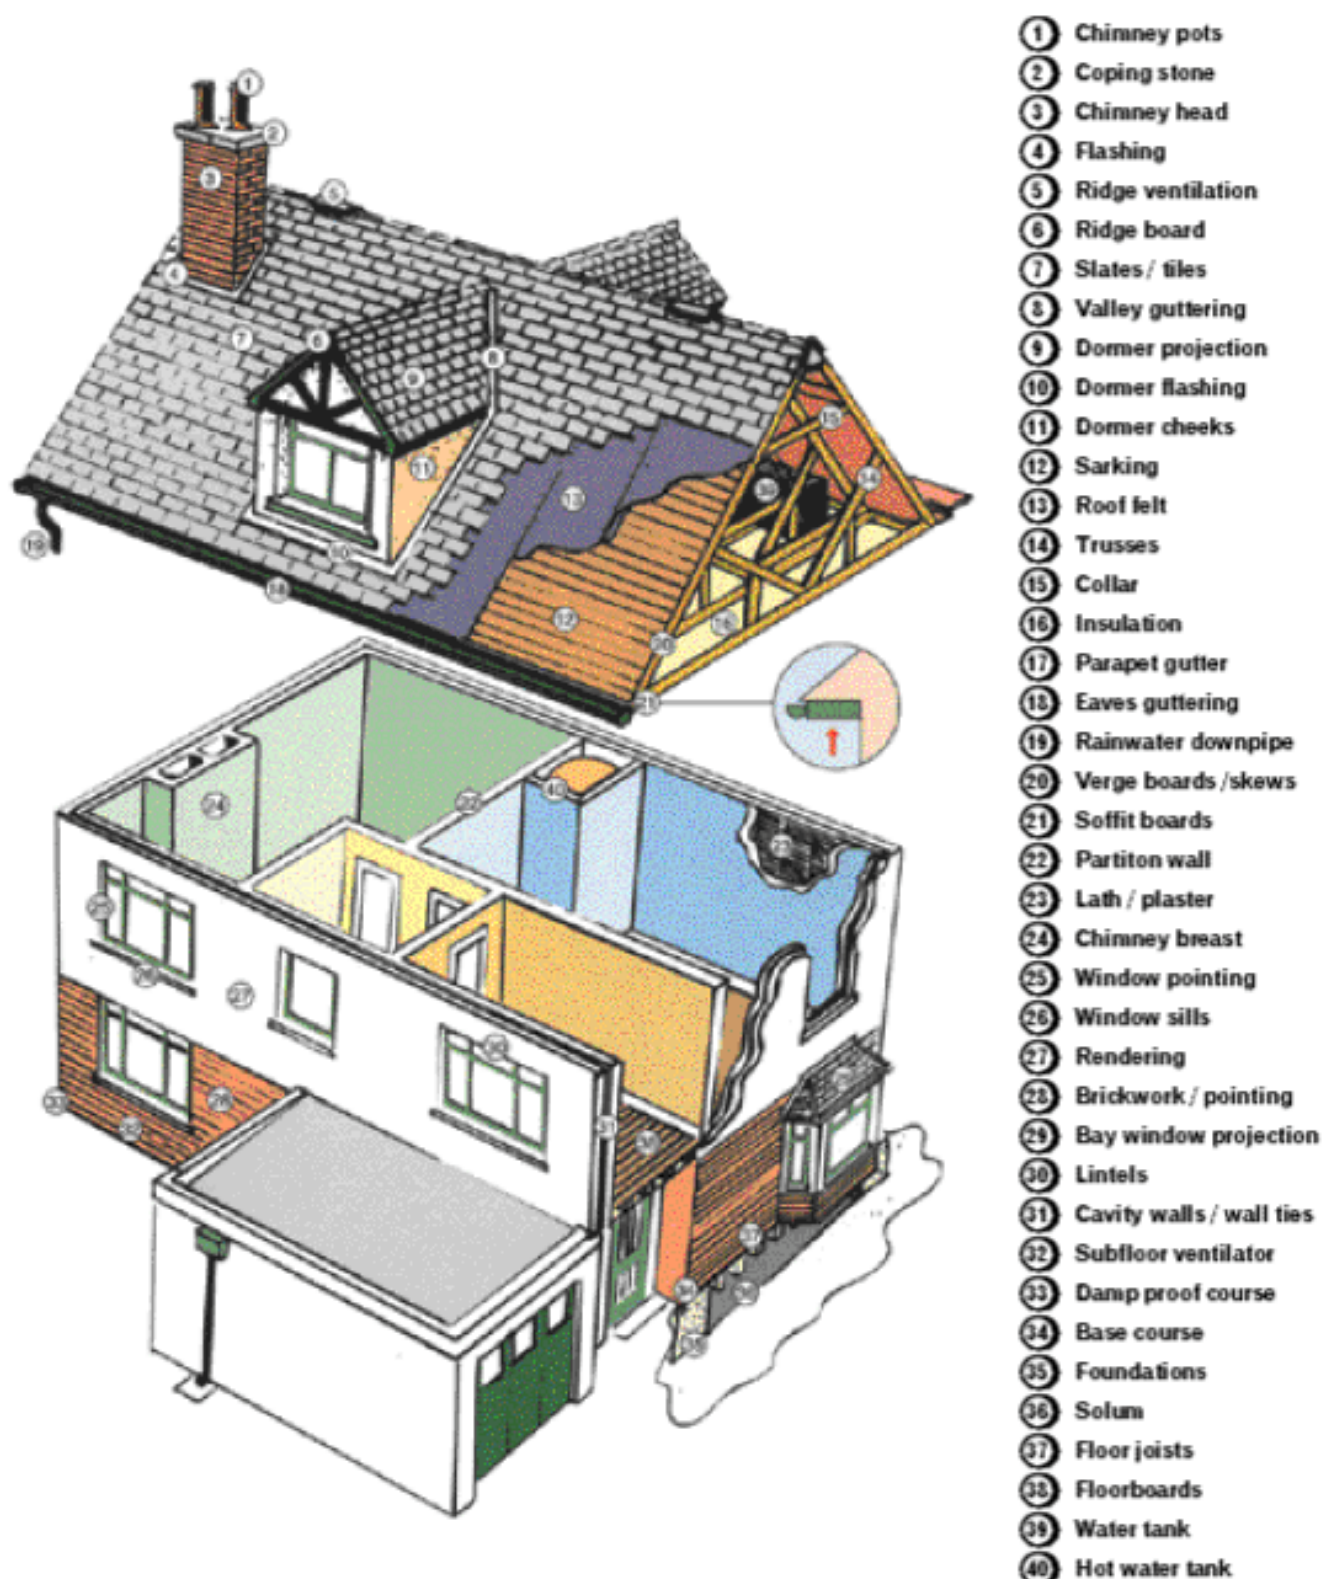
## Sectional diagram showing elements of a typical house

Reference may be made in this report to some or all of the above component parts of the property. This diagram may assist you in locating and understanding these terms.
