epoch home report

16 Newhaven Road
Edinburgh
EH6 5PU
07/04/2023

Single Survey

Property address	16 Newhaven Road, Newhaven, Edinburgh, EH6 5PU
Customer	Mr & Mrs Rogers
Customer address	
Prepared by	Graham & Sibbald
Date of inspection	4th April 2023

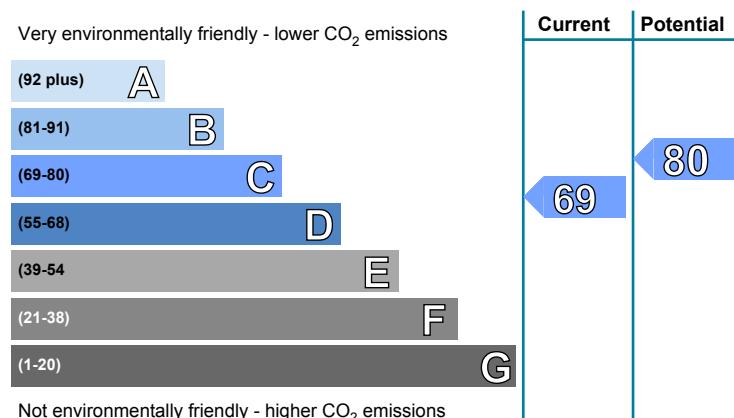
Environmental Impact (CO₂) Rating

This graph shows the effect of your home on the environment in terms of carbon dioxide (CO₂) emissions. The higher the rating, the less impact it has on the environment.
