espc:home report

27 2F2 Bellevue Crescent
Edinburgh
EH3 6NF
17/03/2025

Single Survey

Property address	2F2, 27 Bellevue Crescent, Broughton, Edinburgh, EH3 6NF
-------------------------	--

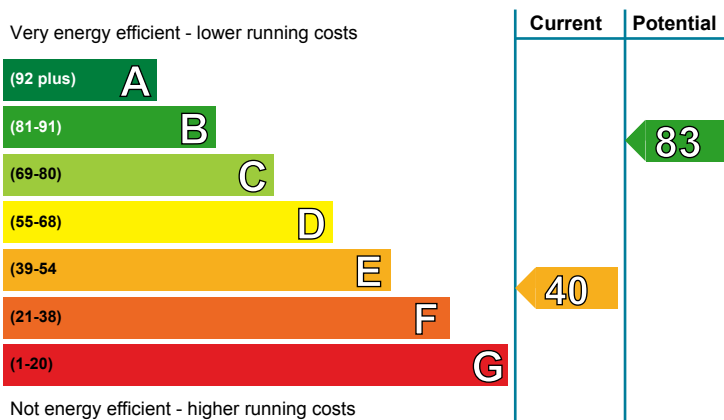
Energy Efficiency Rating

This graph shows the current efficiency of your home, taking into account both energy efficiency and fuel costs. The higher this rating, the lower your fuel bills are likely to be.

Your current rating is **band E (40)**. The average rating for EPCs in Scotland is **band D (61)**.

The potential rating shows the effect of undertaking all of the improvement measures listed within your recommendations report.

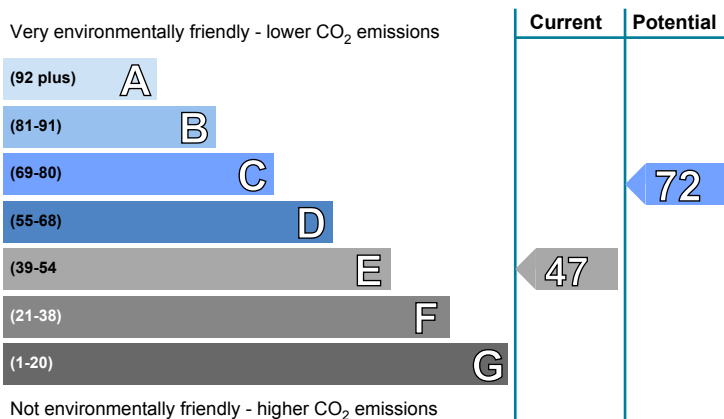
Environmental Impact (CO₂) Rating

This graph shows the effect of your home on the environment in terms of carbon dioxide (CO₂) emissions. The higher the rating, the less impact it has on the environment.
