Home Report

Scottish Single Survey

Property address	30 Strathalmond Road Edinburgh EH4 8AF
-------------------------	--

Prepared by	Shepherd Chartered Surveyors
--------------------	------------------------------

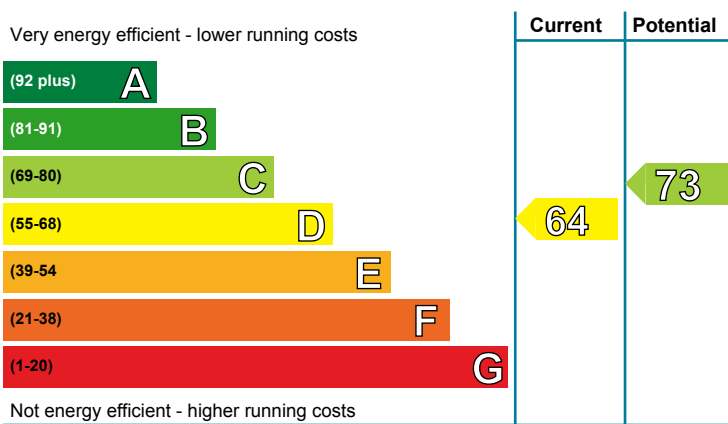
Energy Efficiency Rating

This graph shows the current efficiency of your home, taking into account both energy efficiency and fuel costs. The higher this rating, the lower your fuel bills are likely to be.

Your current rating is **band D (64)**. The average rating for EPCs in Scotland is **band D (61)**.

The potential rating shows the effect of undertaking all of the improvement measures listed within your recommendations report.
