5E Forrester Park Drive, Corstorphine Edinburgh EH12 9AY 26/02/2024

SINGLE SURVEY REPORT

5E Forrester Park Drive Edinburgh EH12 9AY

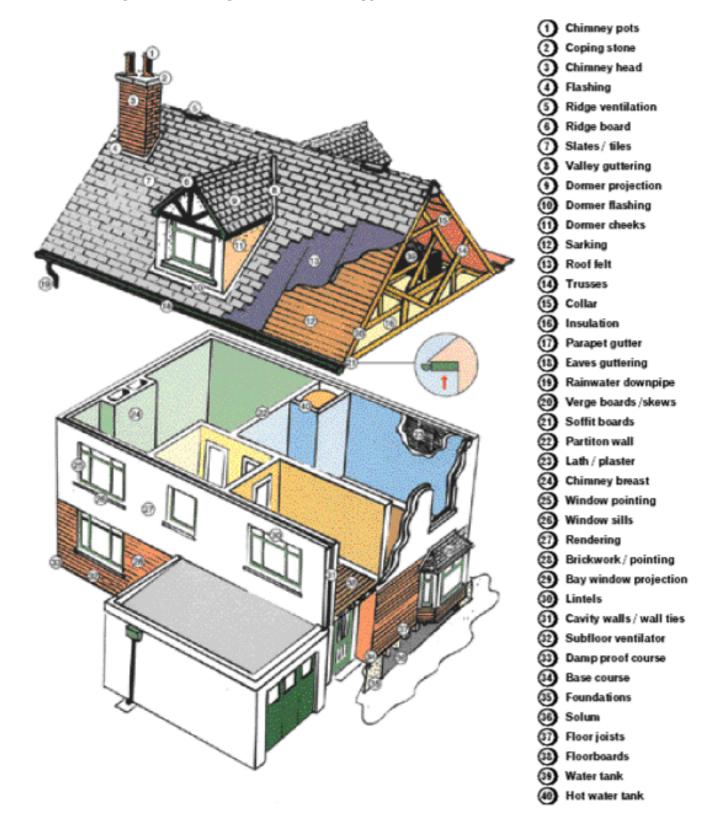
Sectional diagram showing elements of a typical house

Reference may be made in this report to some or all of the above component parts of the property. This diagram may assist you in locating and understanding these terms.
