2F
41 COATES GARDENS
NEW TOWN
EDINBURGH
EH12 5LF

Home Report

Energy Performance Certificate (EPC)

Scottish Single Survey

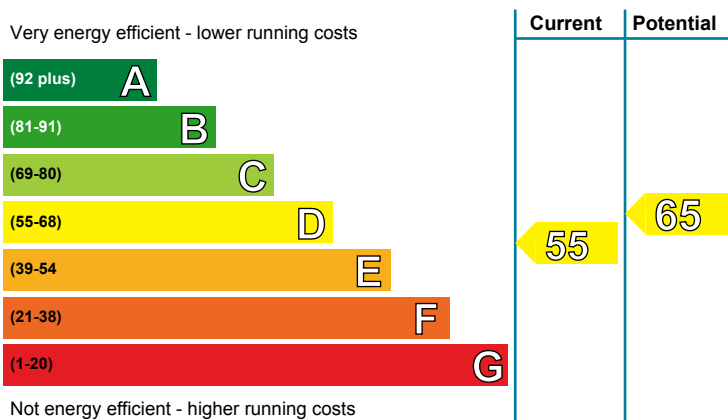
Energy Efficiency Rating

This graph shows the current efficiency of your home, taking into account both energy efficiency and fuel costs. The higher this rating, the lower your fuel bills are likely to be.

Your current rating is **band D (55)**. The average rating for EPCs in Scotland is **band D (61)**.

The potential rating shows the effect of undertaking all of the improvement measures listed within your recommendations report.
